# 2 *Site Observations*

On September 12, 1996, the FEMA Mitigation Directorate deployed a BPAT to coastal North Carolina to assess damage caused by Hurricane Fran. The team was composed of FEMA Headquarters and regional office engineers, a State representative, a consulting structural engineer, a consulting specialist in coastal construction and shoreline erosion, a consulting coastal engineer, the Chief Underwriter of the NFIP, and an engineer from the Insurance Institute for Property Loss Reduction. (See Appendix B for a list of team members.) Some members of the BPAT also represented the American Society of Civil Engineers (ASCE) Committee on Flood-Resistant Design and Construction.

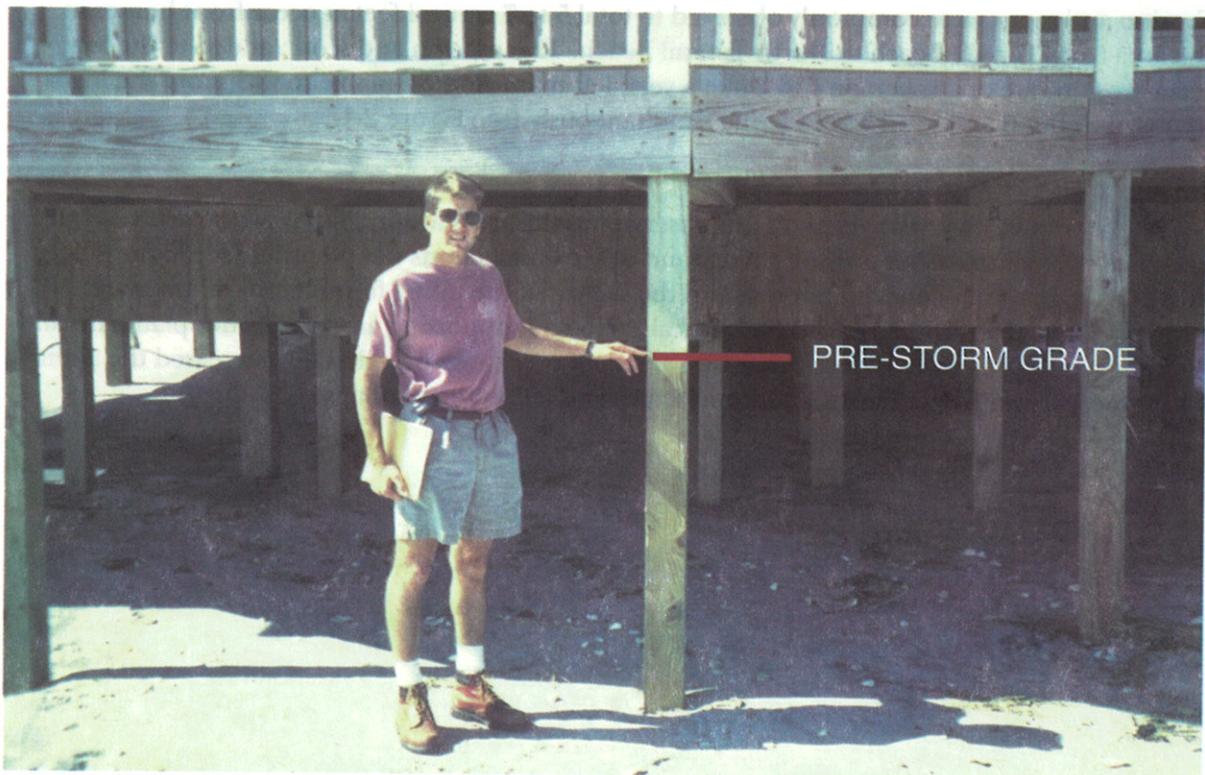
Coastal areas from Cape Fear to Cape Lookout experienced significant erosion and scour. In many locations, especially from Topsail Beach to North Topsail Beach, localized frontal dunes were eroded and the beach profile was lowered 2 to 3 feet. Erosion beneath oceanfront homes averaged 4 to 6 vertical feet (see Figure 2-2). In addition, erosion and localized scour at vertical foundation members was observed to have occurred.

*Figure 2-2 Erosion resulted in significant loss of supporting sand, averaging 4 to 6 feet, under oceanfront buildings.*

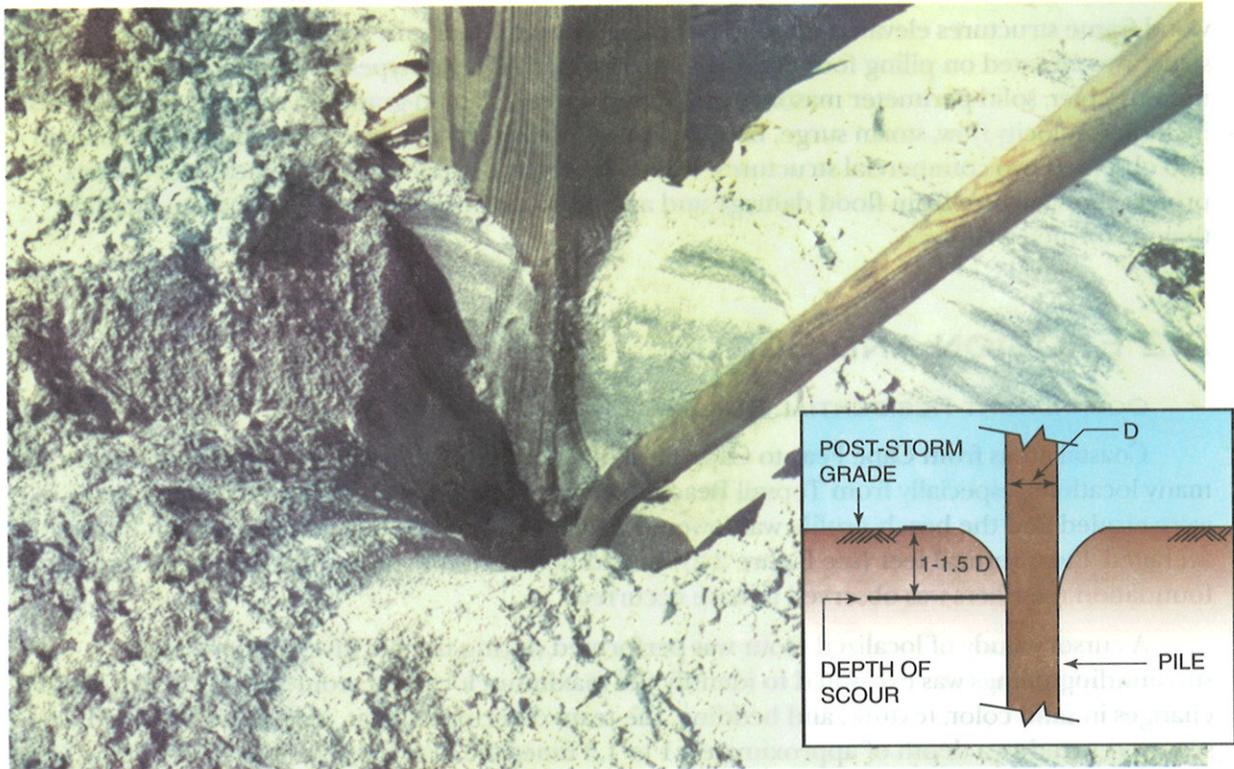
A cursory study of localized scour was performed during the site investigation. Sand surrounding pilings was excavated to identify the maximum localized scour that occurred. From changes in sand color, texture, and bedding, the team determined that, in general, localized scour occurred to a depth of approximately 1 to 1.5 times the diameter or width of the piling (see Figure 2-3). The depth of scour around 8-inch-diameter round pilings and 8-inch x 8-inch square pilings supporting oceanfront structures was measured to be approximately 10 to 11 inches.

Figure 2-3 Determination of localized scour from changes in sand color, texture, and bedding.

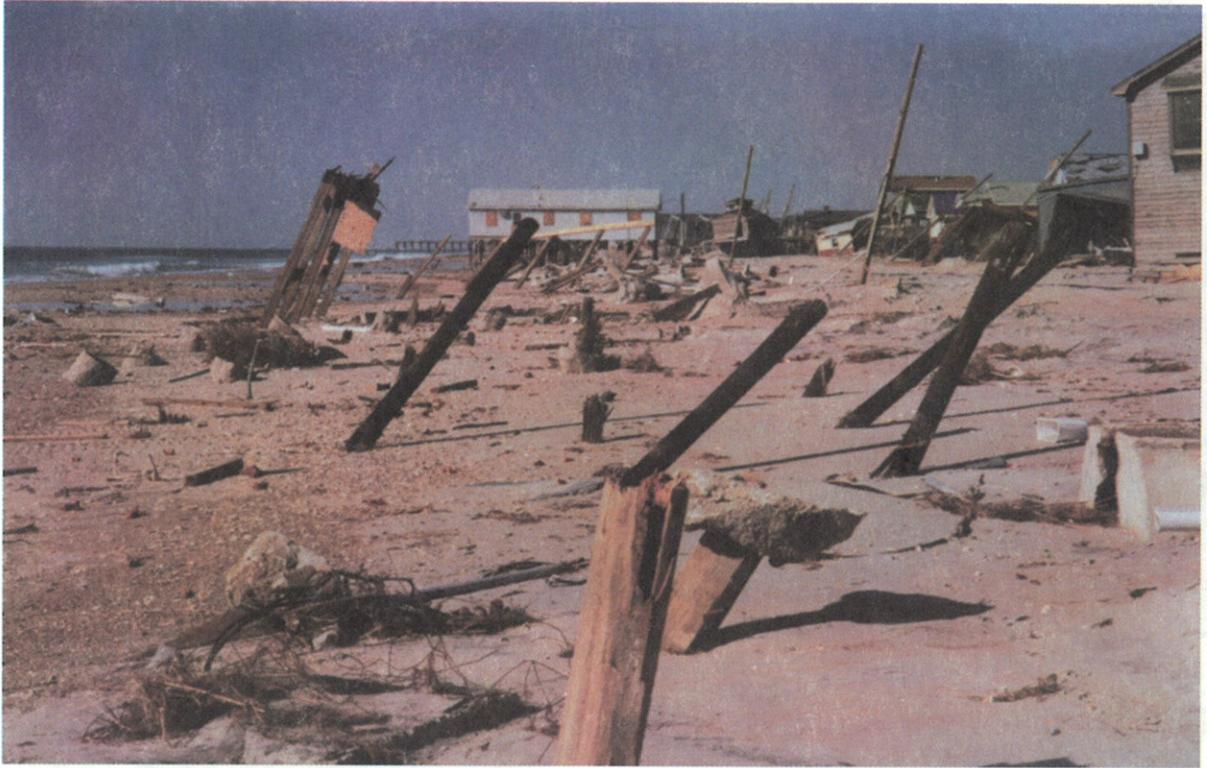
Erosion and scour were commonly observed to total 5 to 7 vertical feet at oceanfront homes in the area from Topsail Beach to North Topsail Beach. This erosion and scour, added to the long-term erosion rate of an average 1 to 2 feet a year, left many homes unable to withstand the loads imposed by flood and wind forces acting simultaneously (see Figure 2-4).

*Figure 2-4* Loss of the frontal dune and the resulting erosion and scour left many coastal houses unable to resist wind and flood loads acting simultaneously.

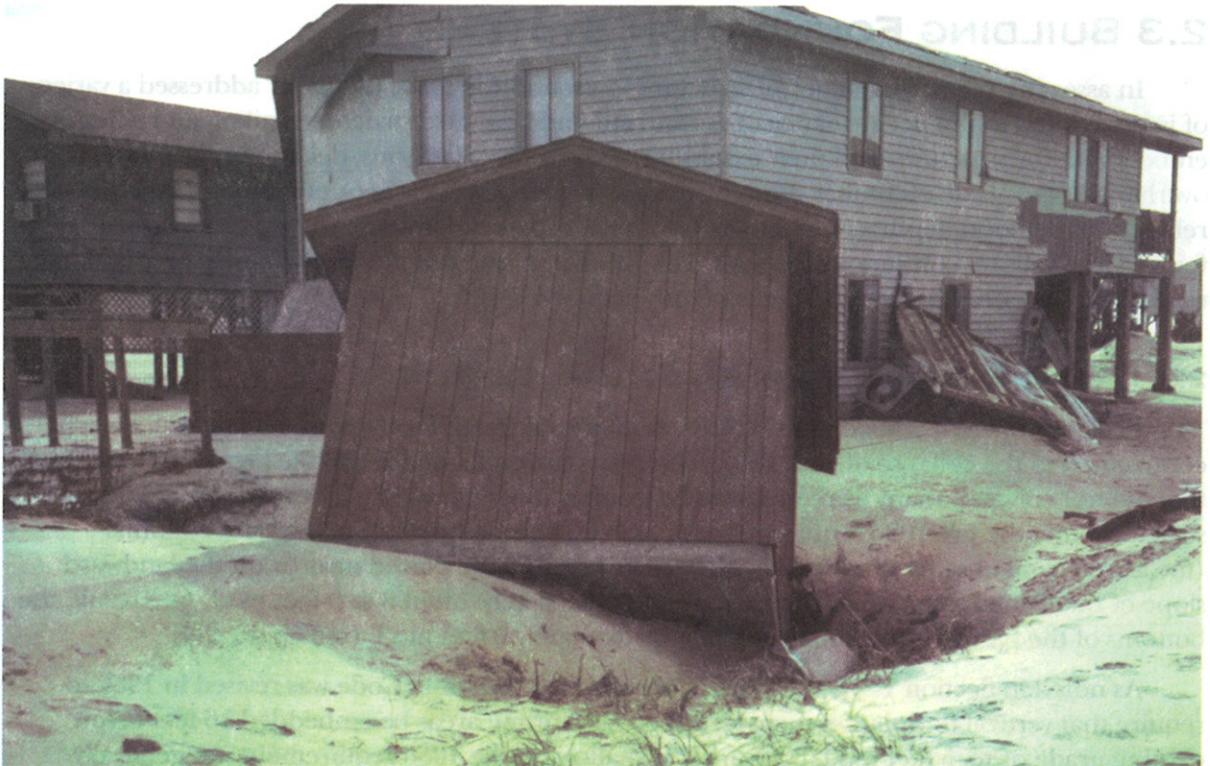
*Figure 2-5* Overwash of barrier islands generated high-velocity flows that caused extensive scour adjacent to large objects.

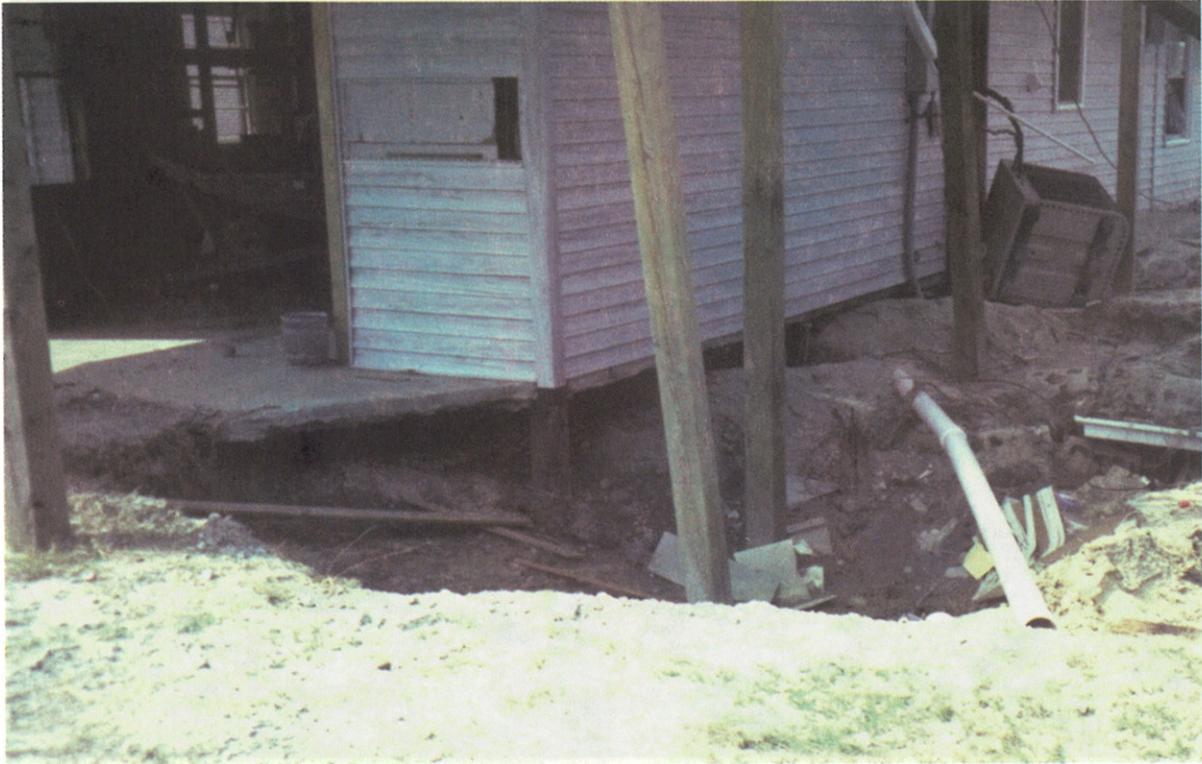
*Figure 2-6 The disruption of velocity flows by large, non-breakaway objects generated extensive scour that undermined vertical foundation members and slabs-on-grade.*

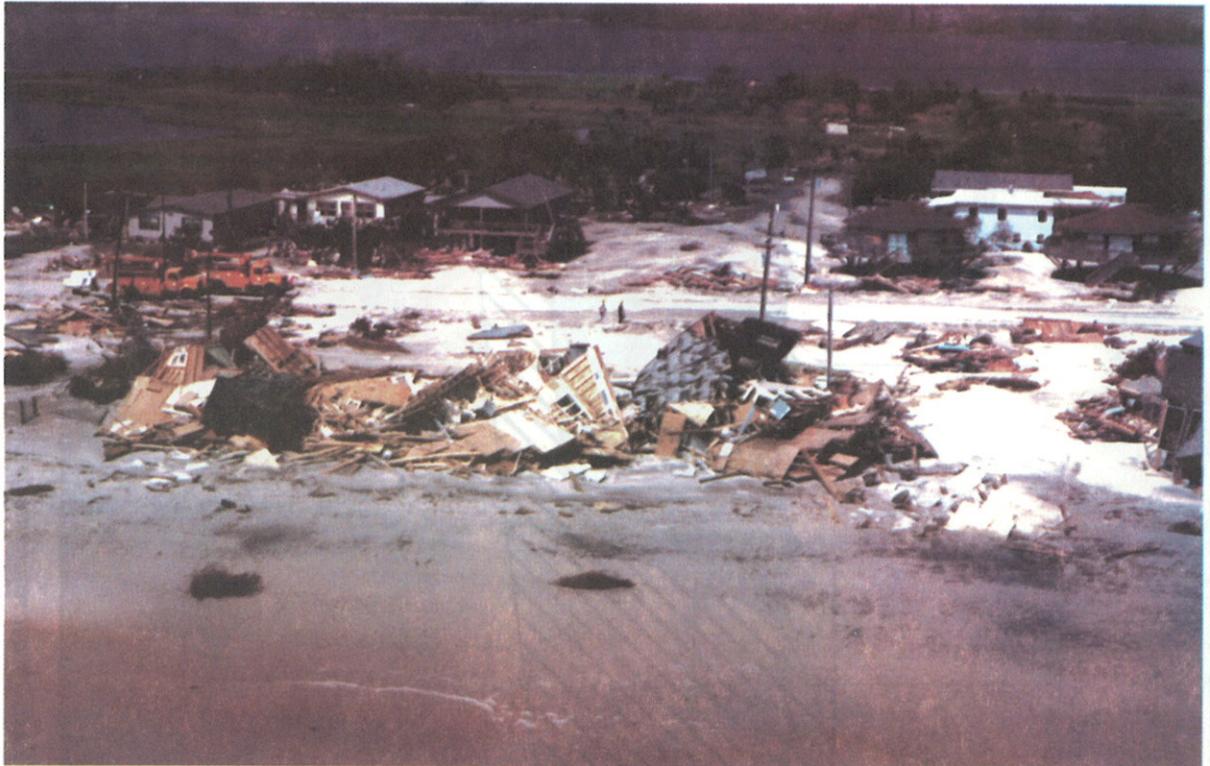
Lack of sufficient embedment of vertical structural foundation members may well have contributed to the collapse of over 100 oceanfront residential buildings (see Figure 2-7). Of those that did not collapse, many were found to be leaning (see Figure 2-8). The majority of these structures met the pre-1986 requirement for an 8-foot embedment of pilings and columns (measured from existing grade). Many front-row houses were placed near or on the landward slope of the frontal dune, where the ground elevations were often 8 to 9 feet m.s.l. As a result, the bottoms of the pilings or columns were at approximately 0 feet m.s.l. (see Figure 2-9)

*Figure 2-7 Over 100 oceanfront houses were washed off their foundations or completely destroyed.*

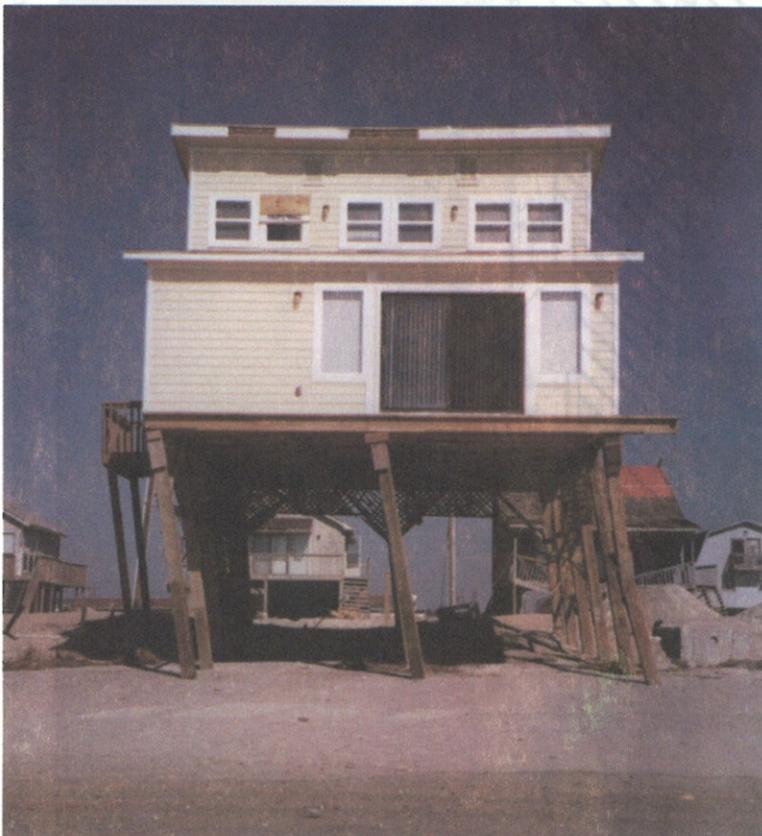
*Figure 2-8 Many oceanfront houses built prior to current (1986) North Carolina State Building Code requirements were found to be leaning or destroyed.*

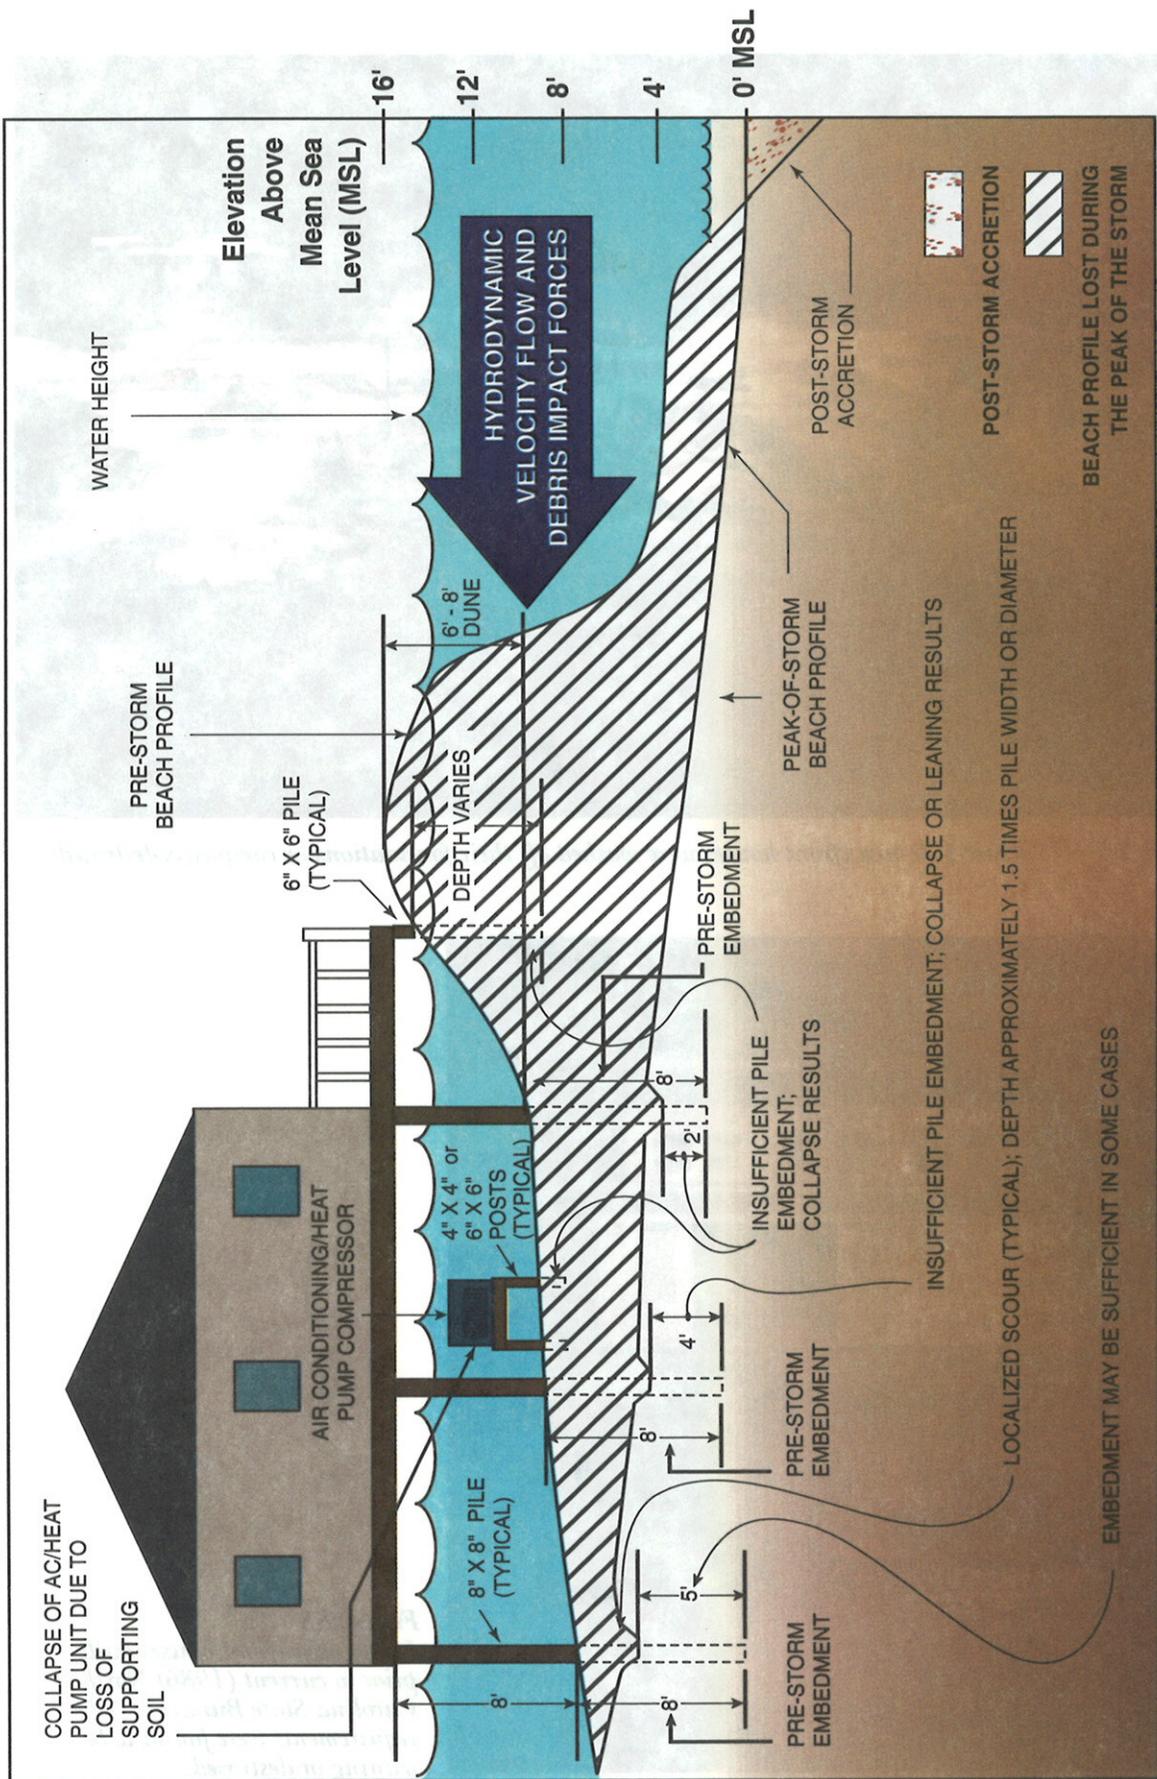
Figure 2-9 Typical collapse mechanism of post-FIRM building based on pre-1985 embedment requirements in North Carolina coastal areas.

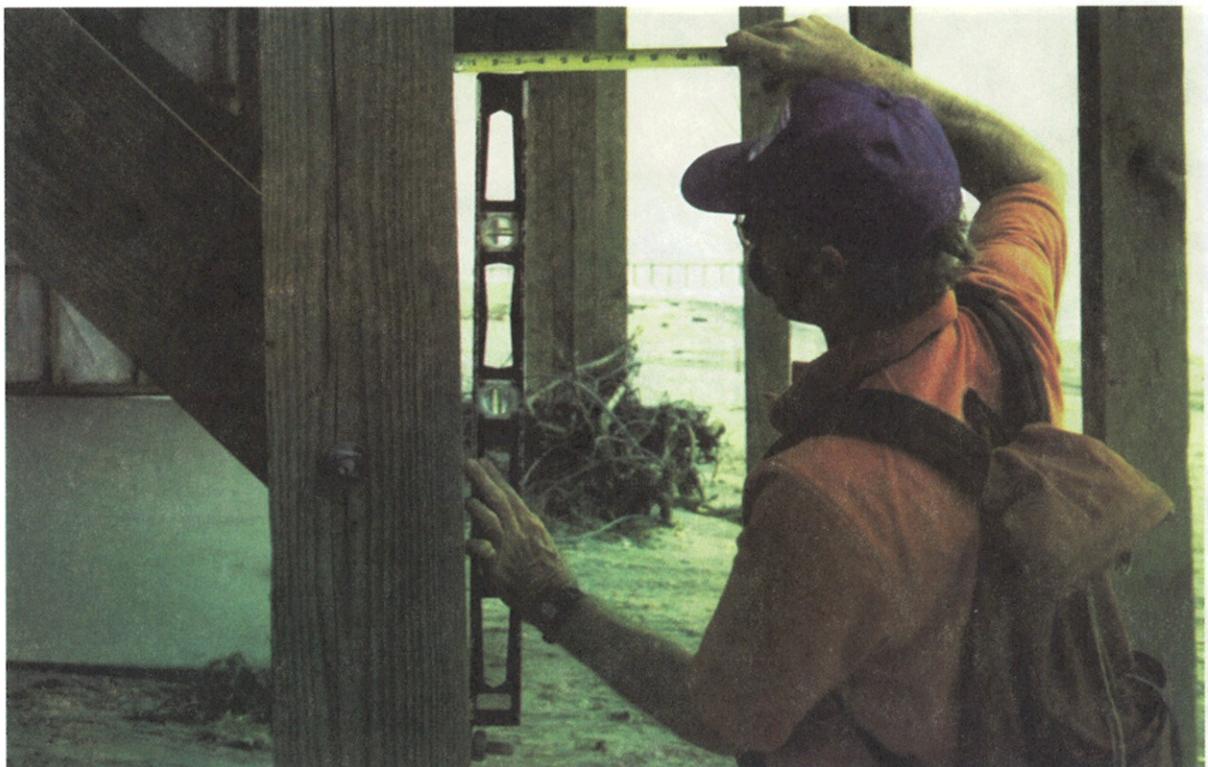
Although post-1986 oceanfront structures generally performed better than oceanfront structures built prior to 1986, several foundations supporting oceanfront structures that were observed to be leaning were suspected of being post-1986 (see Figure 2-10). The remaining embedment depth of the foundation members beneath these structures was not determined by the BPAT; however, for example, with a pre-storm grade of 11 feet m.s.l., erosion of approximately 6 vertical feet to an elevation of approximately 5 feet m.s.l., and localized scour of an additional 1 vertical foot, the vertical foundation members should still have been embedded approximately 9 feet below grade during the height of the storm. This depth should have been sufficient to prevent leaning in many cases. One possible explanation is that the pilings under these leaning structures did not meet the current embedment depth requirement.

*Figure 2-10* One of several buildings observed to be leaning landward that were suspected of having been constructed to current North Carolina State Building Code requirements.

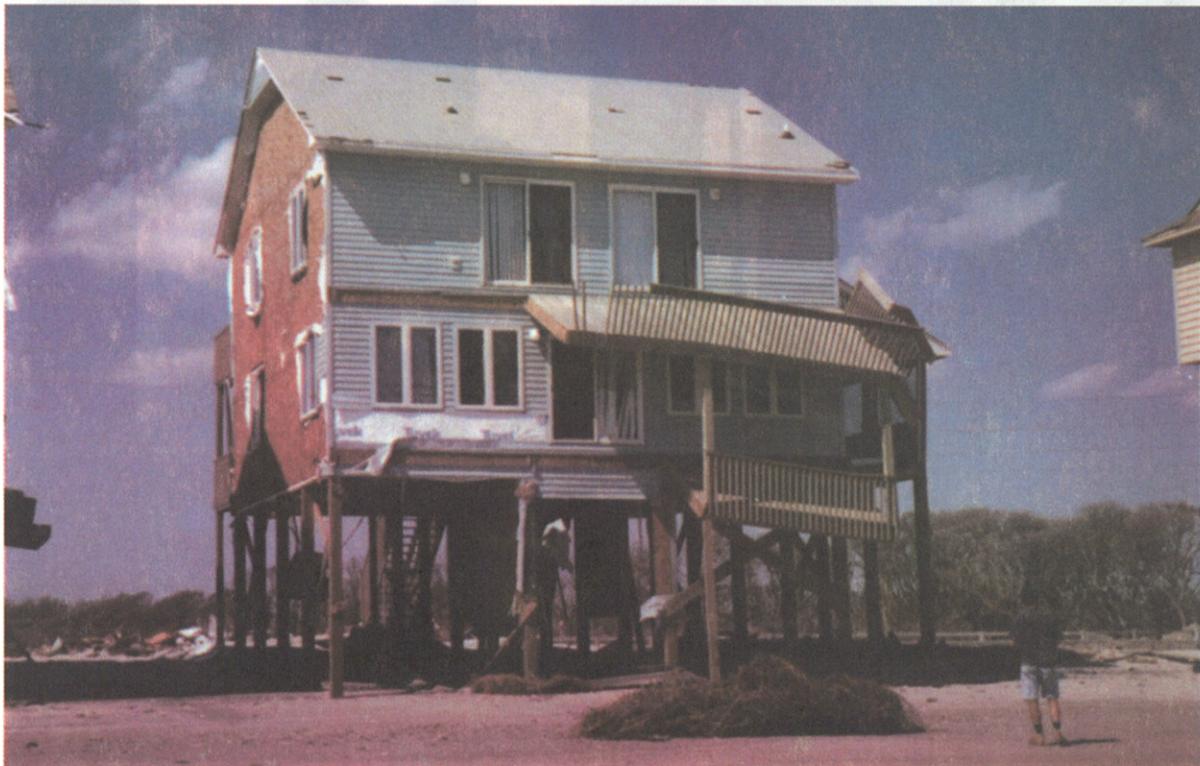
Lack of sufficient embedment of vertical foundation members for decks, porches, and roof overhangs attached to oceanfront and landward residential buildings resulted in the collapse of several hundred of these building extensions (see Figure 2-11).

*Figure 2-11 The BPAT observed several hundred decks and porches that collapsed as a result of insufficient foundation support.*

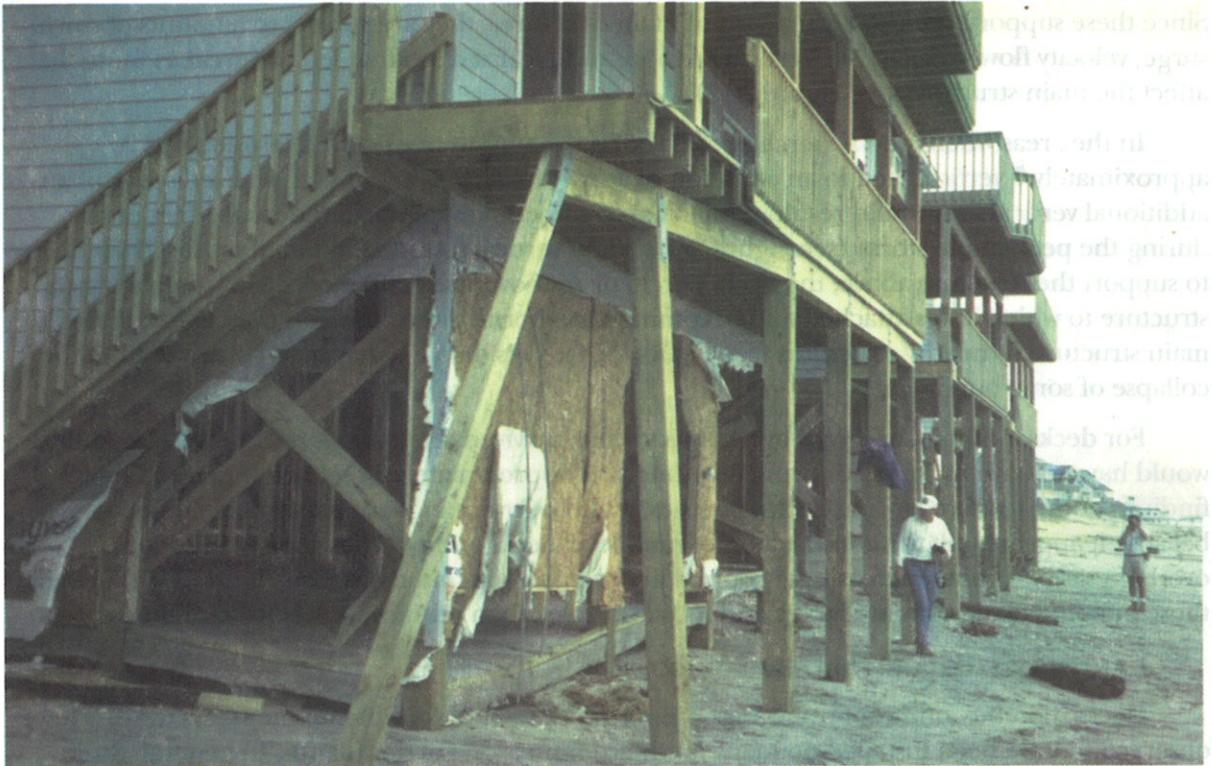
Vertical foundation members supporting unroofed decks did not have to meet the pre-1986 State Building requirement for 8-foot piling embedment, nor do they have to meet the post-1986 requirement for 16-foot embedment. Vertical foundation members for covered porches and roof overhangs are supposed to meet the criterion applied to the foundation members for the main structure. The BPAT found that vertical foundation members for decks, porches, and roof overhangs were often embedded to a depth of only 2 to 6 feet below existing grade (see Figure 2-12).

*Figure 2-12 Example of building constructed to current North Carolina State Building Code requirements with insufficient embedment of piles/columns under two-story deck.*

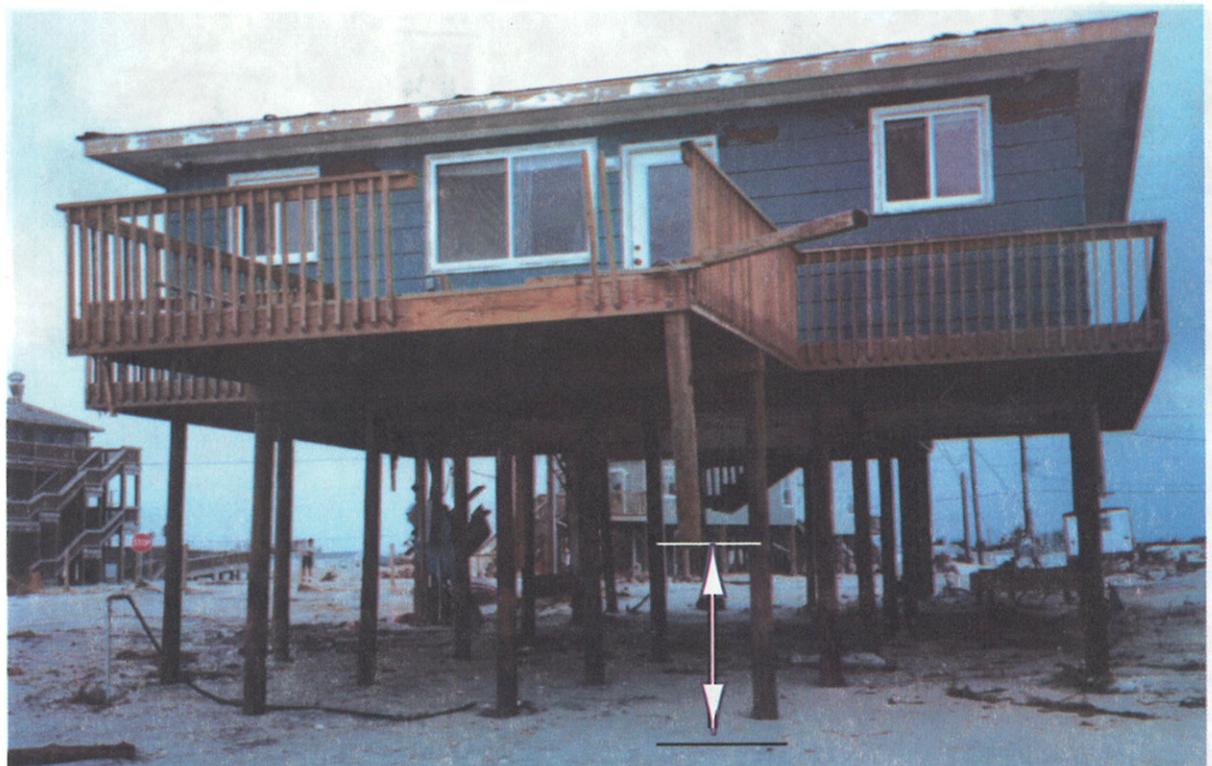
*Figure 2-13 Embedment of deck supports into frontal dune was often shallow. After erosion of the dune, the bottom of the support for this deck was left several feet above grade.*

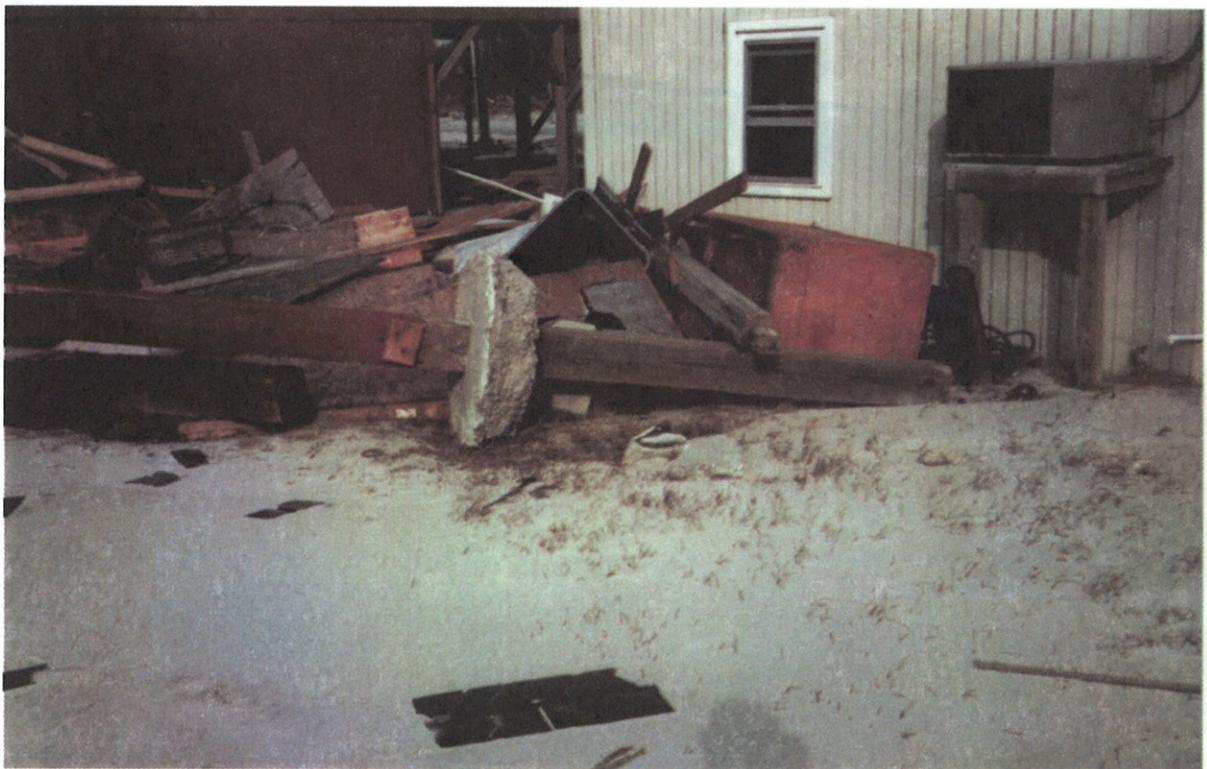
In the areas where decks, porches, and roof overhangs were observed, erosion was approximately 7 vertical feet, to an elevation of approximately 4 feet m.s.l. Localized scour of an additional vertical foot would result in total loss of embedment to an elevation of 3 feet m.s.l. during the peak of the storm (see Figure 2-9). When vertical foundation members lost their ability to support the structure above, the deck, porch, or roof overhang often collapsed, damaging the structure to which it was attached and becoming waterborne debris that was then carried into the main structure or nearby structures (see Figure 2-14). This damage may have contributed to the collapse of some buildings.

Figure 2-14 Storm-generated debris impacted nearby structure.

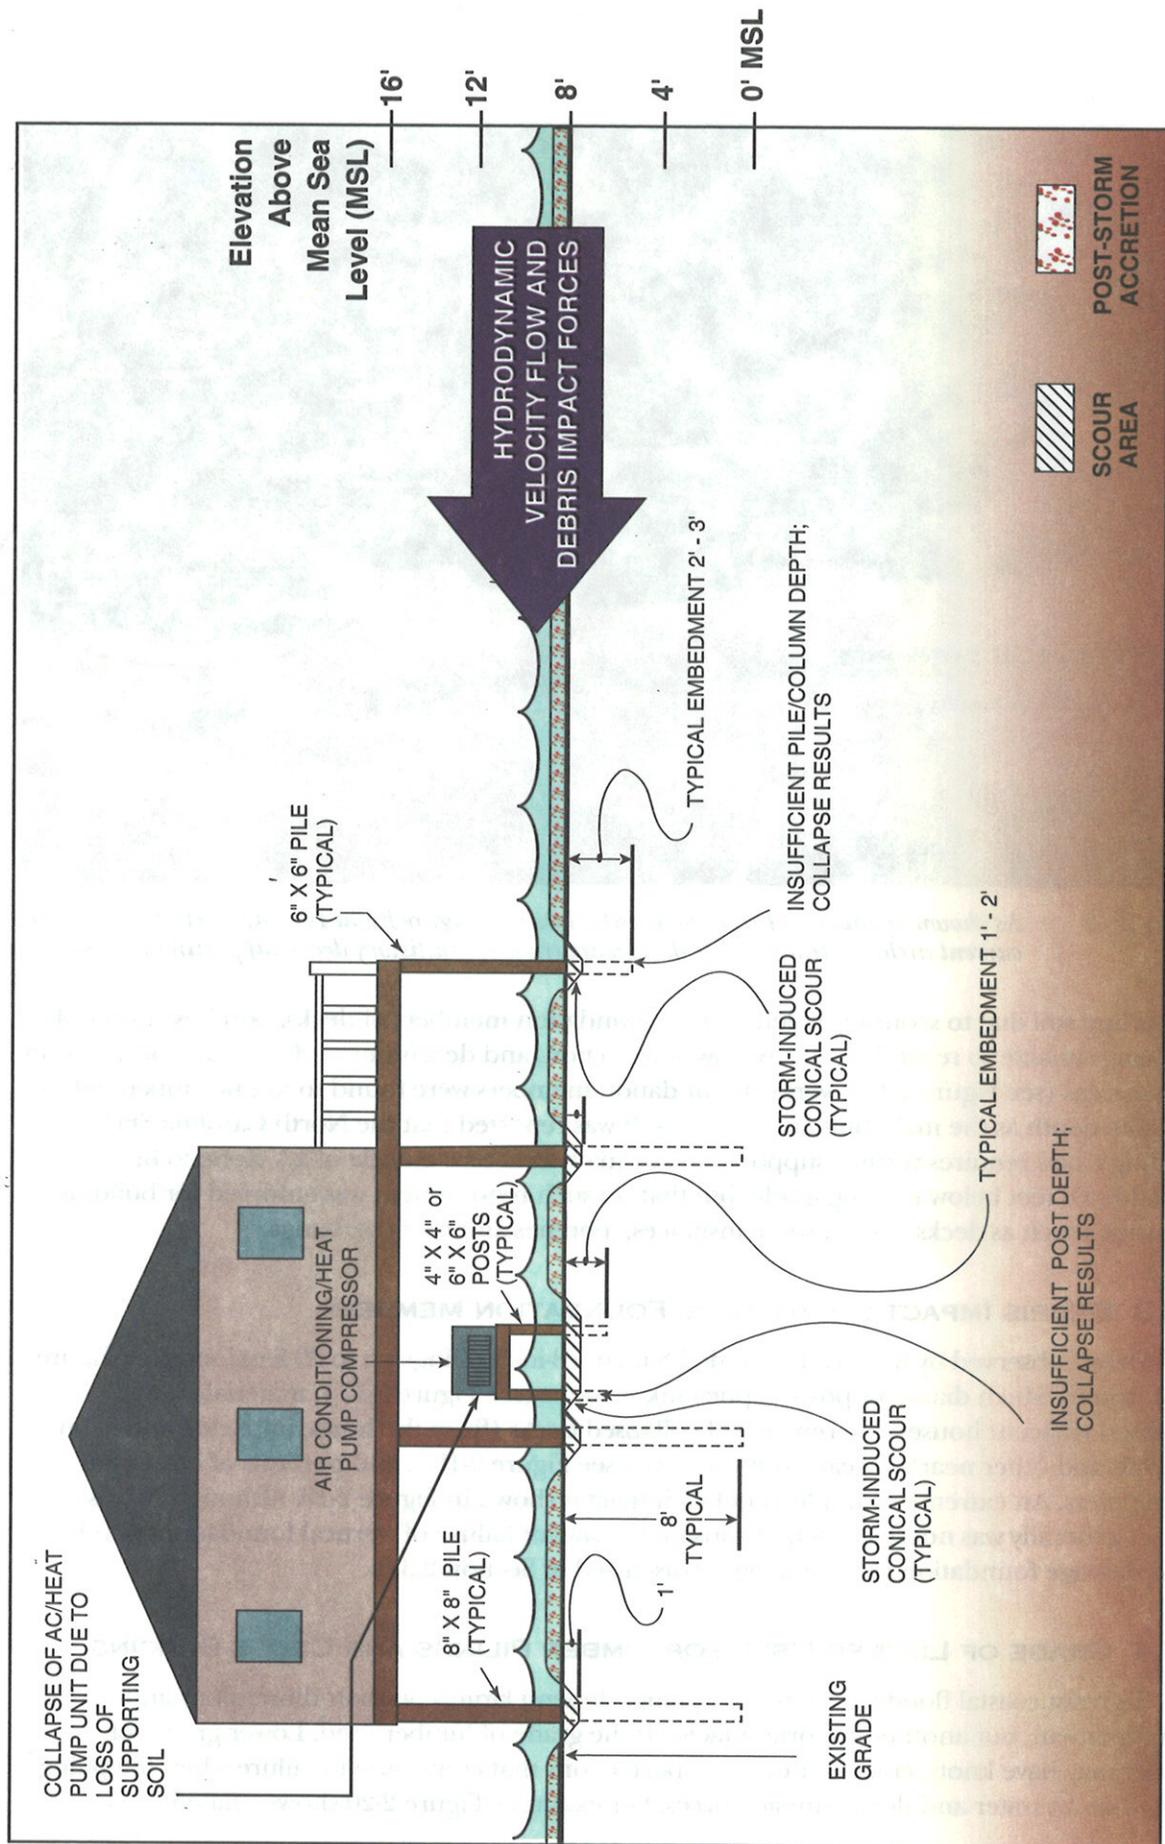
supporting soil due to scour often left vertical foundation members of decks, porches, and roof overhangs unable to resist the velocity flow, wave action, and debris impact forces that occurred in coastal areas (see Figure 2-16). Vertical foundation members were found to not be embedded to the same depth as the main building supports. It was reported that the North Carolina State Building Code requires vertical supports for the main structure outside of a V Zone to be embedded 8 feet below existing grade, but that no such requirement was enforced for building extensions such as decks and, in some instances, porches and roof overhangs.

Figure 2-16 Typical failure of deck / roof overhang and air conditioning / heat pump compressor platform for landward home.

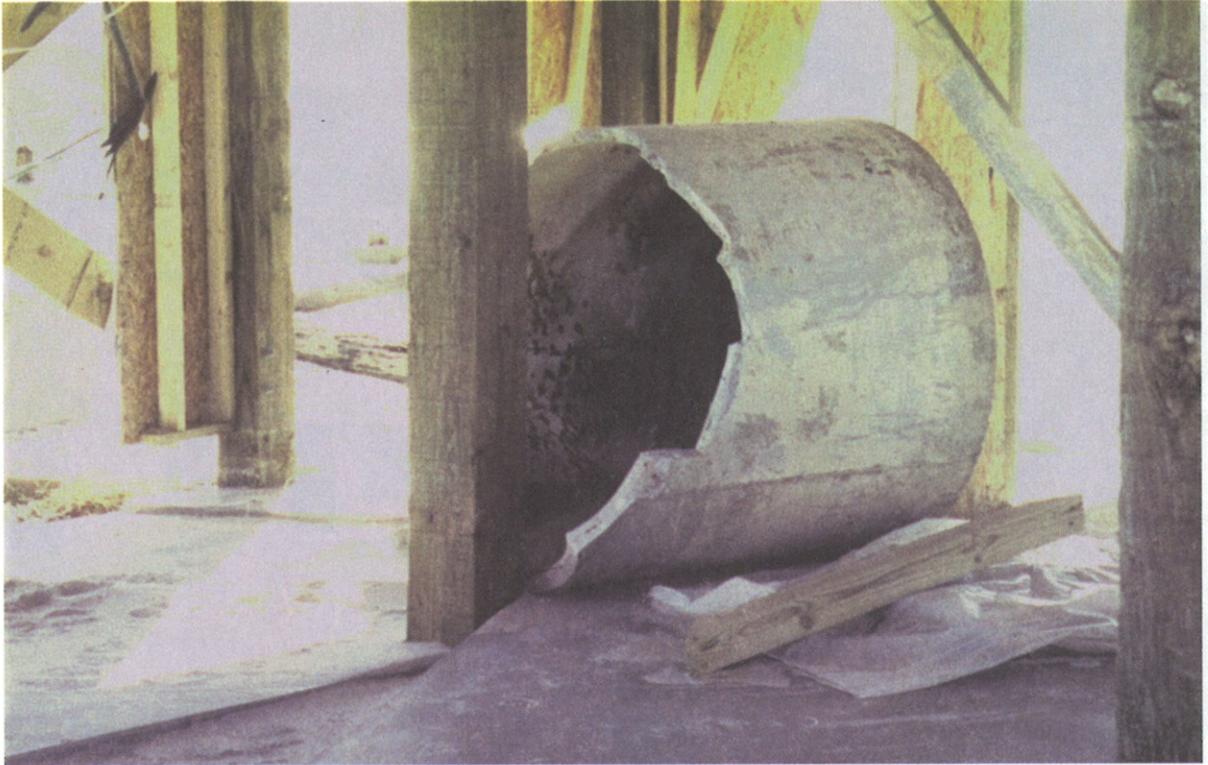
*Figure 2-17 Precast concrete ring section of septic tank became waterborne debris, impacting building foundation members.*

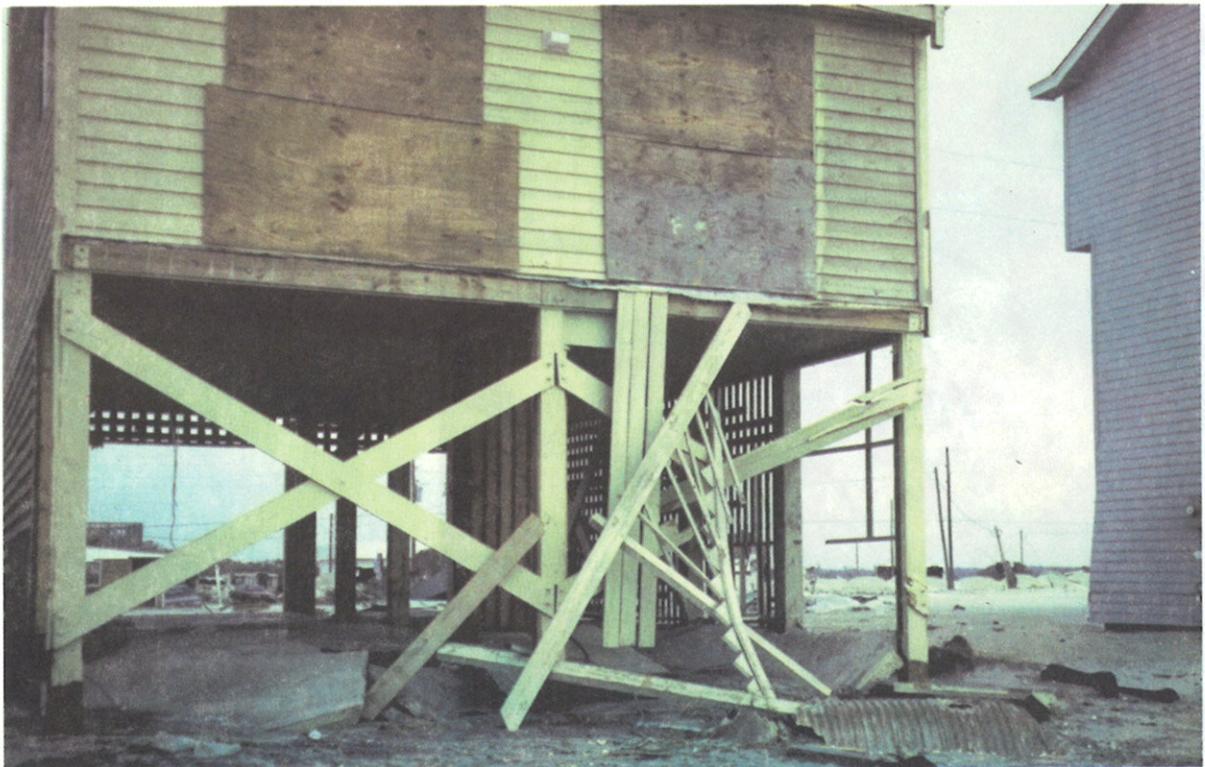
*Figure 2-18 Impact of debris from a damaged deck appeared to have broken cross-bracing.*

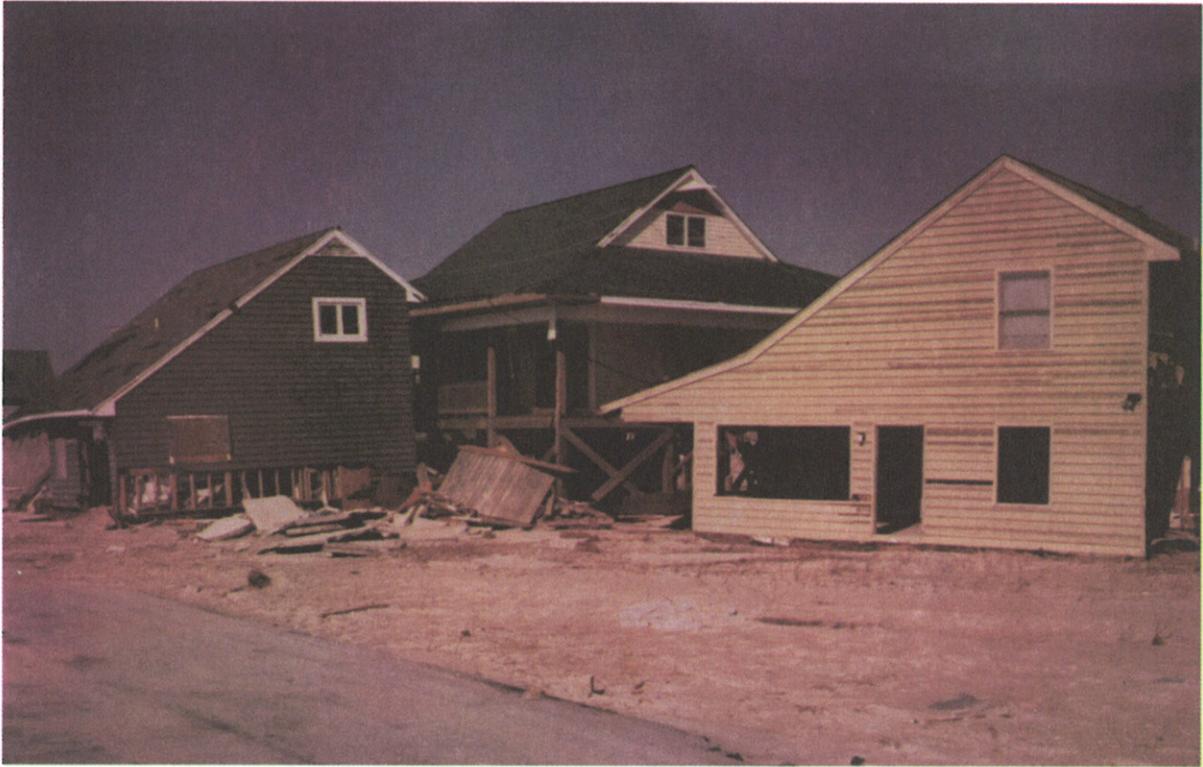
Figure 2-19 Example of extreme impact — two houses floated and pushed into another house.

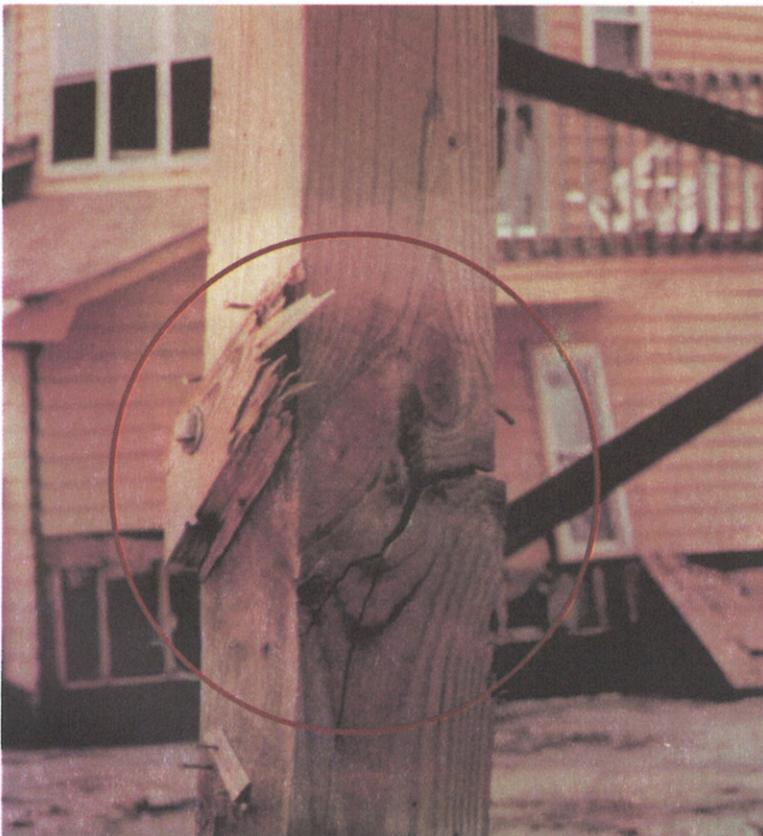
Figure 2-20 Example of broken piling. The piling broke at the location of several knots (circle), where cross-bracing was attached (note remaining bolt and piece of bracing).

piling whose strength was compromised by closely spaced knots. Failures of this type were not widely observed by the BPAT but, as indicated by Figure 2-20, are a potential problem that can lead to structure failure and even collapse.

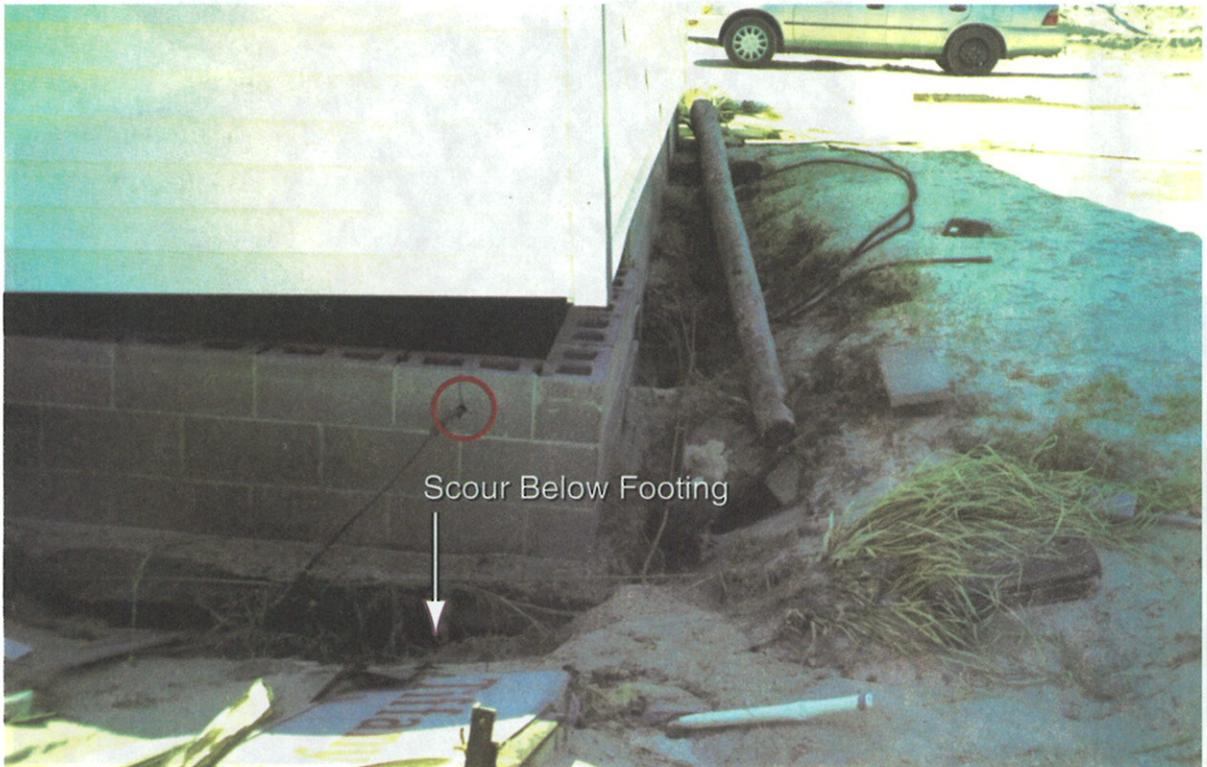
*Figure 2-22 Collapse of footing and foundation wall under elevated wood-frame building. Collapse resulted because obstruction of flow by building caused scour to extend below the bottom of the footing (arrow). Note propane gas line (circled) extending through foundation wall.*

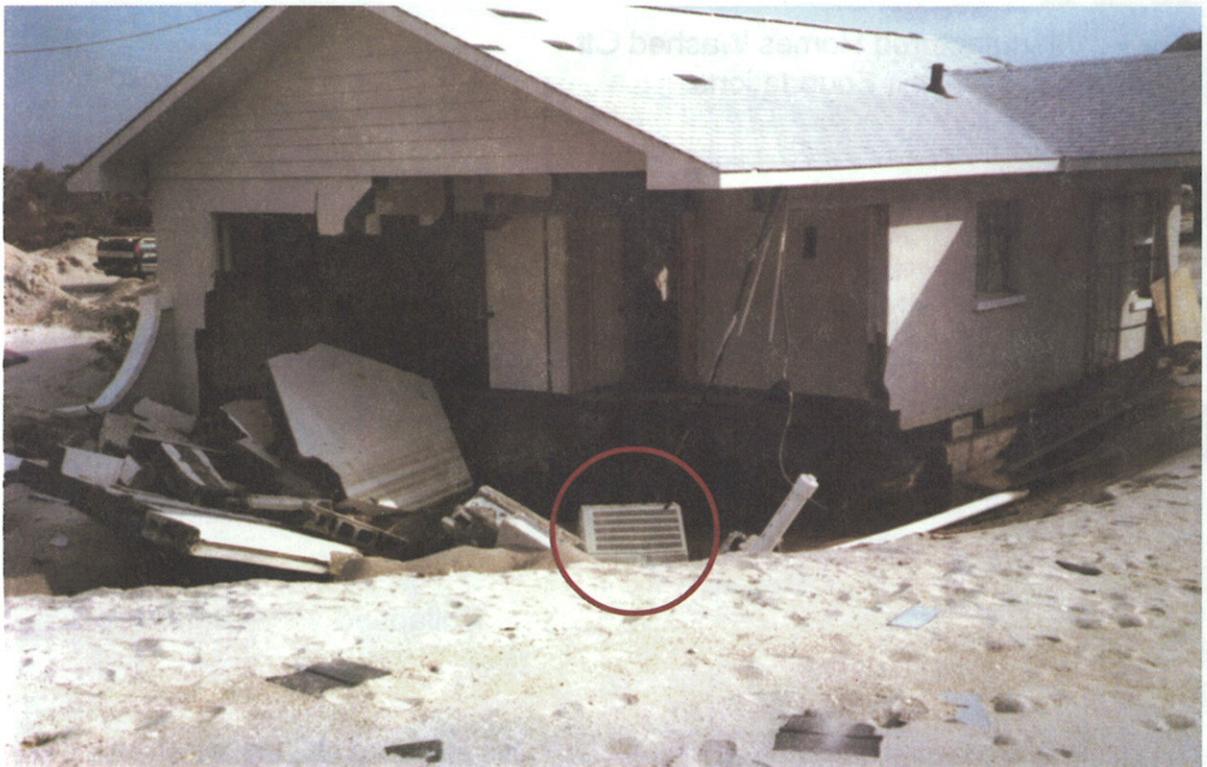
*Figure 2-23 Catastrophic failure of landward building constructed on masonry wall and slab-on-grade foundation. Failure resulted because obstruction of flow by building caused extensive scour. Note compressor collapsed into scour hole.*
