# 2 *Site Observations*

On September 12, 1996, the FEMA Mitigation Directorate deployed a BPAT to coastal North Carolina to assess damage caused by Hurricane Fran. The team was composed of FEMA Headquarters and regional office engineers, a State representative, a consulting structural engineer, a consulting specialist in coastal construction and shoreline erosion, a consulting coastal engineer, the Chief Underwriter of the NFIP, and an engineer from the Insurance Institute for Property Loss Reduction. (See Appendix B for a list of team members.) Some members of the BPAT also represented the American Society of Civil Engineers (ASCE) Committee on Flood-Resistant Design and Construction.

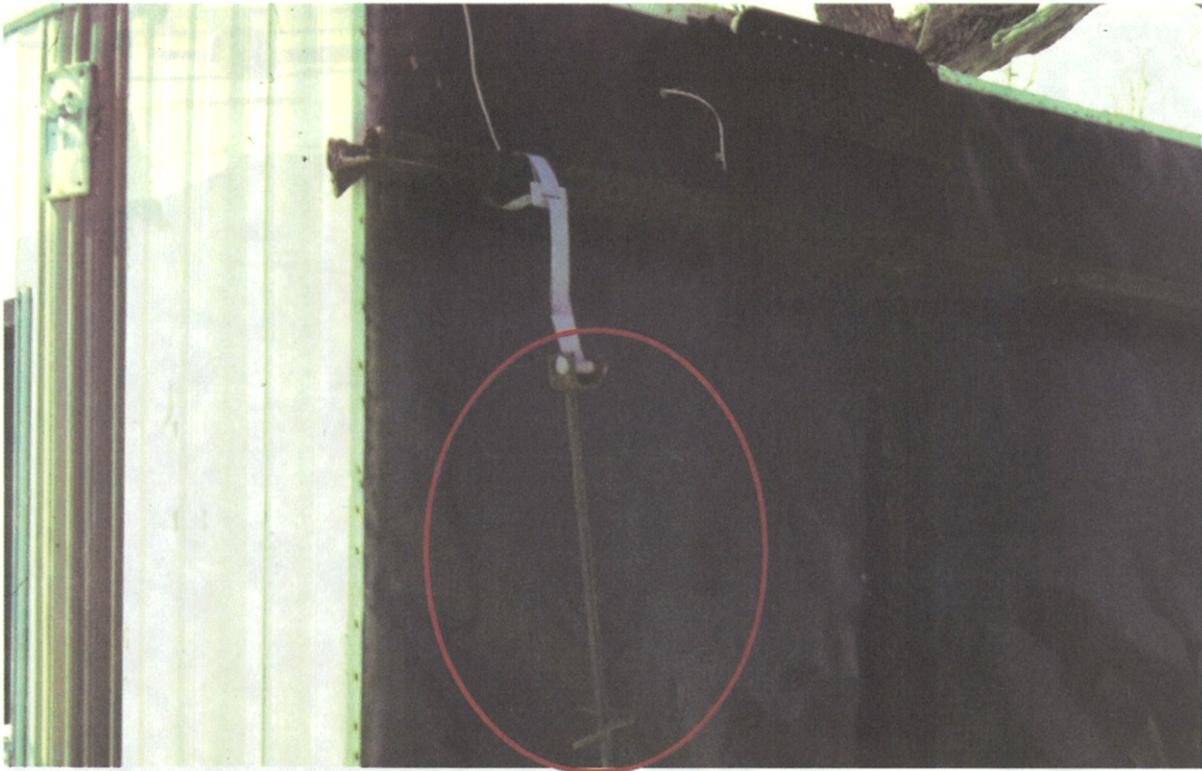
Figure 2-24 Permanently installed RV overturned as a result of anchor pullout. Anchor (circled) is 2 feet long.

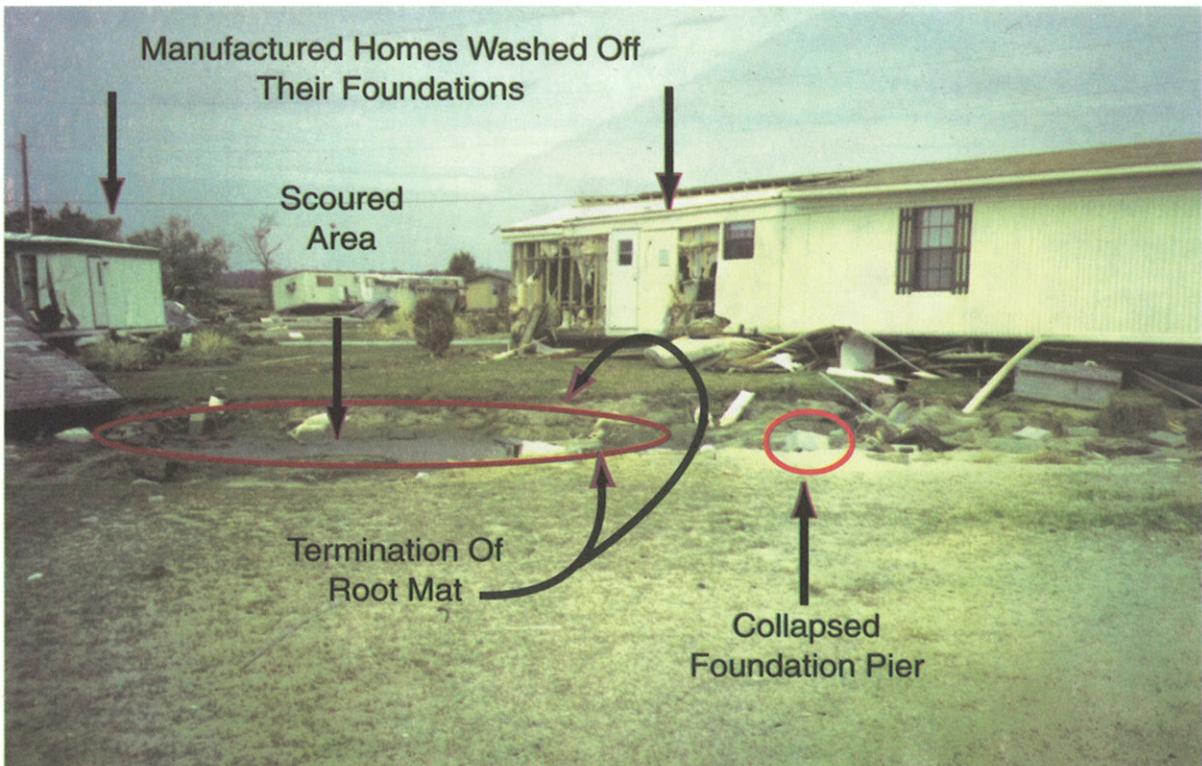
The team observed depressions from 1 to 2 feet deep left by localized scour within the original footprint of the structure (see Figure 2-25). The scour may have been caused by numerous factors, including a discontinuity between the stabilizing root mat provided by grass surrounding the site and the corresponding loss of unprotected sand beneath the home, the creation of a large obstruction by the solid skirt surrounding the foundation system, and localized scour around the dry-stack masonry piers supporting the structure.

Figure 2-25 Localized scour beneath pre-storm footprint of manufactured home. Note the collapsed dry-stack block foundation and termination of root mat, which otherwise would have helped stabilize the adjacent ground.

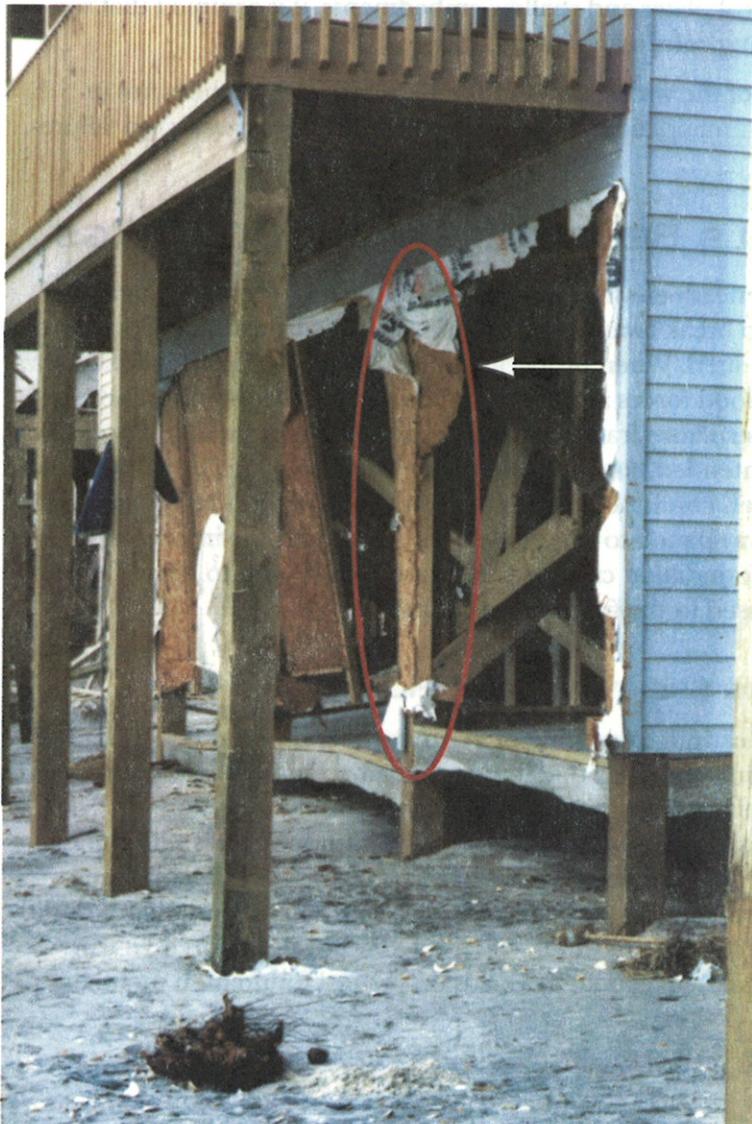
*Figure 2-26*  
*Exterior sheathing of breakaway wall spanned piling.*  
*Note torn sheathing (arrow).*

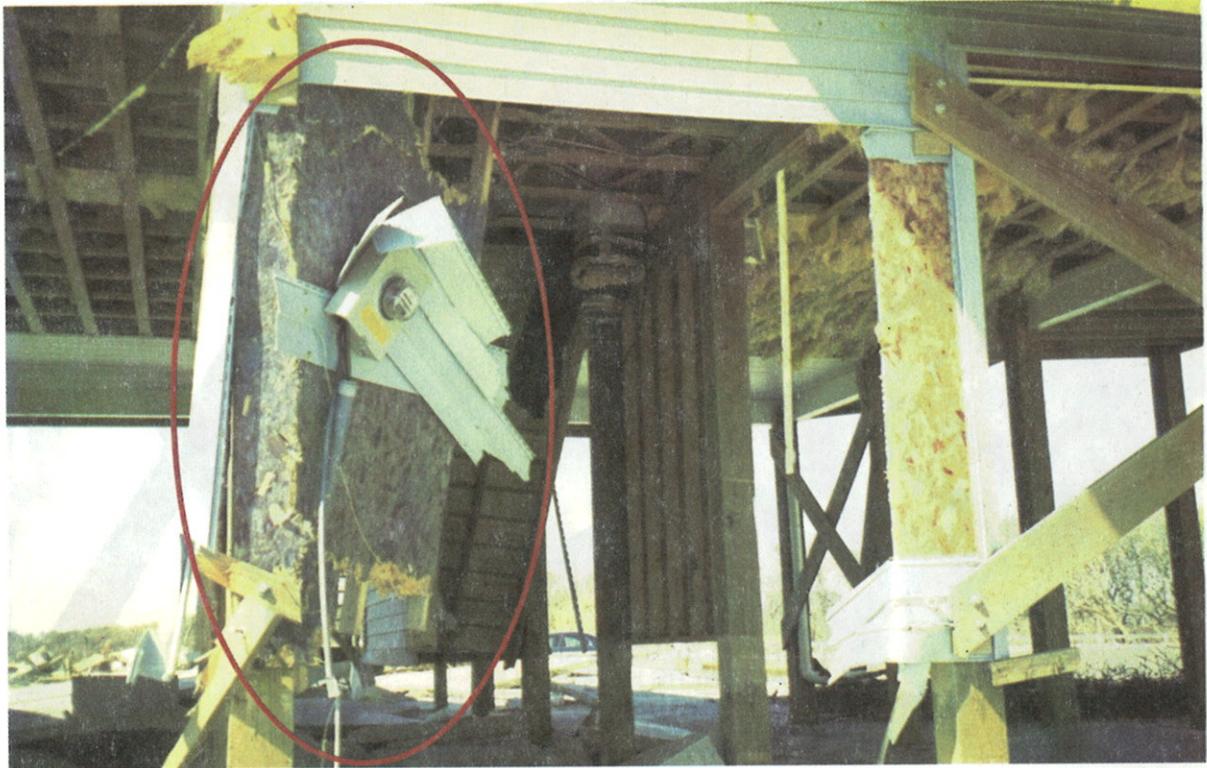
*Figure 2-27 Breakaway wall panel failed to function as designed because continuous sheathing was installed across pilings. No structural damage was observed; however, note damage to utility components installed on breakaway wall panel.*

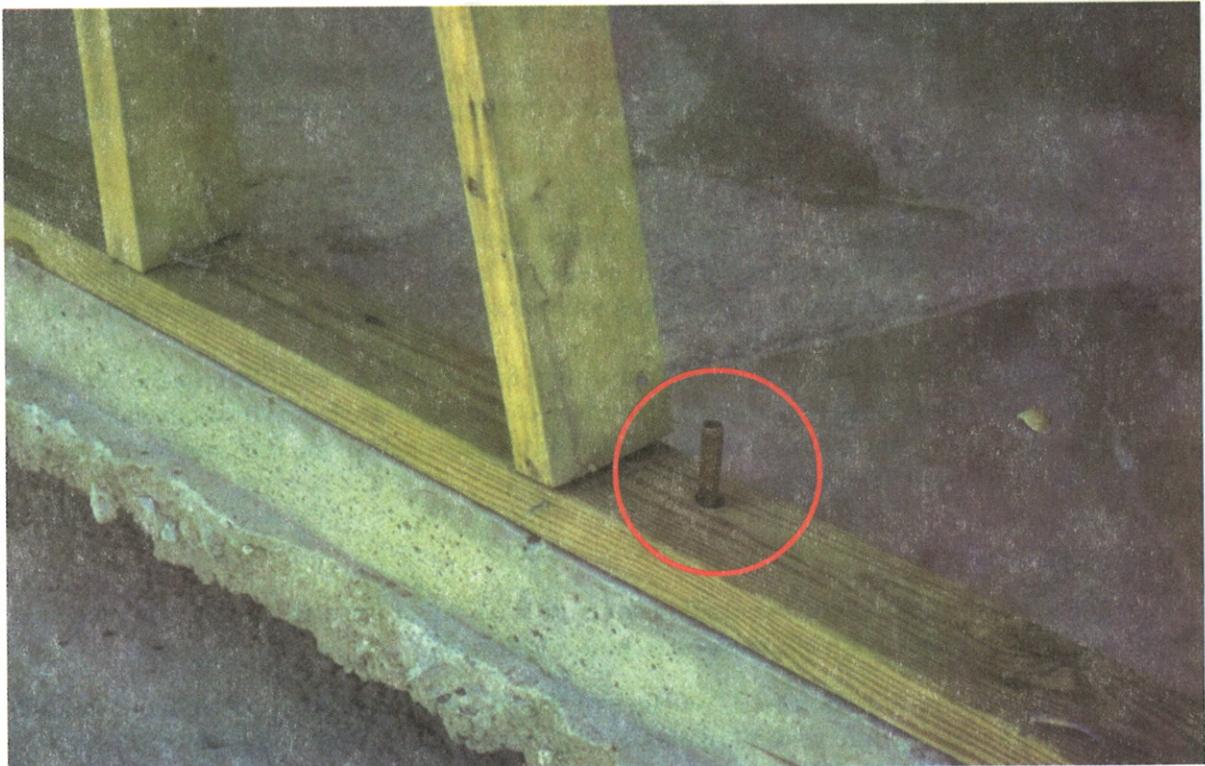
*Figure 2-28 Use of anchor bolts through the sill plate of a breakaway wall is improper. Even though this bolt does not have a nut and washer, it prevented the wall from breaking away laterally.*

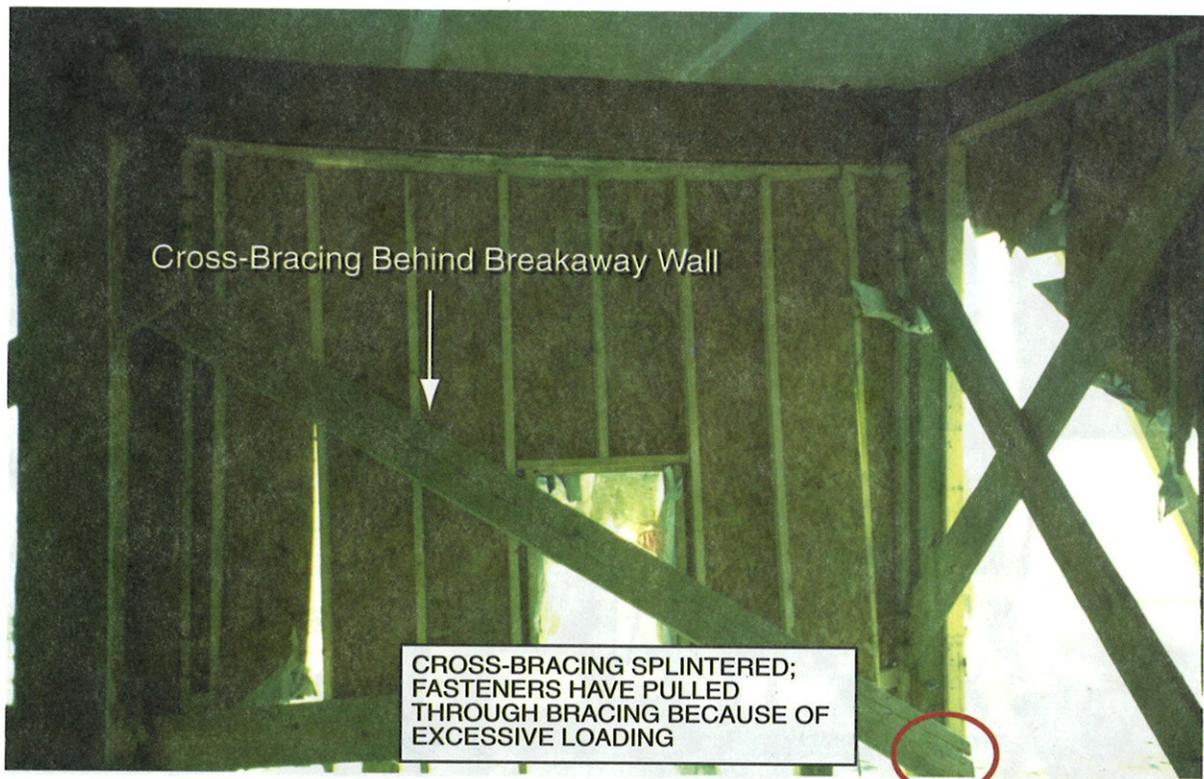
by flood waters, they moved back and came to rest vertically against the cross-bracing. As a result, the vertical surface exposed to velocity flow, breaking waves, and debris impact increased tremendously and so did the corresponding loading on the cross-bracing. For cross-bracing installed across a typical 8-foot span between pilings, the resulting loading far exceeds the bending moment capacity of 2x or 3x wood braces in the narrow dimension. As a result, the cross-bracing often failed.

Figure 2-29 Improper installation of breakaway walls (on the seaward side of cross-bracing) resulted in failure of cross-bracing. Note breakaway wall pushed against cross-bracing.

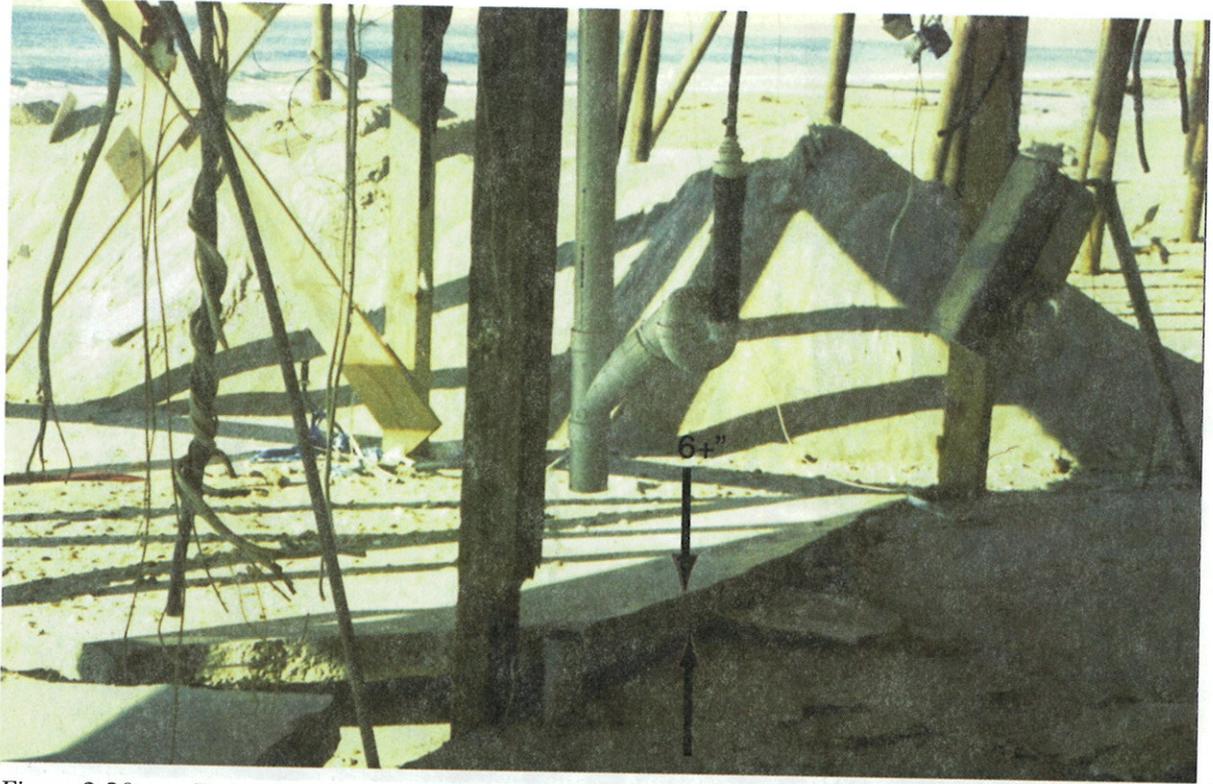
Figure 2-30 Example of unnecessarily thick slab.

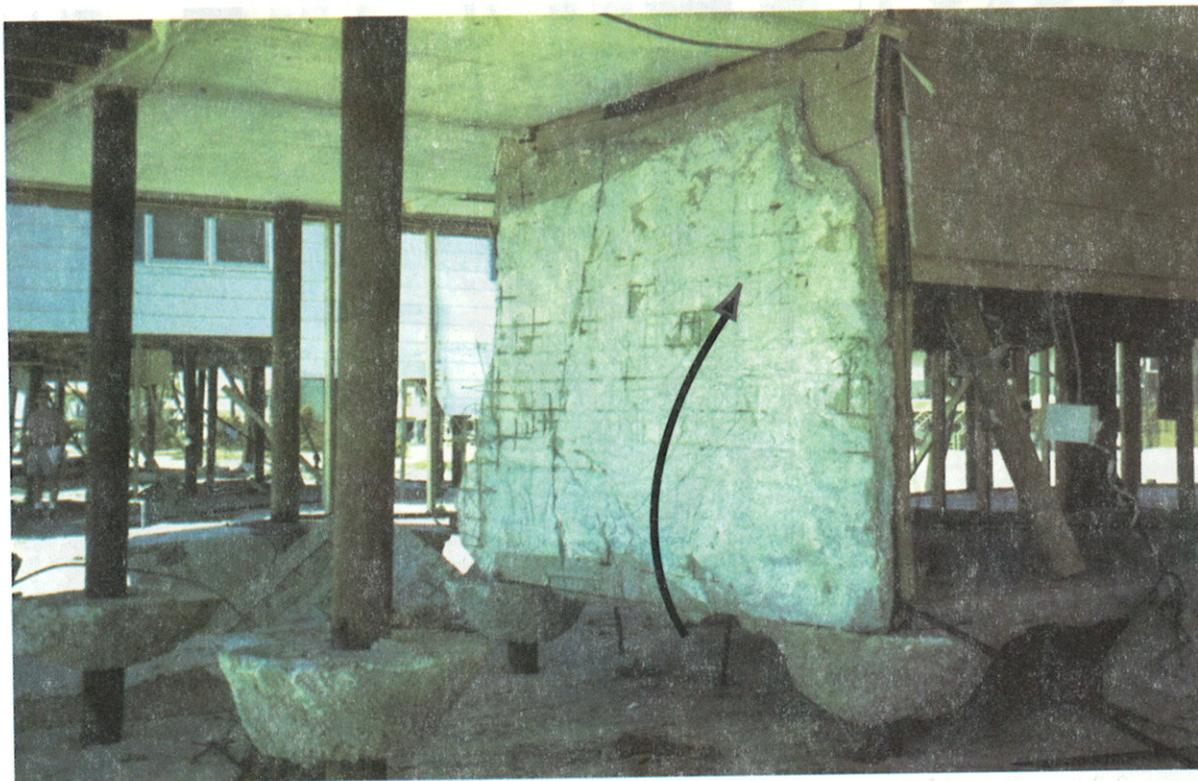
*Figure 2-31 Concrete slab-on-grade flipped up, probably by wave action, came to a rest against two foundation members, generating large, unanticipated loads on the foundation. Note slab is supported on concrete collars around piles and contains wire mesh.*

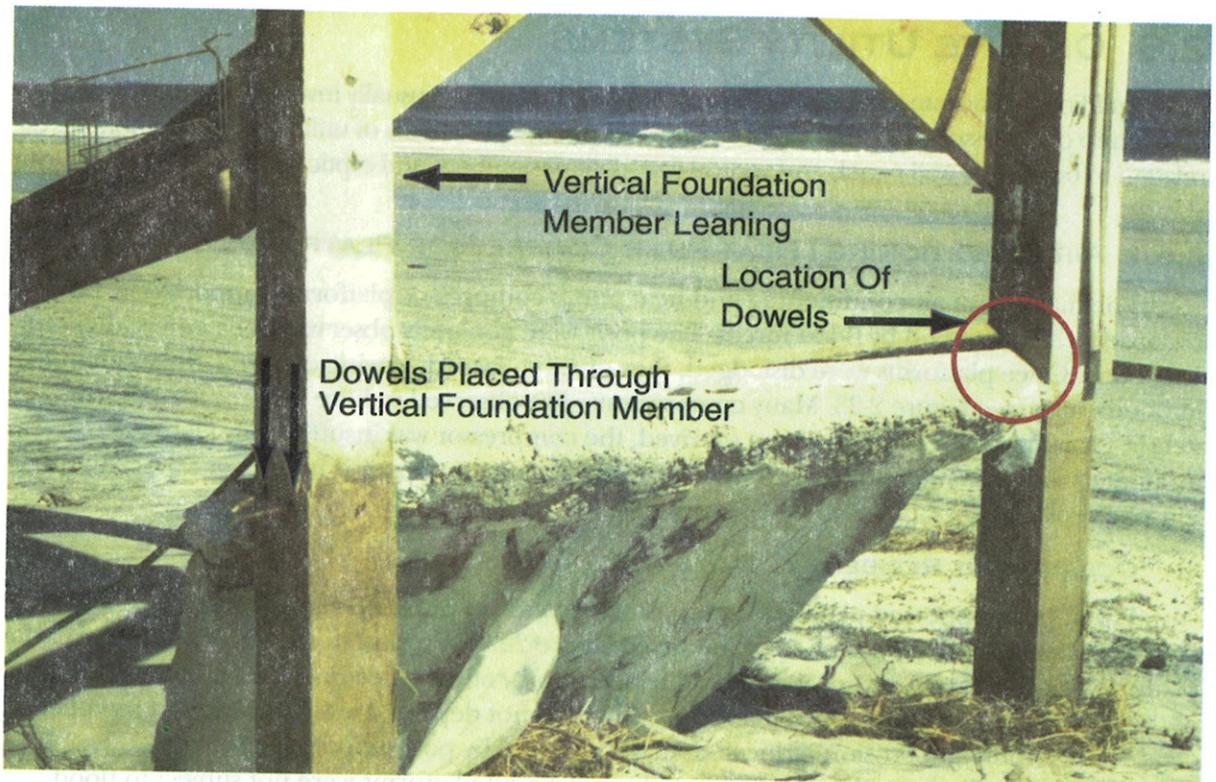
Although the BPAT was unable to define a cause-and-effect relationship, several buildings with this slab-to-foundation pin detail were found to be leaning. The team members believe that the inability of the slab to break free of the vertical foundation members was at least partially responsible for the failure of the vertical foundation members to remain plumb.

Figure 2-32 Use of steel dowels to tie slabs to vertical foundation members prevented the proper breakup of slab. A portion of the slab was left attached to the piling, resulting in large, unanticipated loads on foundation members. Note leaning vertical member, on right.

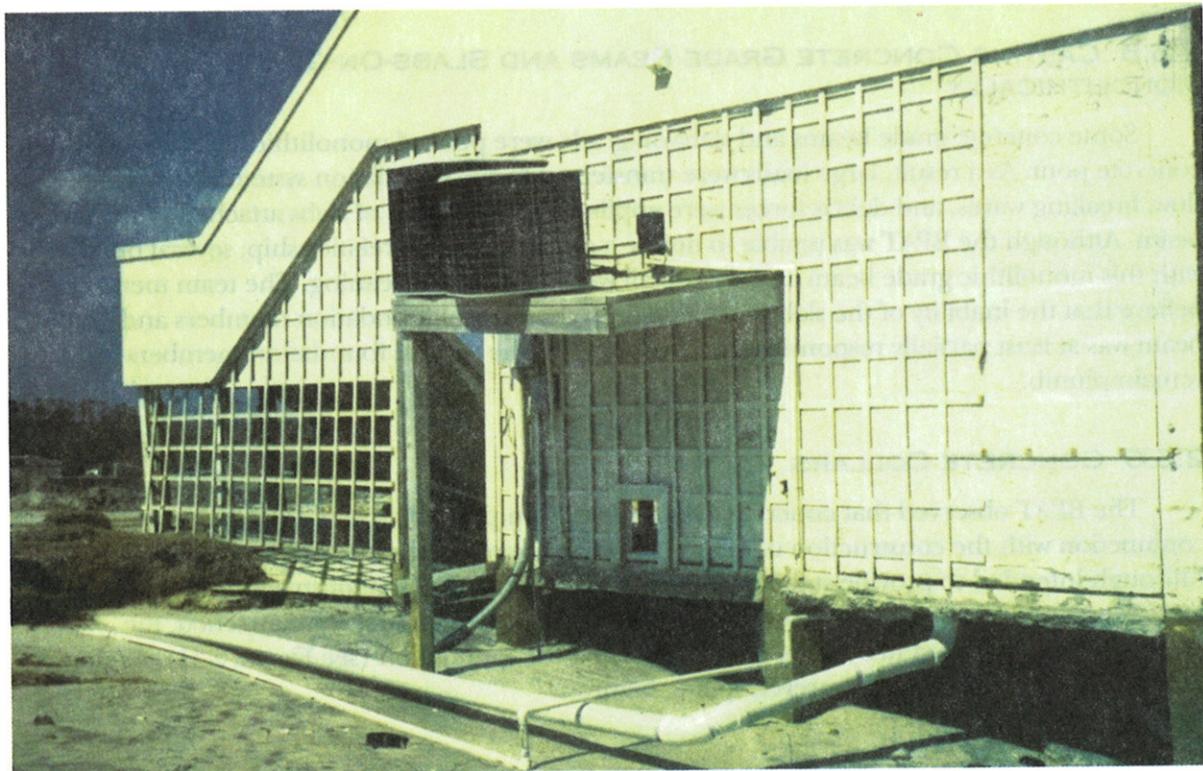
*Figure 2-33 Air conditioning / heat pump compressor platform leaning because erosion and scour caused loss of one supporting column.*

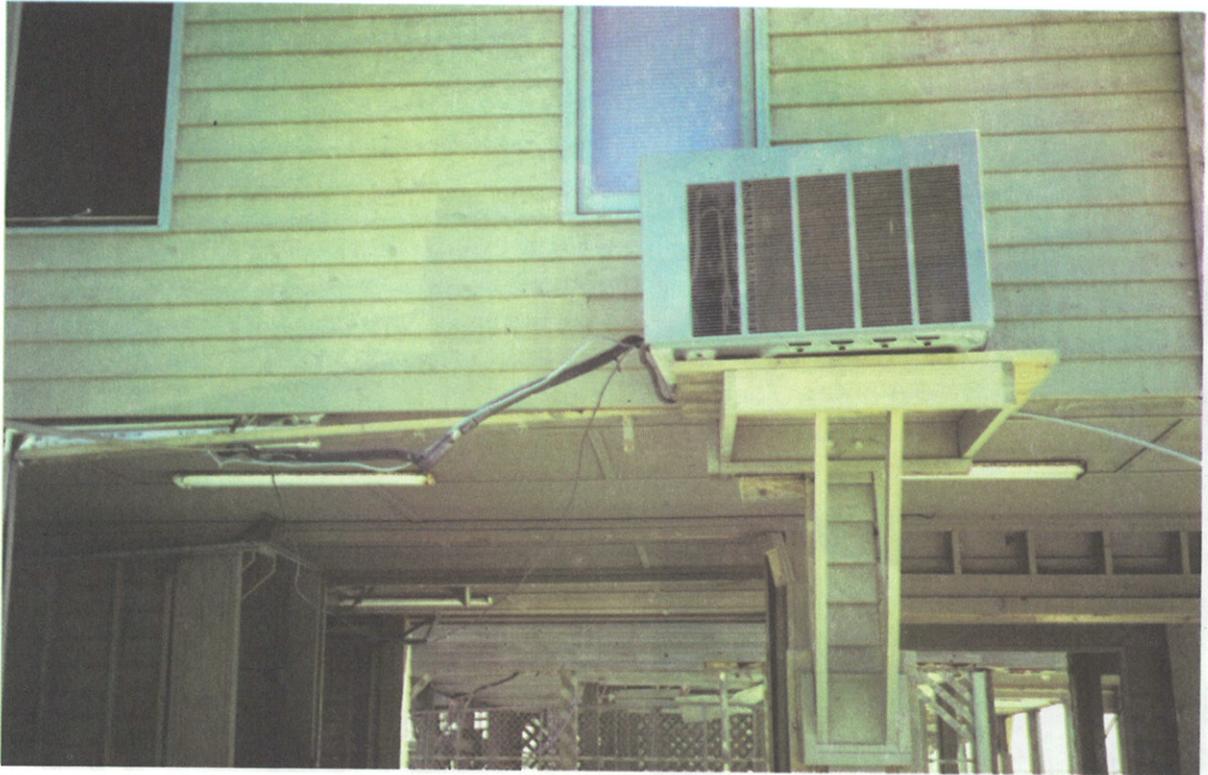
*Figure 2-34 Although the air conditioning/heat pump compressor platform on this oceanfront house was adequately elevated with cantilever bracing, the compressor was almost pushed off the platform by wind because of the lack of the necessary attachment.*

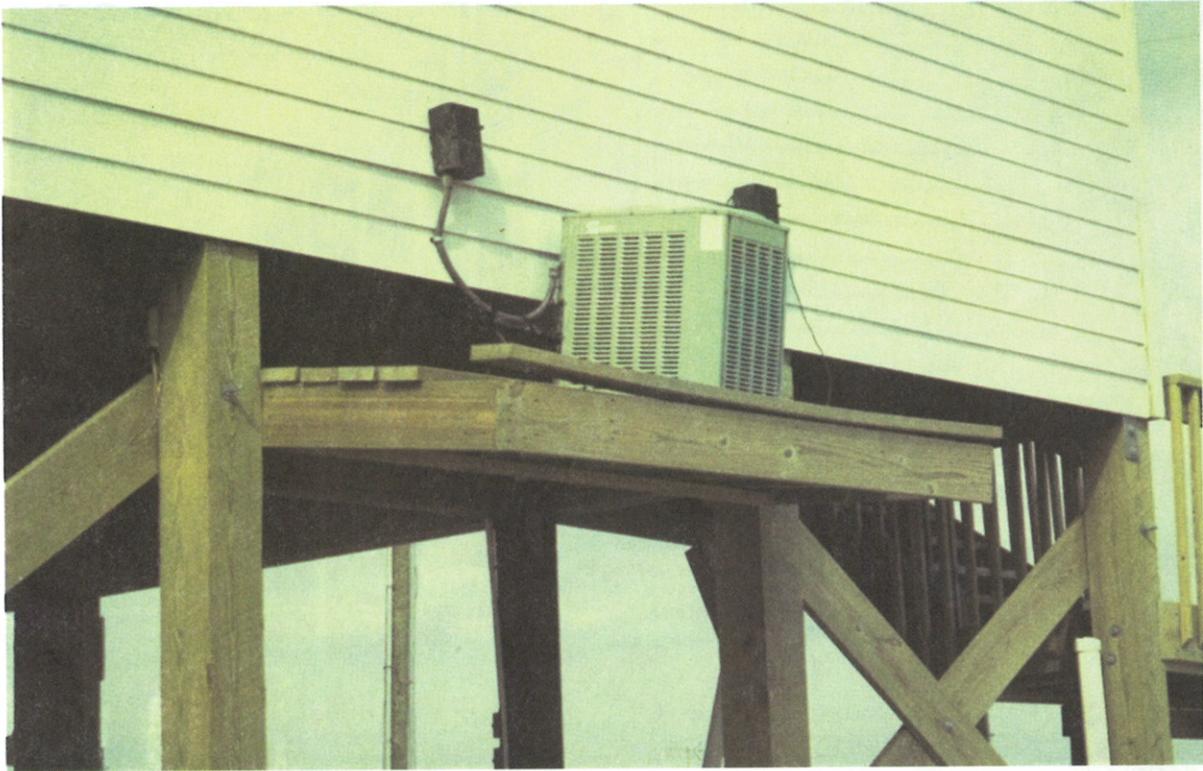
Figure 2-35 Air conditioning / heat pump compressor platform leaning because scour caused loss of two supporting posts.

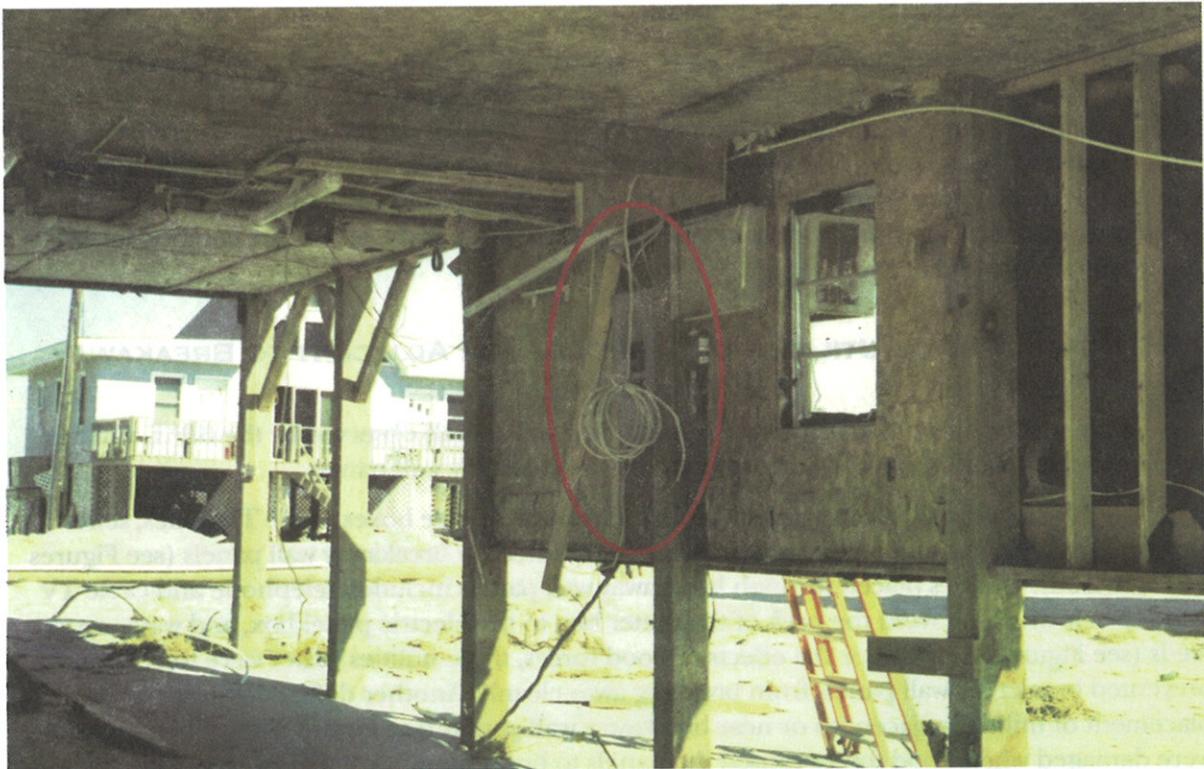
Figure 2-36 Example of utility component (electric panel box) installed on a breakaway wall panel.

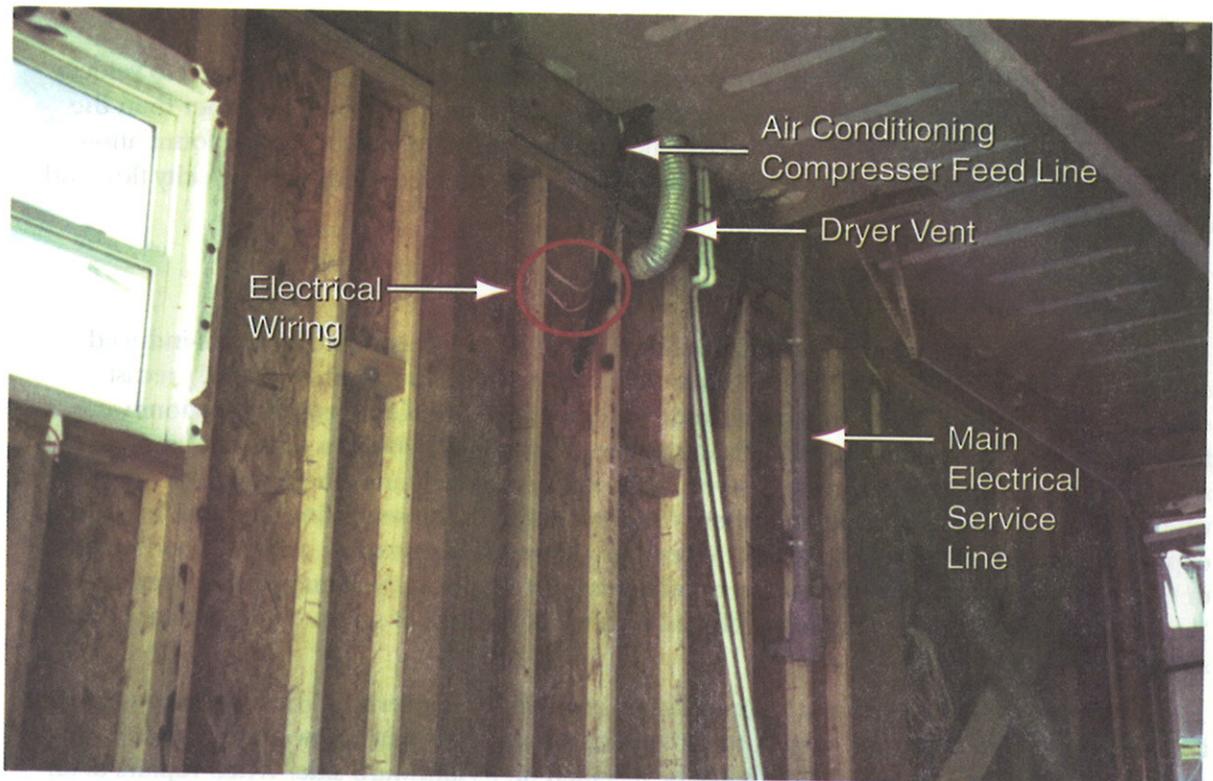
Figure 2-37 Utility components (dryer vent, air conditioning compressor feed line, main electrical line out of meter box, and electric wiring) penetrating breakaway wall panel.

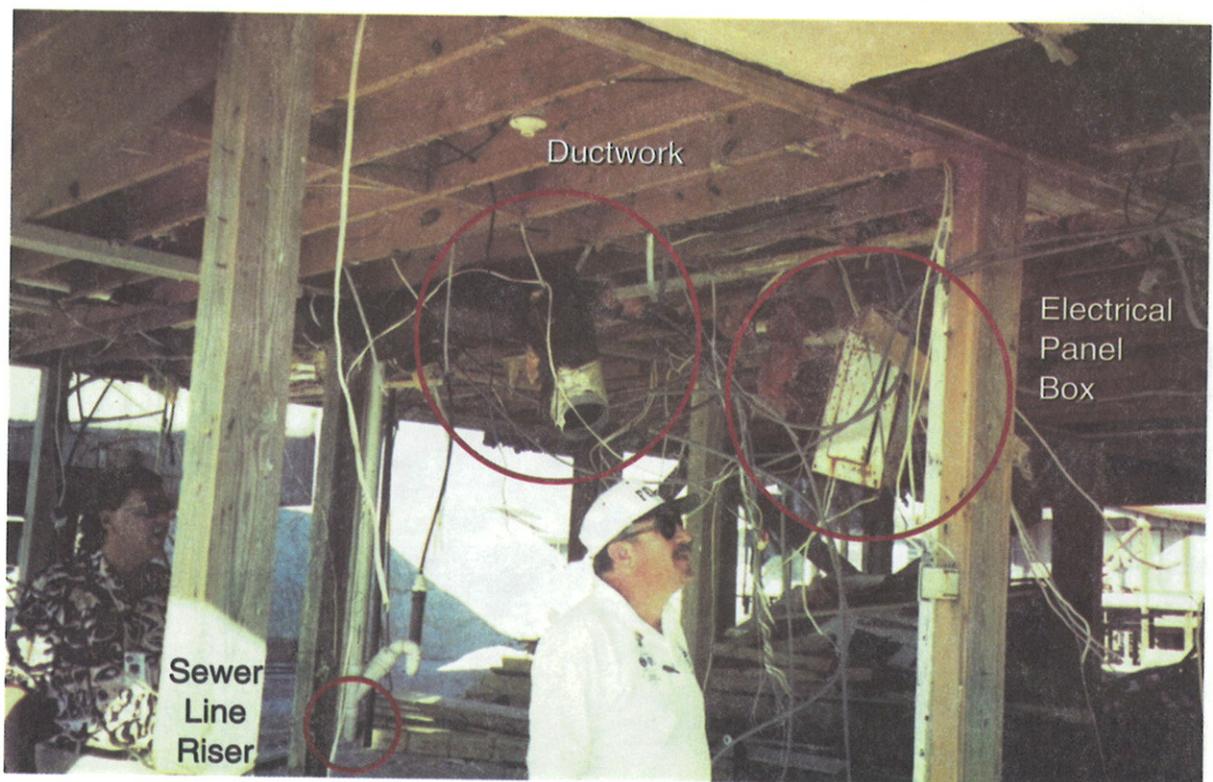
Figure 2-38 These utility components (wiring, electric panel box, ductwork, and sewer line) were installed adjacent to breakaway wall panel and were damaged when the walls broke away. Note broken sewer line riser pipe on seaward side of piling.

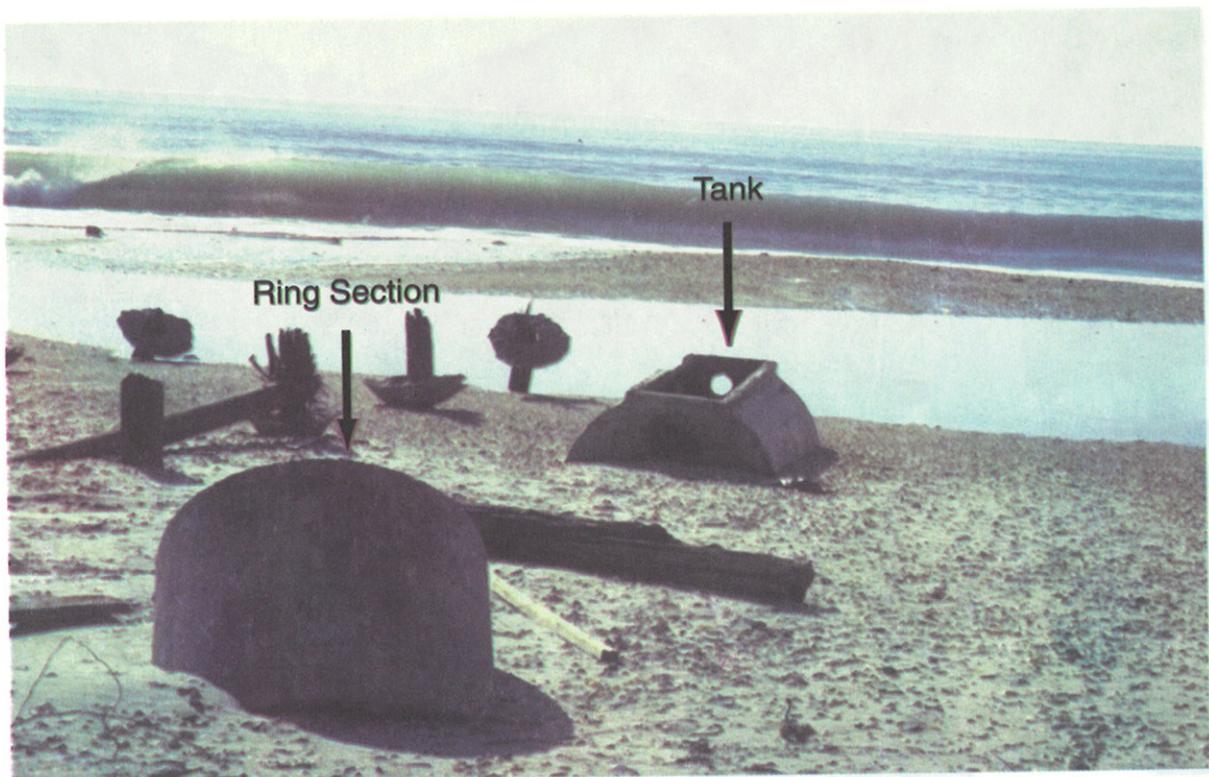
Figure 2-39 Oceanfront erosion and scour unearthed and damaged septic tanks and systems. Note precast ring section and precast tank.

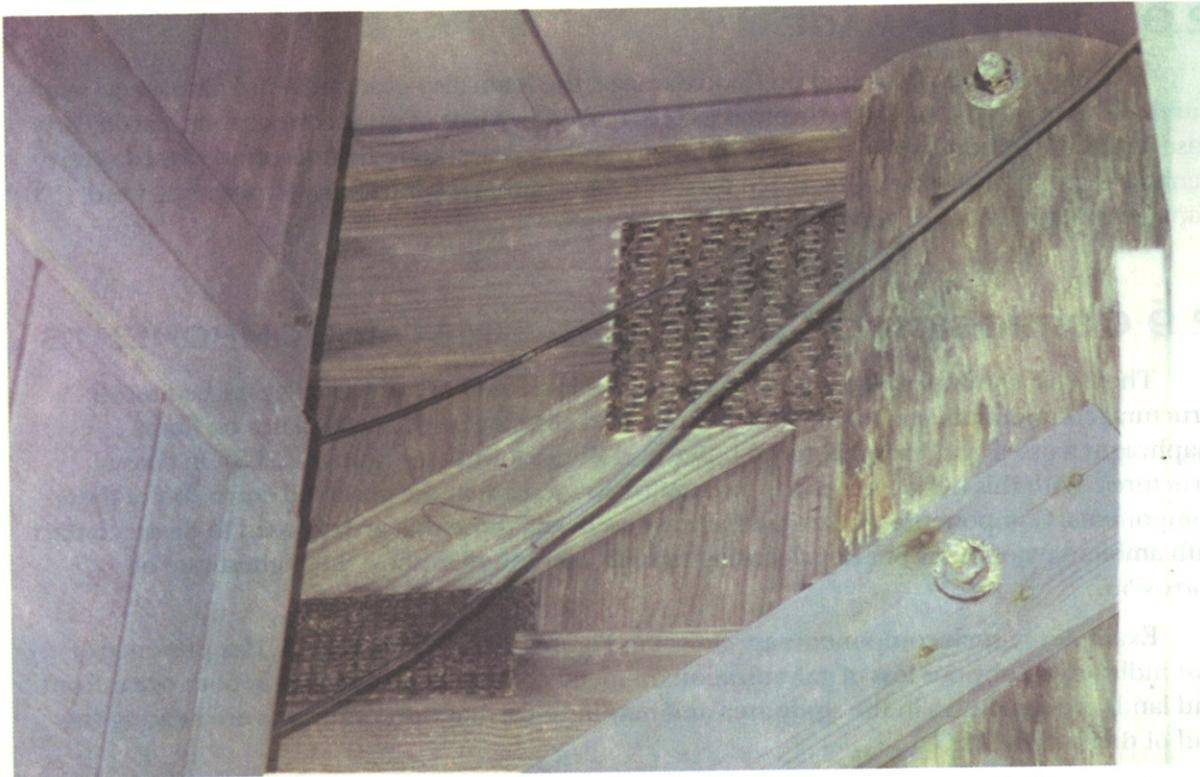
Figure 2-43 Corrosion of galvanized floor truss plates was observed in many buildings.

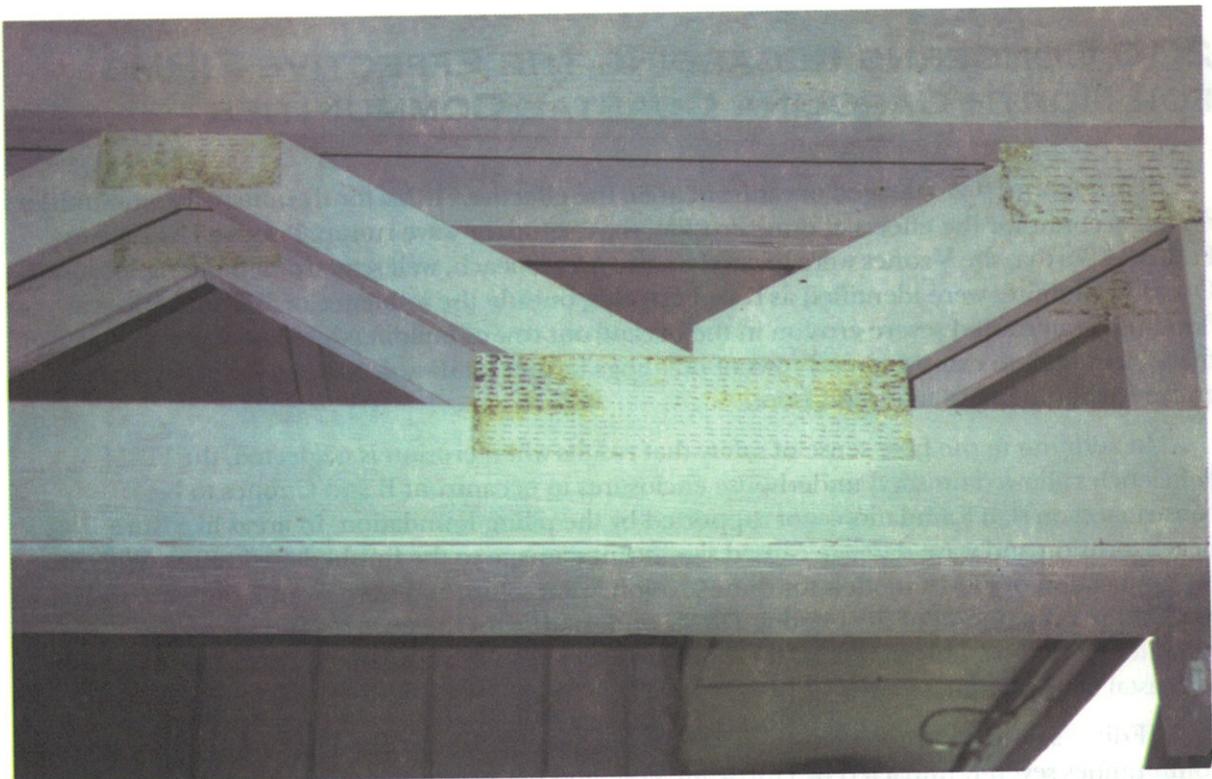
Figure 2-44 Corrosion of galvanized floor truss plates was observed in many buildings. Note that painting does little to slow the process of corrosion in coastal environments

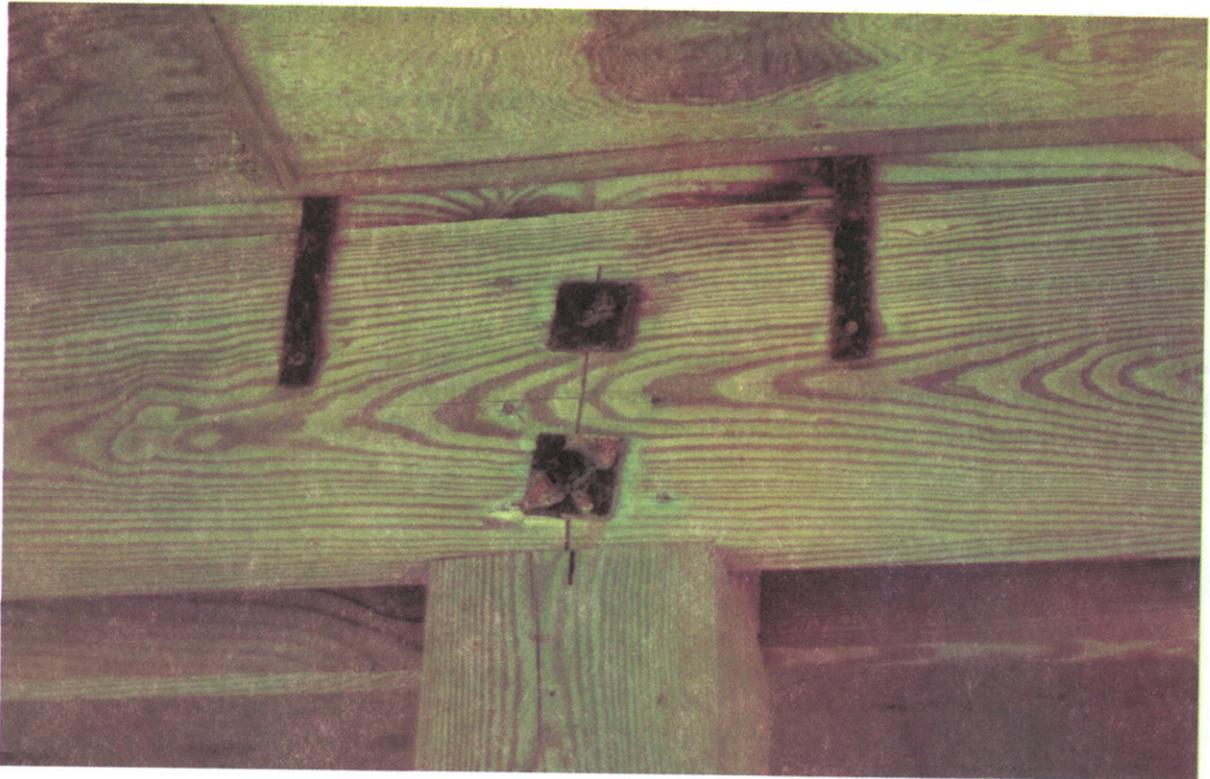
Figure 2-45 Corrosion of hurricane straps and steel plates was also observed in many locations.
