Safe and Sound Above the Storm Surge

Full Mitigation Best Practice Story

Santa Rosa County, Florida

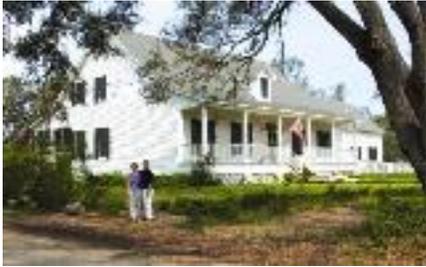
On August 10, 2005, the eye of Hurricane Dennis passed near the Rossers' home. The only damage to the house from the Category 3 hurricane was from wind, which loosened some courses of vinyl siding. This event proved again that the extra effort

The Rossers' house withstood Hurricane Dennis with very little damage.

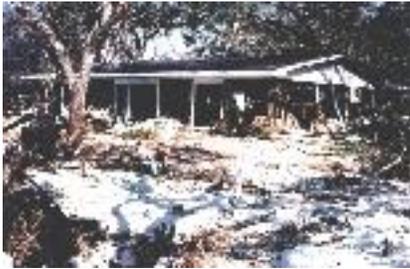
This house was severely damaged by Hurricane Ivan.
