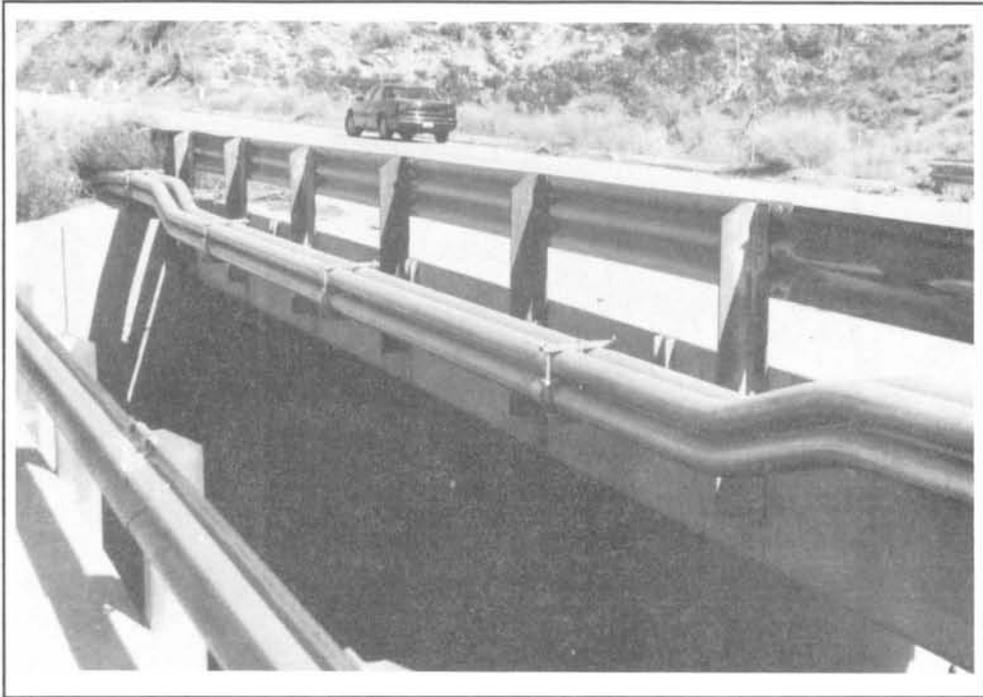
When the conduits (which are normally buried) are routed to a bridge location, they are generally brought to the surface and hung with light anchors from the bridge. Figure 10 shows them on a typical bridge crossing on the abandoned portion of Highway 66; Figure 11 shows some of the details of the bridge hangers and the conditions of the conduits; Figure 12 shows them hung from a highway culvert wall just south of Cajon Junction; Figure 13 shows some of the details of the wall anchors near the culvert location of Figure 12. Just south of the culvert shown in Figure 12 the

Figure 10 Fiber Optic Conduits On A Bridge On The Abandoned Portion of Cajon Blvd. Extension

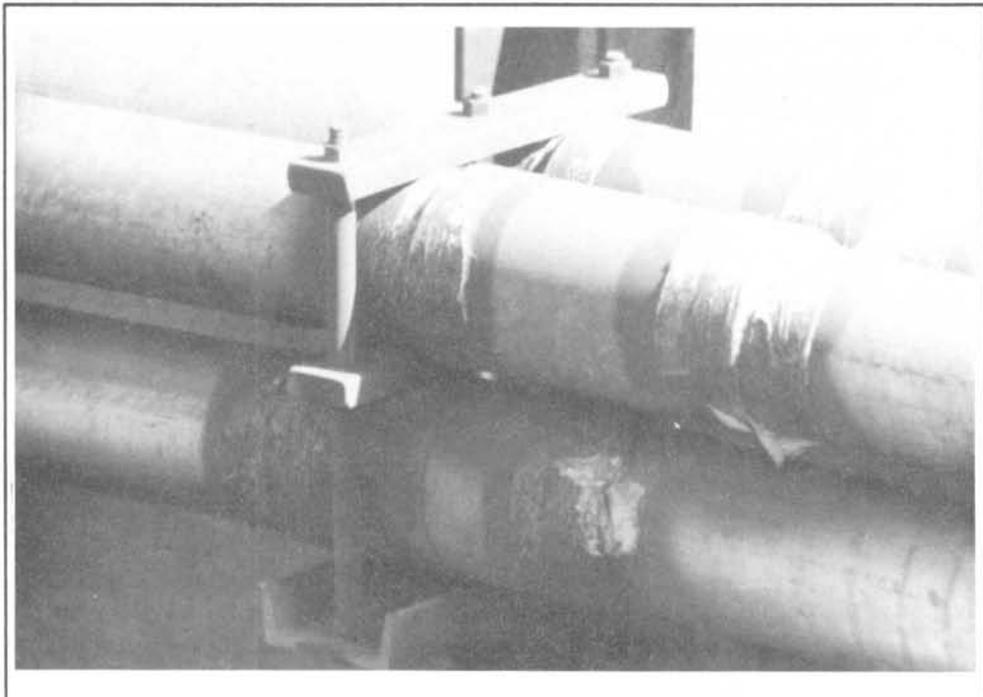
Figure 11 Details Of The Fiber Optic Conduits Of Figure 10

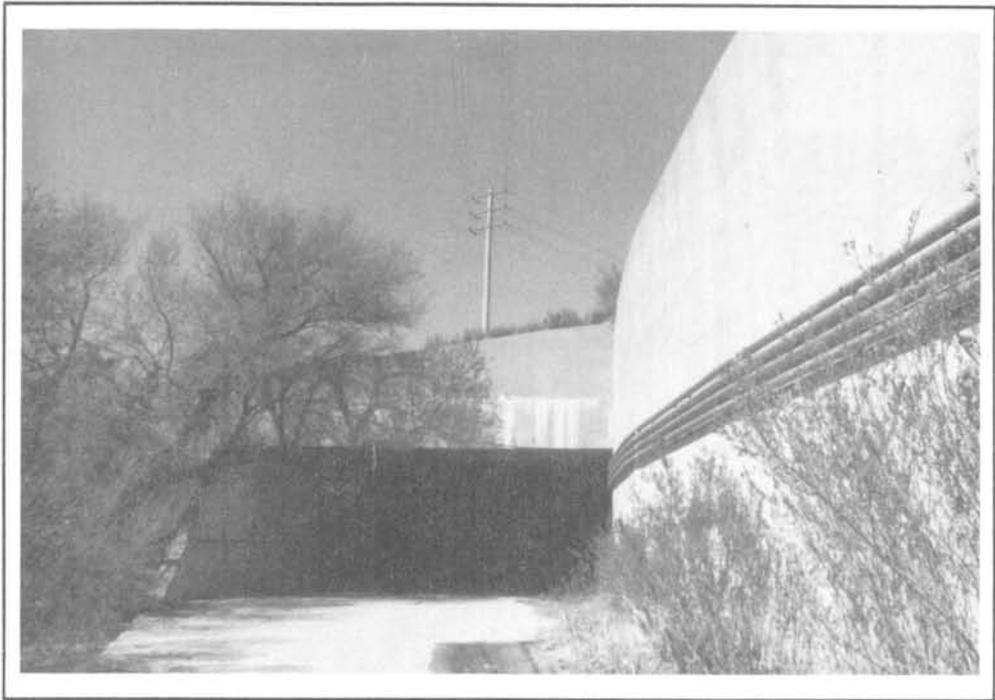
Figure 12 Fiber Optic Conduits On A Concrete Culvert That Passes Under I-15

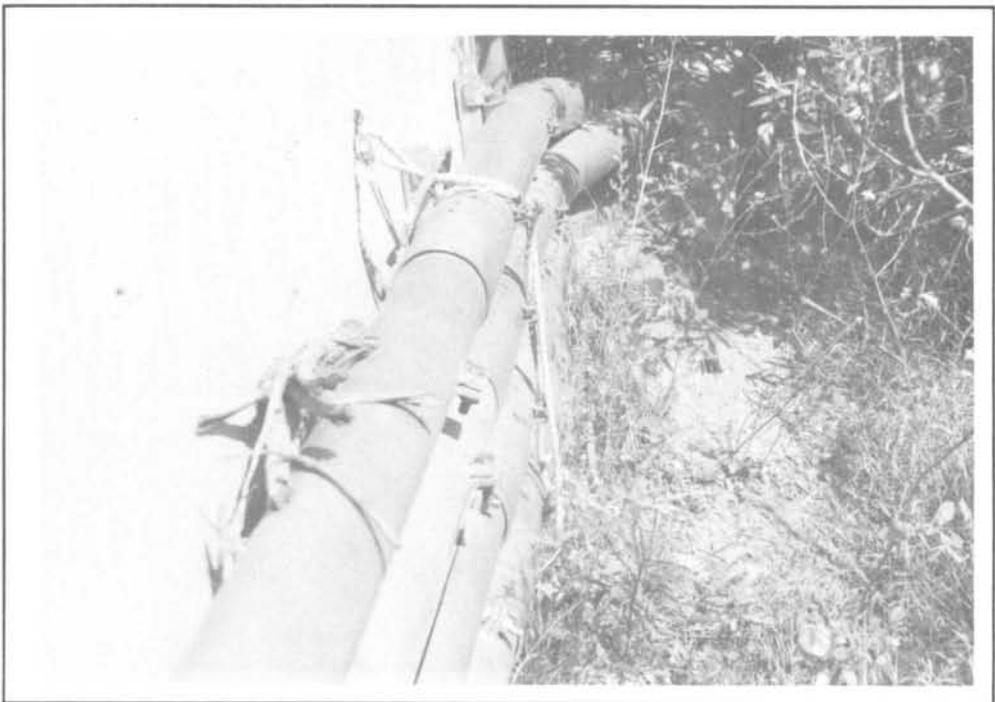
Figure 13 Wall Support Details For The Fiber Optic Conduits Of Figure 12

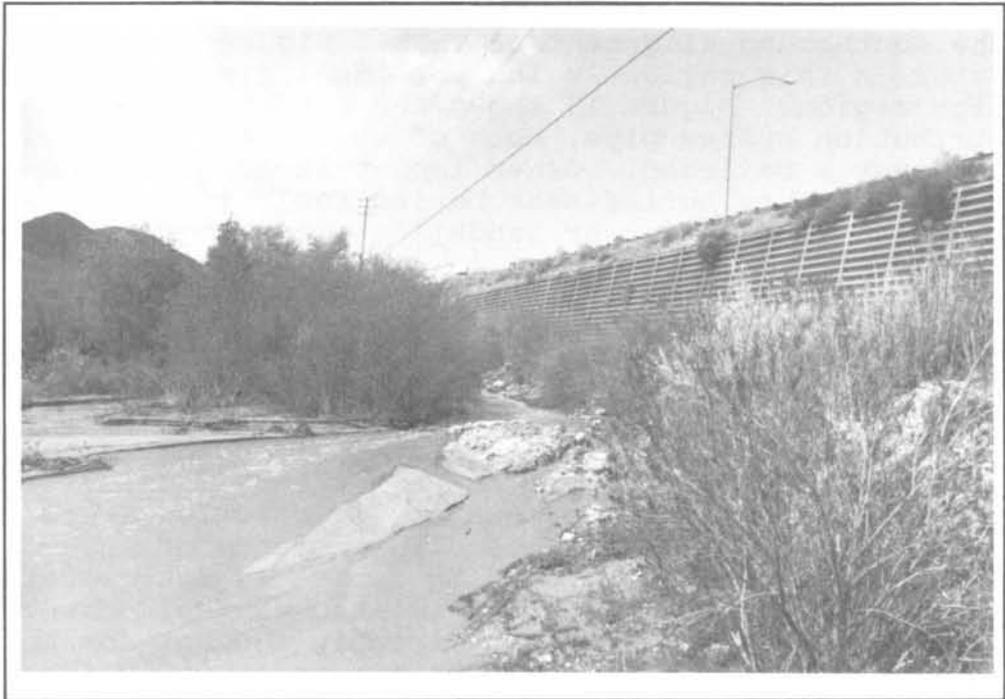
Figure 14 Surface Water Conditions Near The Toe Of The I-15S Retaining Crib Wall

fiber optic cables are buried at the toe of a crib wall used to support the southbound alignment of I-15. Figure 14 shows the surface water in this region, which was identified as a potential liquefaction region. Figure 15 shows the conduits hung under a water distribution system pipe, both of which are supported from a road bridge over a railroad. Other important collocations include where the conduits are buried near buried fuel pipelines, a number of which are in liquefaction or landslide prone regions.

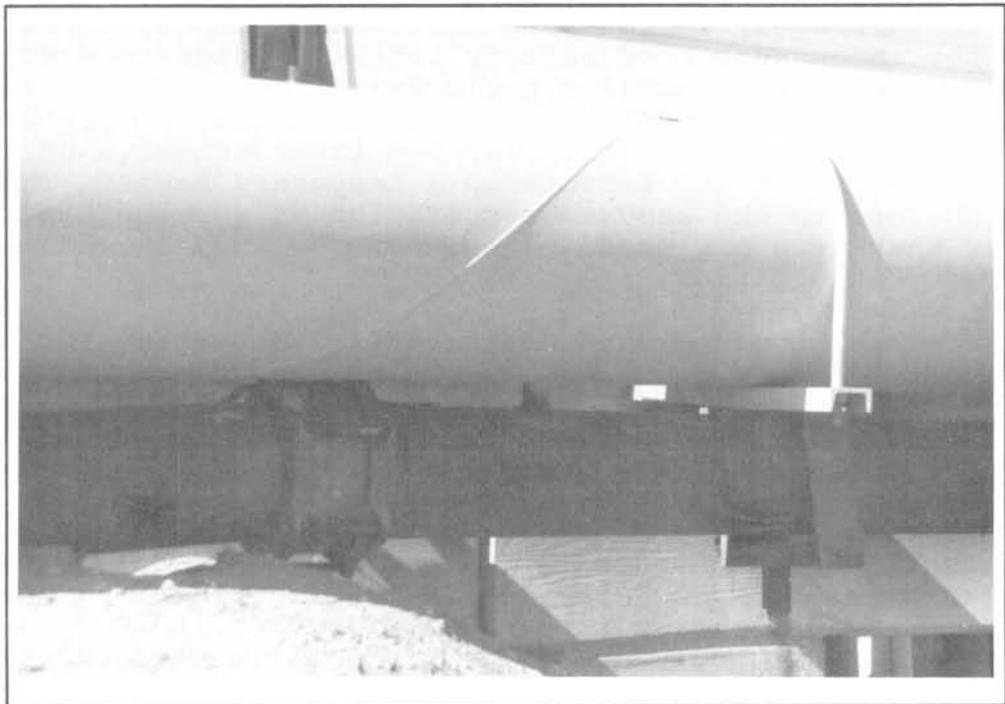
Figure 15 Fiber Optic Conduits Under a Heavy Water Pipe, Both On A Highway Bridge

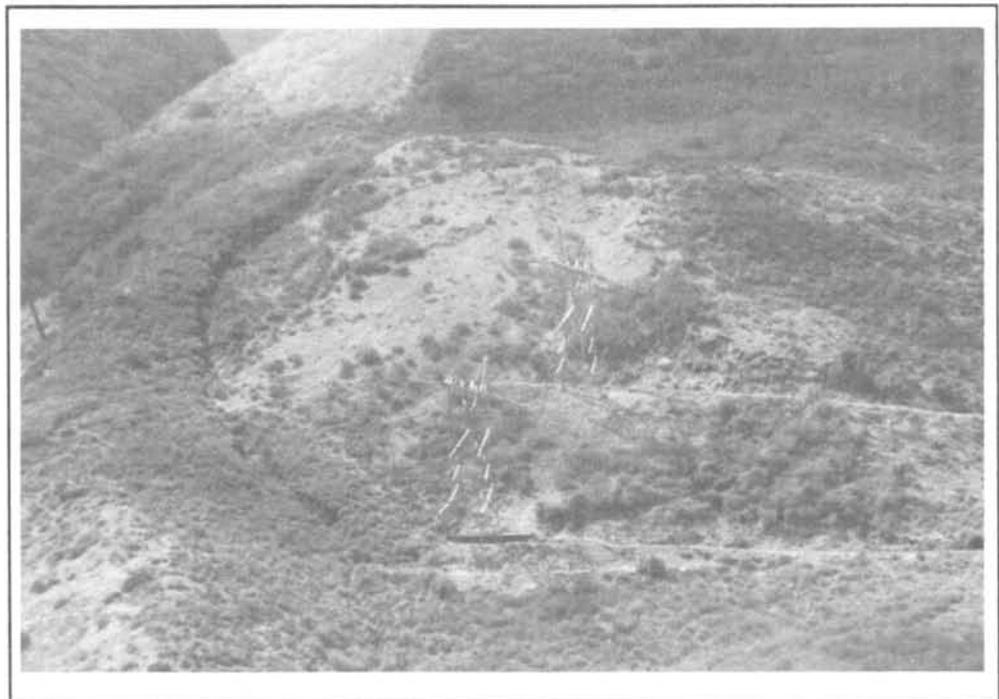
Figure 17 A Landslide Scar With Power Towers In The Slide Area

Transmission lines often traverse more rugged areas, and as such they are susceptible to landslide damage. Figure 17 shows two transmission towers located in an old landslide scar (the original towers were damaged in the landslide). This location is an important collocation site, as a buried natural gas transmission pipeline and the railroad tracts are located just below the slide area. Figure 18 shows the location of two high voltage power transmission tower systems, a buried natural gas transmission pipeline (shown by a surface marker), and the 8- and 14-inch buried petroleum products pipelines (also shown by a surface marker).

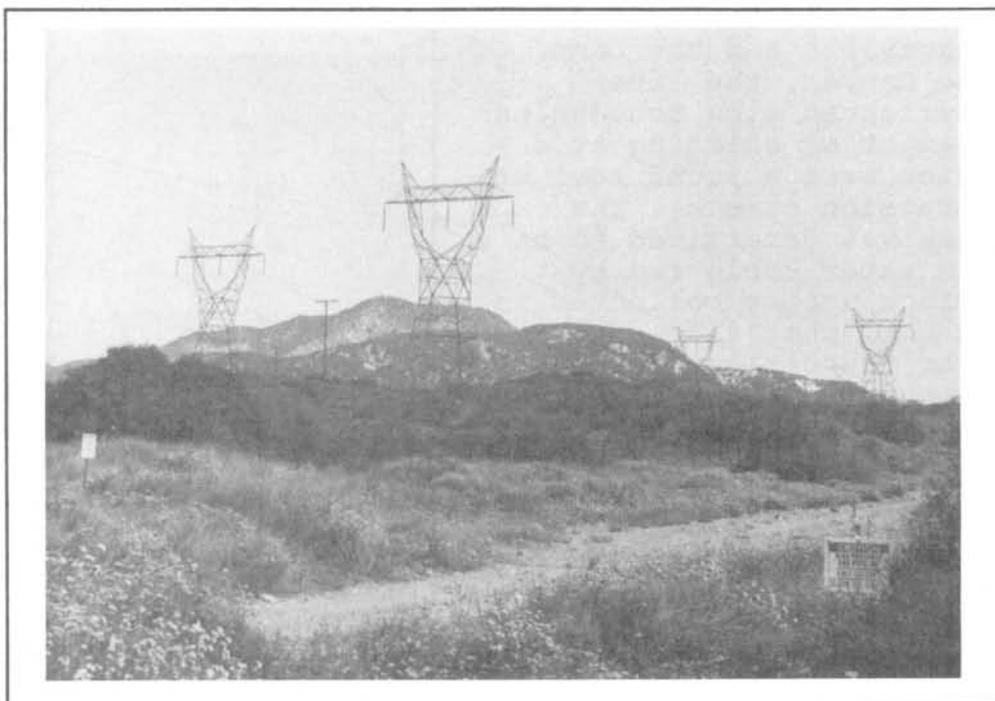
the San Andreas fault and rift zone) is the most significant collocation condition for the electric and the fuel lifelines.

Figure 18 Power Lines, Natural Gas & Petroleum Products Pipelines Intersection Over the San Andreas Fault Rift Zone

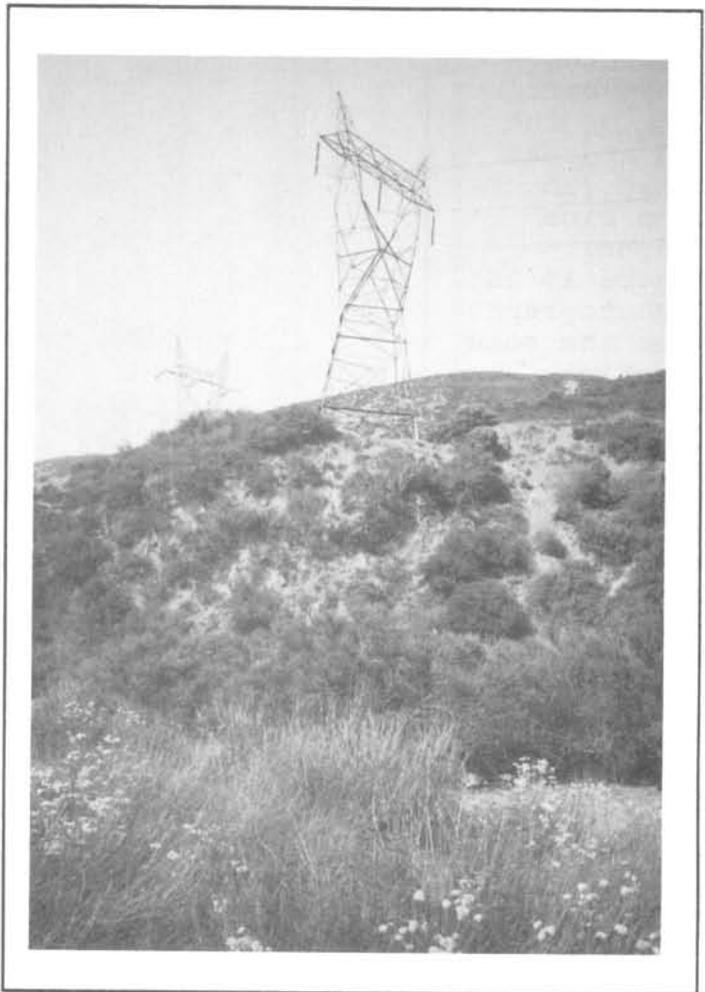
study. At a section between Highway 138 and the Lone Pine Canyon, the lines experienced slow foundation movement or shifting at a region where a local bowl or depression exists. The cause was determined to be a high water table fed by surface waters collected in the bowl that allowed the tower foundations to slowly respond to the tension imposed by the lines themselves. The solution was found to be to cover the ground with a concrete mixture so that surface waters would not seep into the water table at that location. The towers now appear to be stable. On several other occasions, local brush/forest fires have heated the copper conductors to the extent that they partially annealed and sagged. This problem was resolved by retensioning the line in those regions. It is of importance because it indicates the problems that earthquake-induced fires could have on this lifeline system.

Figure 19 Power Tower At A Ravine Edge
In The San Andreas Fault Rift Zone

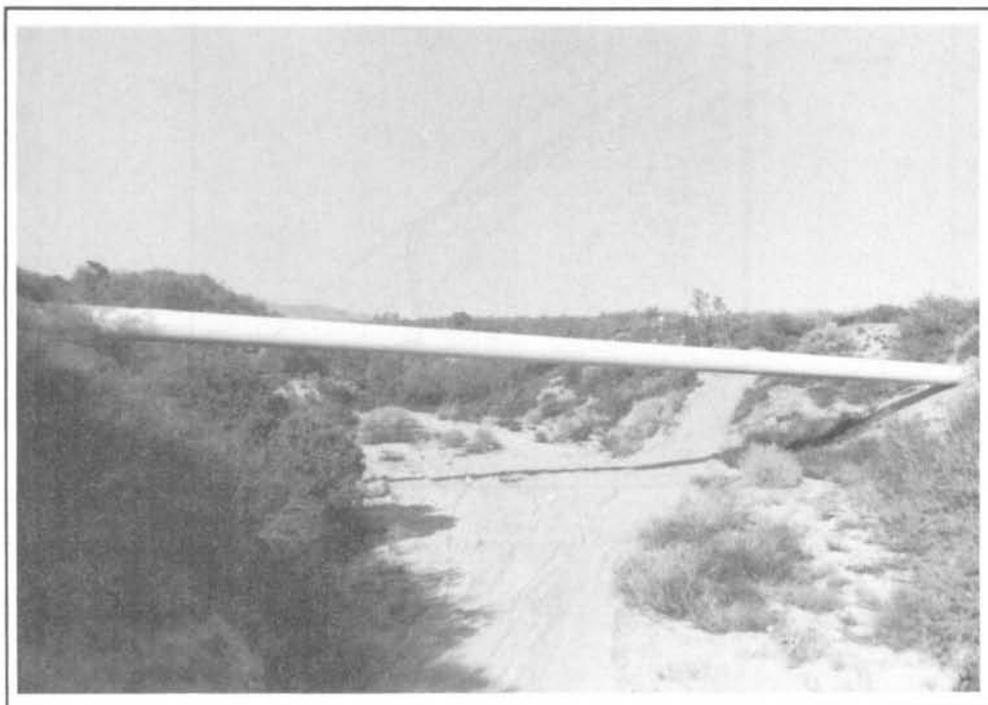
Figure 21 Typical Long Open Span On The 36-Inch Natural Gas Pipeline

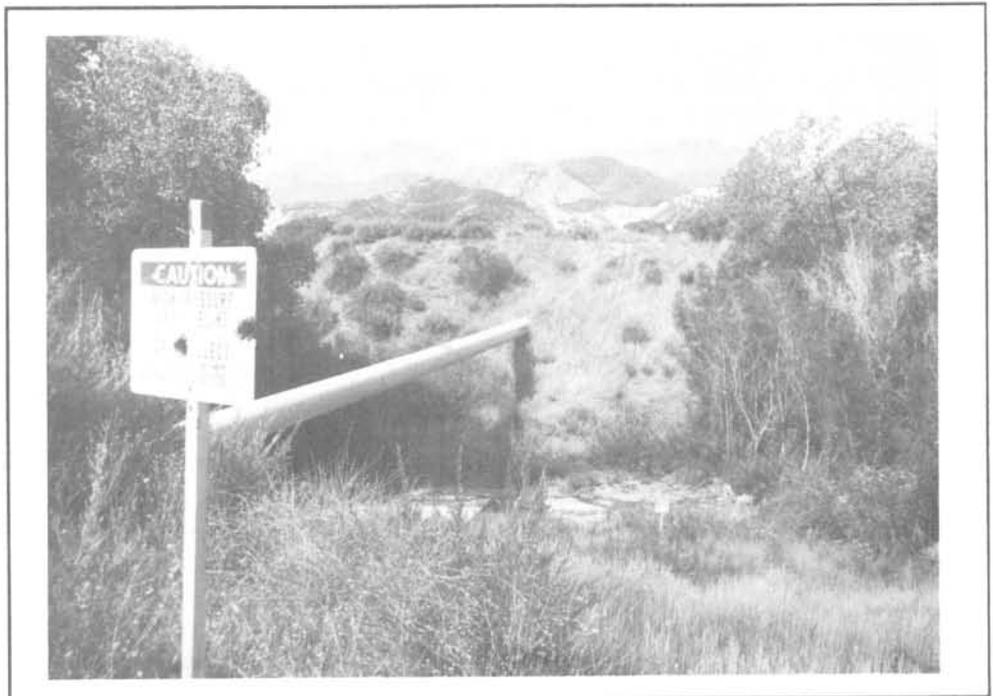
Figure 22 Two Natural Gas Pipelines Near Highway 138, One Buried, One Exposed

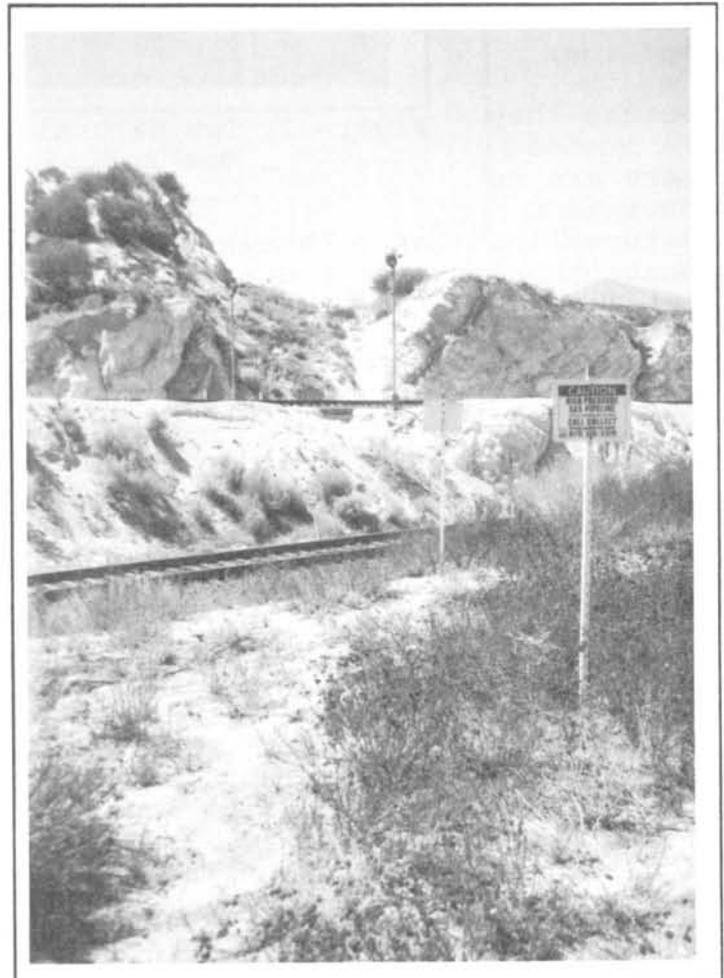
Figure 23 Natural Gas Pipeline Crossing Under Railroad Beds

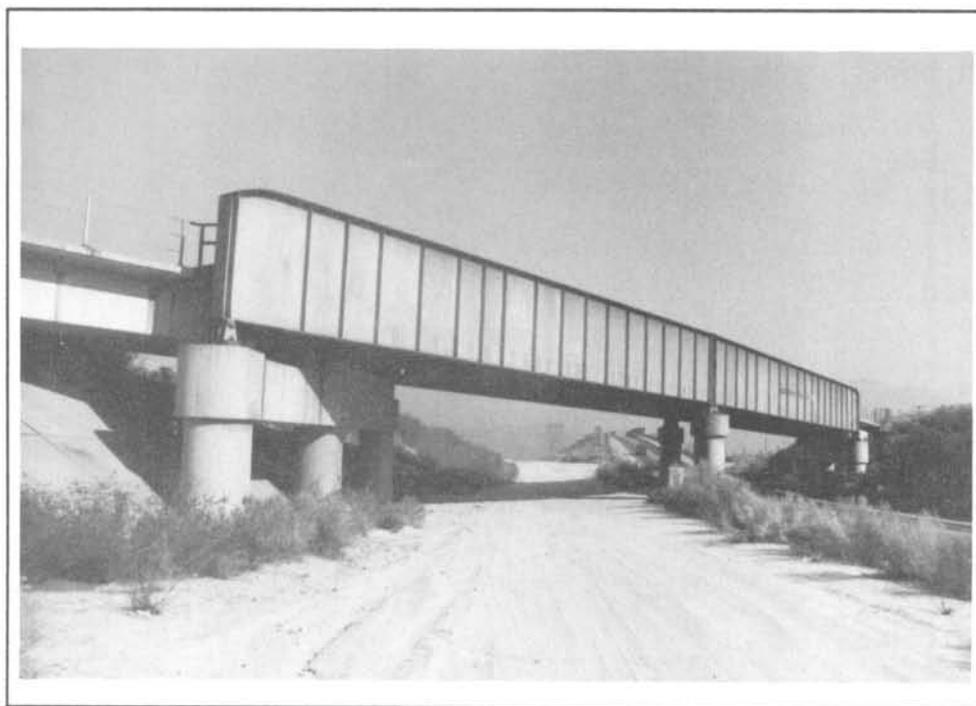
plate, girder bridge on the Southern Pacific railroad over Highway 138 which is sharply skewed, and which has bearings which are vulnerable to loss (Figure 29). It is expected that the multiple span structures will have one or more spans dislodged where they are subjected

Figure 29 Railroad Bridge Over Highway 138
(Collapse Expected)

to MMI= VIII shaking intensity zones or are on potentially liquefiable soils. The failure of the Bridge shown in Figure 29 was responsible for much of the access time estimate for repair of I-15, since it blocked Highway 138 from being an immediate detour route for equipment needed for the I-15 repairs.

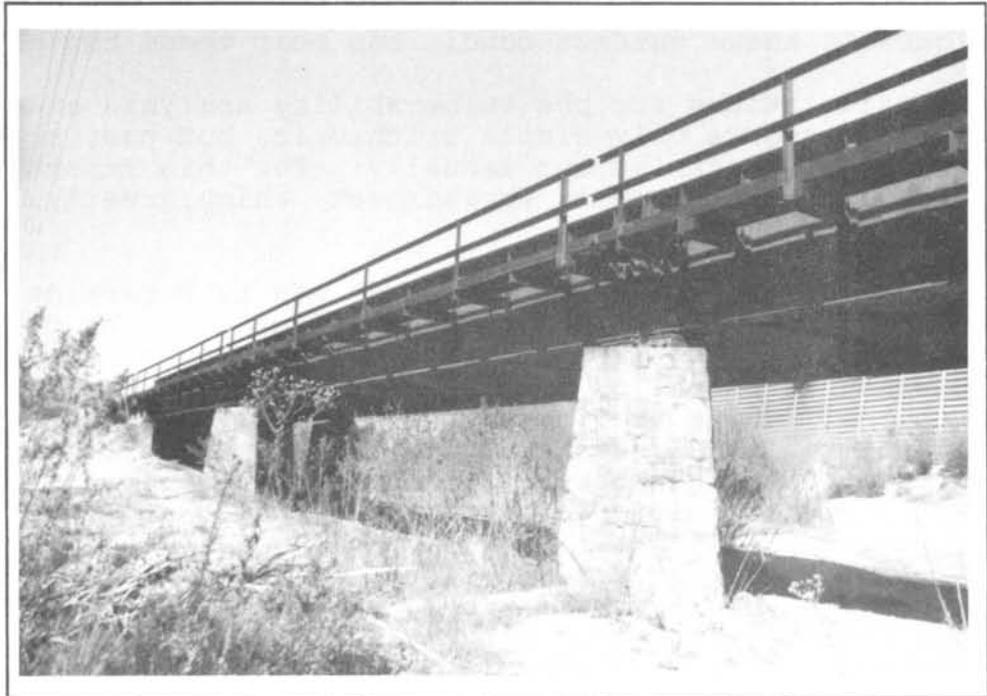
Figure 30 Santa Fe Railroad Rubble Masonry Pier Bridge

There is one bridge on the Santa Fe railroad just south of the I-15 truck weighing station which is founded on rubble masonry piers on sandy soil with a high water table (Figure 30). Loss of one or more spans is anticipated. That is contrasted to the Union Pacific railroad bridge at the

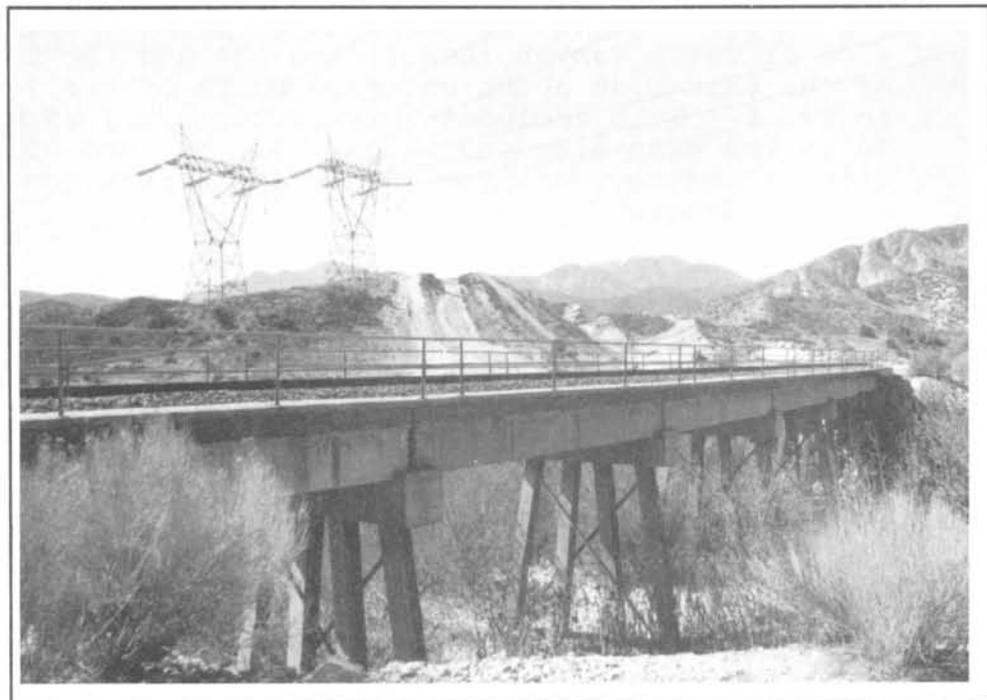
Figure 31 Union Pacific Railroad Bridge With Power Lines Overhead

same location (Figure 31) which has steel column, pile piers. Figure 14 shows surface conditions near these two bridges.
