Multiple Measures Protected University from Floods

Full Mitigation Best Practice Story

Harris County, Texas

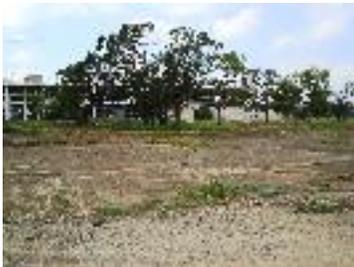
Overland water flows to a large detention pond

“The two biggest projects and the most expensive projects were, first, the overland flow channel to let water down to the detention pond easier and faster, and, second, the installation of an underground drain line that ties into the city line,” said Tomlinson.
