## Mitigation Can Be Appealing

### Full Mitigation Best Practice Story

#### *Guadalupe County, Texas*

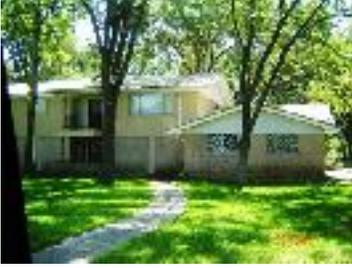
A picture of the neighbor's house, which was damaged by the flood.

In June 2007, Geronimo Creek flooded. More than three-and-one-half feet of water entered ground-level homes in their neighborhood causing damage. The Acuna’s home was unscathed.

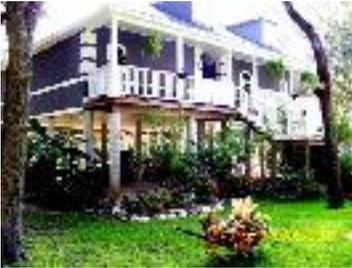
Side View of the Acuna's Home

Construction of the 1,805 square foot stucco home began in March 2005 and was completed within six months by a local builder. The first floor is elevated 12 feet above the slab foundation on 32 concrete pilings with embedded anchor plates for added support. The open space below provides parking, storage, and building access. The home backs up to Geronimo Creek, which feeds into the Guadalupe River.

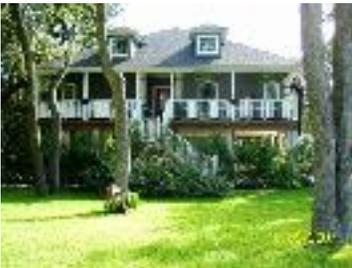
Front View of the Acuna's home.

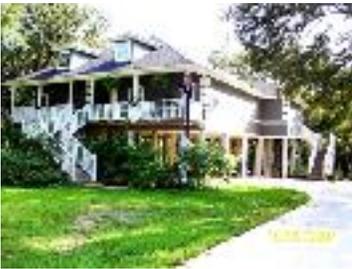
Side View of the Acuna's home.
