A Bridge Over Powered Water Full Mitigation Best Practice Story

Stephens County, Oklahoma

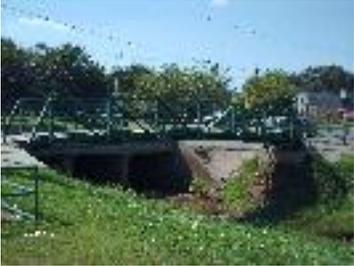
Elevated Footbridge on Main Street

Vaughn's experience as a public works director taught him the power of water, especially moving water. With that experience in mind, Vaughn built a pedestrian bridge on Main Street in the late 1990s at a height three feet above the BFE.

The elevated bridge project took 30 months to complete and included a concerted effort to educate the City Council regarding the benefits of building above the BFE prior to construction. The bridge now stands about four feet above street level supported by deep footings, and according to Vaughn includes access from both sides of the bridge in compliance with the Americans with Disabilities Act.
