Venting Breakaway Walls Saves Homeowner Thousands

Full Mitigation Best Practice Story

Okaloosa County, Florida

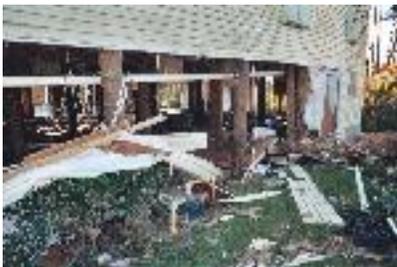
Although the Sluka’s main living area was undamaged, when the breakaway walls failed as designed, everything inside the storage area—tools, tapes, personal papers—was washed away. In terms of damage to the building, high winds caused minor siding damage. Dan estimates it cost about \$24,000 to repair the flood damage. His NFIP flood insurance policy covered some flood damage to the building, but not to the stored belongings, the latter of which Dan estimated were worth about \$20,000.

Damage from Hurricane Ivan: Dan Sluka lost many irreplaceable personal items when his breakaway walls broke away.

Dan decided he wanted to do something different when repairing so the breakaway walls wouldn’t fail so easily in future storms. He researched hydrostatic pressure and discovered a manufacturer making engineered and certified flood vents, which could help limit future damage while still protecting the primary structure from wave and surge forces.

Dan then had his builder install the flood vents when replacing the breakaway walls. The vents are insulated to allow the storage space to be air conditioned to minimize mold growth in the humid months in the Gulf. Float devices automatically open the vents during a flood to equalize pressure from floodwater so the walls shouldn’t break away until the water gets deep enough for significant wave action.

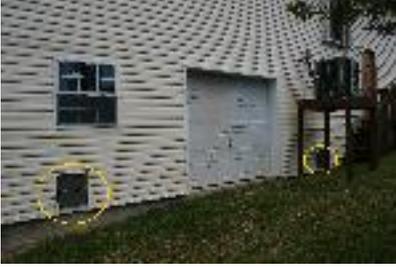
Dan's idea to install flood vents in the breakaway walls was tested in 2005 when Hurricane Dennis flooded the neighborhood. Although 2.5 feet of water entered the storage area through the flood vents, instead of a large bill to repair the breakaway walls, says Dan, "I just had to power wash the walls. We didn't have any damage."

Vents Helped Prevent Damage during Hurricane Dennis
