Safe Building Practice Protects Investment

Full Mitigation Best Practice Story

Baxter County, Arkansas

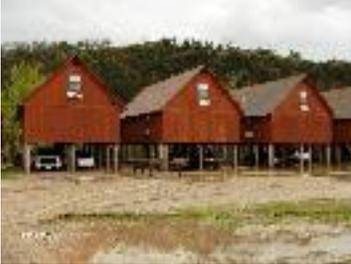
This is a picture of the elevated cabins at Norfolk River Resort

Research data reported the Base Flood Elevation (BFE) to be 397 feet. The ground level of each cabin is at 401 feet, four feet above the BFE. Each 1,800 square feet cabin rests on 18 concrete pilings. The pilings are 14 inches in diameter. They are embedded seven feet below the surface and eight feet above the ground. Each rests on a two feet by two feet concrete footer. The area beneath the cabins is used for parking.

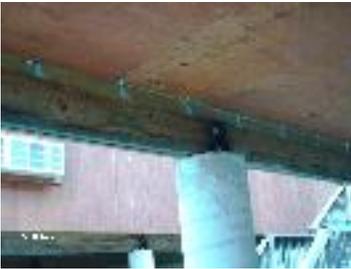
Picture of hurricane straps which are attached to the 2x4's beneath each cabin

McCumber fortified the cabins for high wind events. All floor joists have hurricane clips. All trusses have hurricane straps. There is connectivity from the roof to the floor. The hurricane straps are nailed to the 2x4’s which are anchored to the 2x12’s and the 2x12’s are anchored to the concrete pilings. He also secured the outdoor furniture and equipment. Benches and gas grills are anchored with hurricane straps nailed to 2x4’s chains and smaller barbecue pits are anchored in concrete.

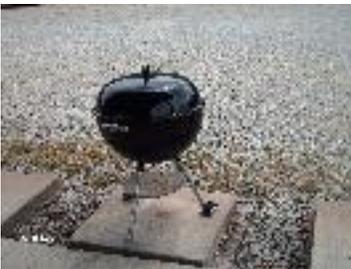
Picture of anchoring method used to secure outdoor equipment
