FEMA 339 / March 1999

Building Performance Assessment Report

Hurricane Georges In Puerto Rico

Observations, Recommendations, and Technical Guidance

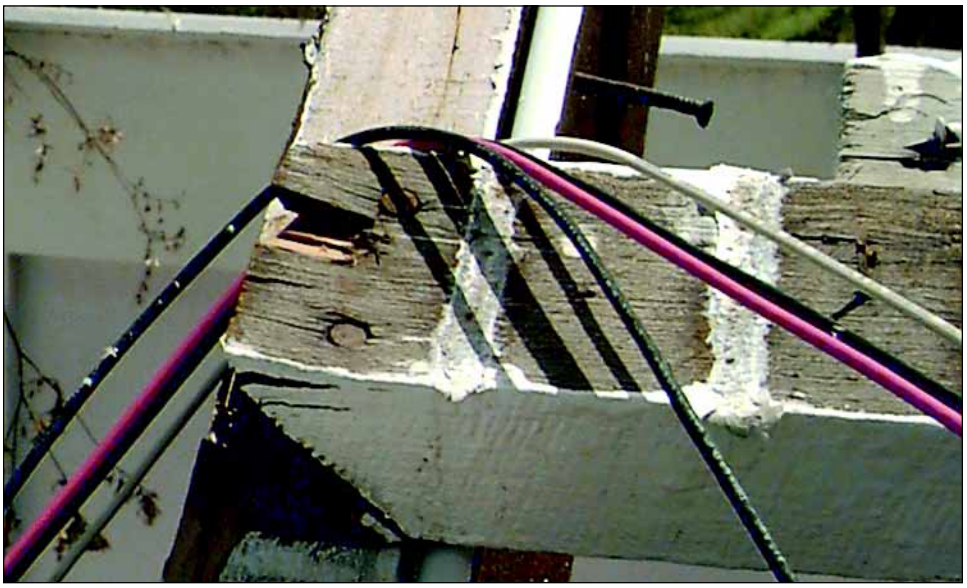
FIGURE 4-9 Masonry wall church that lost roof purlins and its corrugated metal roof. Nails were the only connections used to resist wind loads. The gable ends of this church were unsupported except for purlins resting in the masonry.

FIGURE 4-10 Nailed roof structure connection from church in Figure 4-9.

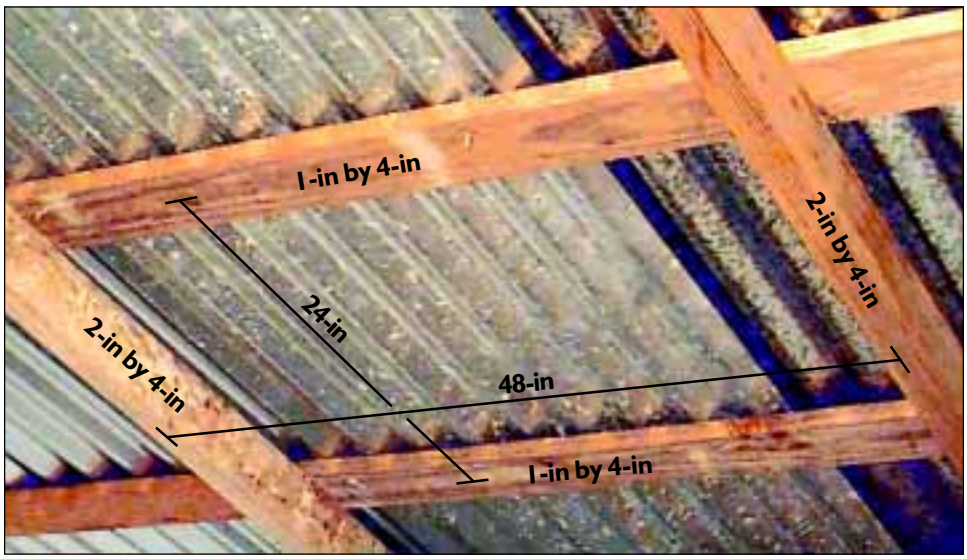
FIGURE 4-16 Typical wooden roof structure with metal roof panels above. Nails connected the metal panels to the nailers and the nailers were nailed to the joists.

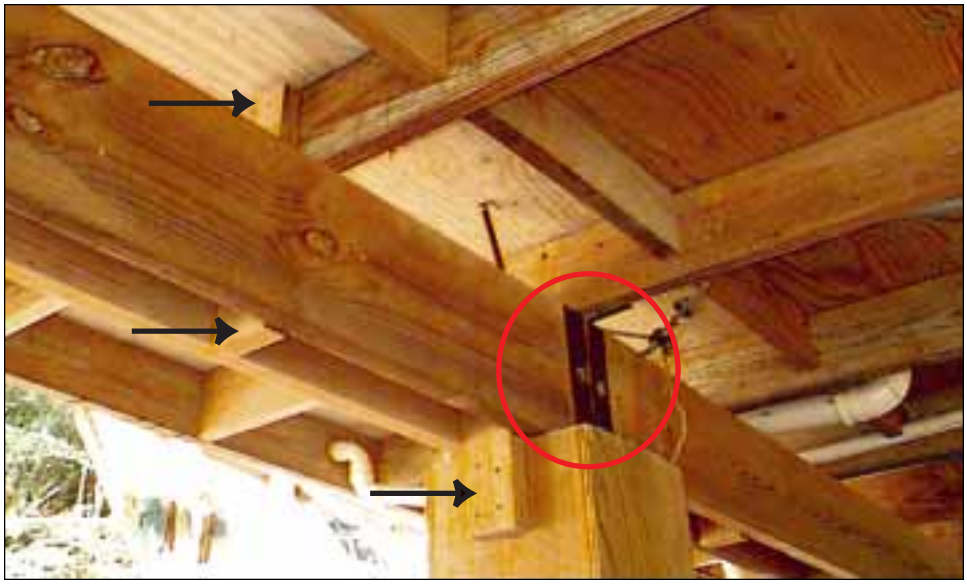
FIGURE 4-18 Example of a non-engineered connection between the building foundation (concrete column) and the floor system. The wooden floor beam is connected to foundation rebar with an improper nailed connection.

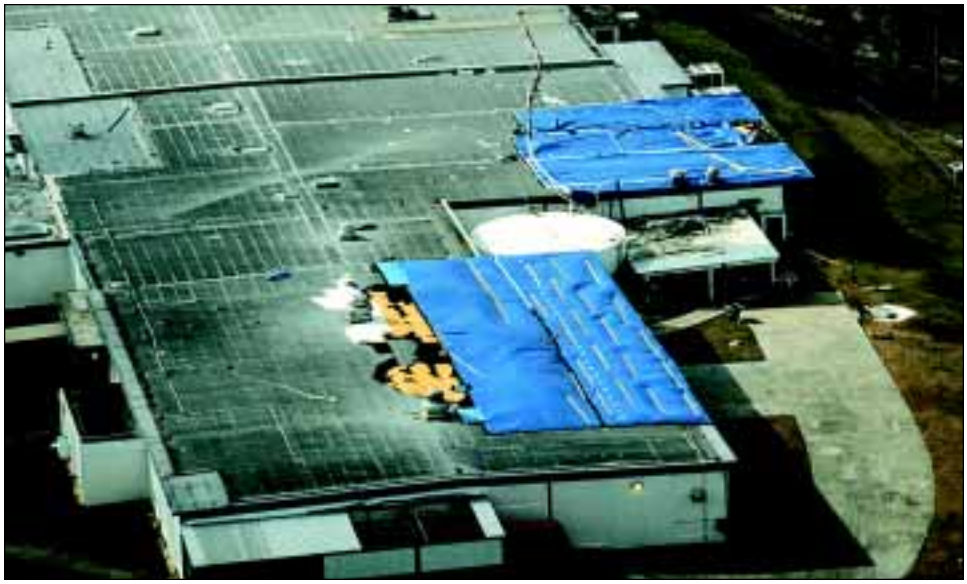
FIGURE 5-22 This built-up membrane had a mineral surface cap sheet. Because of the roof covering damage, this manufacturing facility on the island of Culebra was shut down for approximately two weeks after the hurricane. This building also experienced roof damage during Hurricane Hugo in 1989.

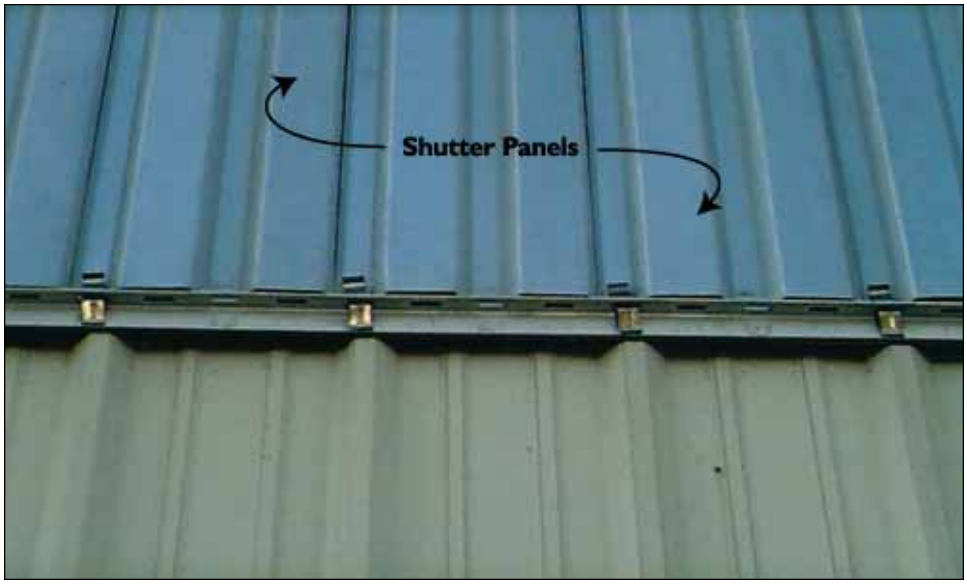
FIGURE 5-36 Looking up at a shutter panel held in place by clips (a metal wall panel occurs below the shutter track). These clips were spaced 12-in on center. Clips are not as reliable as the bolted attachment shown in Figure 5-35.

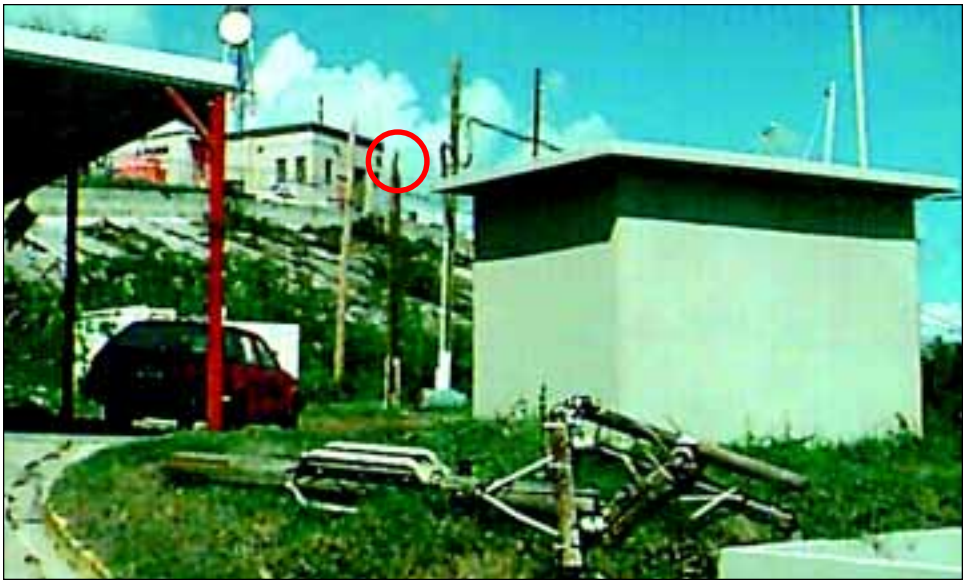
- Broken wood poles: This was caused by too great a load on the pole, including too large a span or various heavy communication lines on the poles (Figures 7-1 and 7-4).
- Leaning poles (wooden and concrete): This was considered minor damage and was easily corrected by straightening and properly embedding the poles in the ground (Figure 7-2).
- Broken concrete poles: Round spun concrete poles generally perform better than the reinforced concrete poles that are widely used in Puerto Rico. There was evidence of spalling and cracking of reinforced concrete poles indicating a probable quality control problem (Figure 7-3).
- Fallen poles: This was a result of improper embedment. Additional damage occurred to the conductors, causing progressive failure to other poles.

FIGURE 7-1 Damaged wood pole. The portion of the wood pole in the foreground broke from the pole (circled) in the back of the picture.

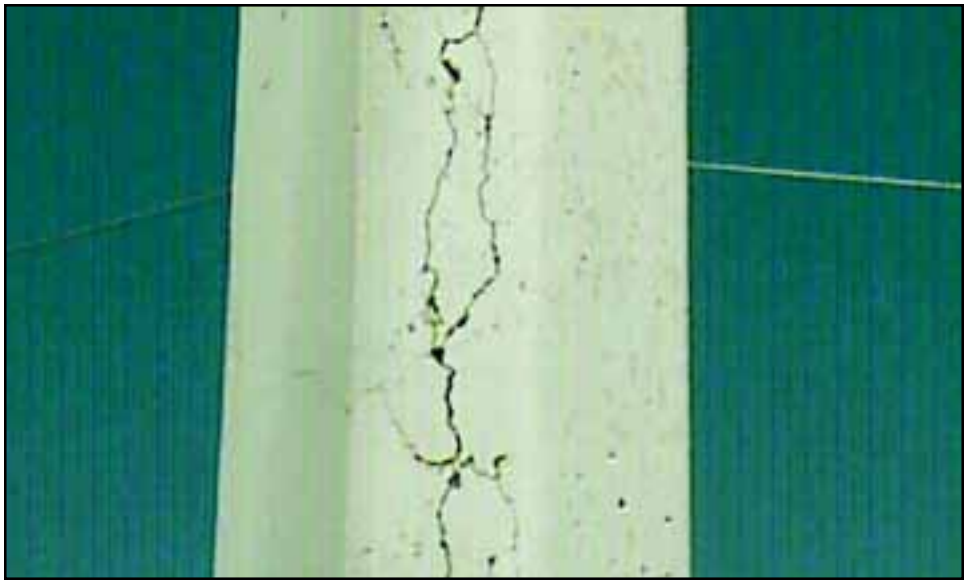
FIGURE 7-3 Observed crack in concrete pole that appears to be a quality control problem.
