# 2 *Site Observations*

On September 12, 1996, the FEMA Mitigation Directorate deployed a BPAT to coastal North Carolina to assess damage caused by Hurricane Fran. The team was composed of FEMA Headquarters and regional office engineers, a State representative, a consulting structural engineer, a consulting specialist in coastal construction and shoreline erosion, a consulting coastal engineer, the Chief Underwriter of the NFIP, and an engineer from the Insurance Institute for Property Loss Reduction. (See Appendix B for a list of team members.) Some members of the BPAT also represented the American Society of Civil Engineers (ASCE) Committee on Flood-Resistant Design and Construction.

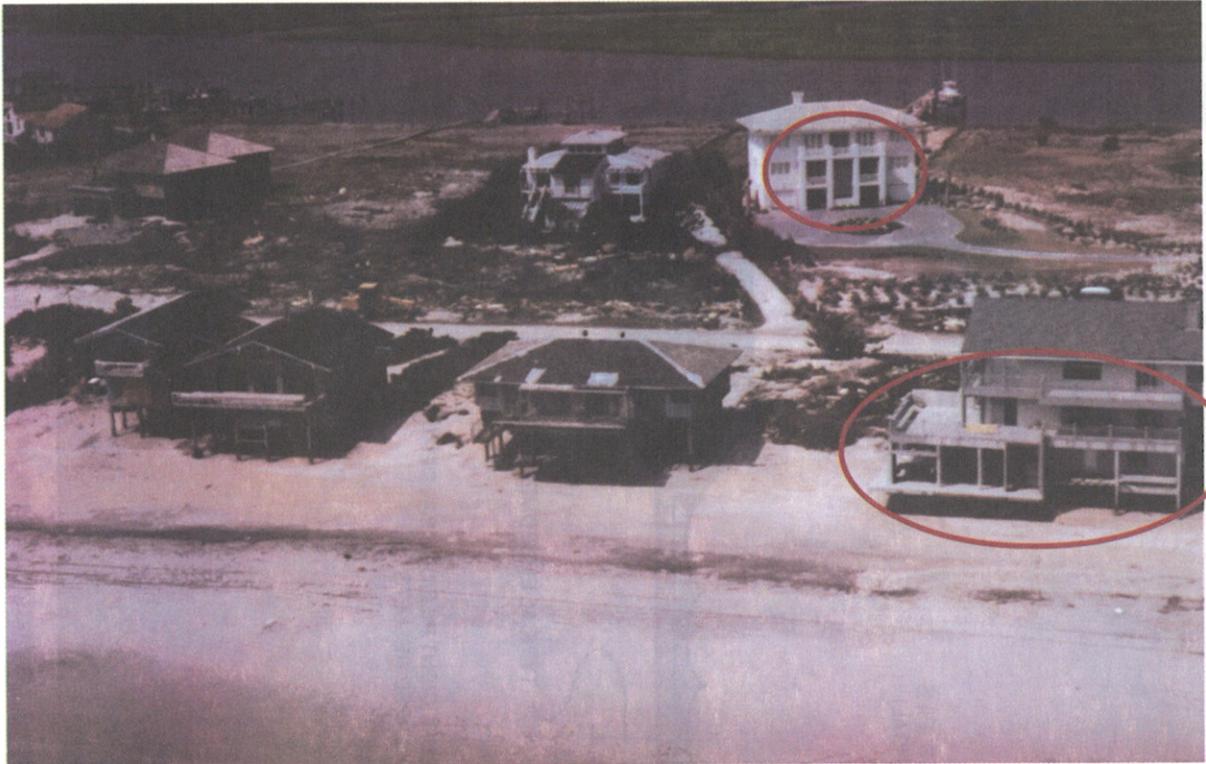
For decks, porches, and roof overhangs to have survived, their supporting vertical members would have to have had a post-storm embedment of approximately 8 feet below grade. The findings of the team regarding decks, porches, and roof overhangs are particularly important because it appears that the construction of multilevel decks and porches supporting roof overhangs is becoming increasingly popular in oceanfront architecture (see Figure 2-15). Usually, these building extensions are larger and more complex than required solely for building access.

Figure 2-15 As shown by this post-Fran photograph taken at Figure Eight Island, North Carolina, a current architectural trend is the construction of multistory decks supporting roof overhangs.

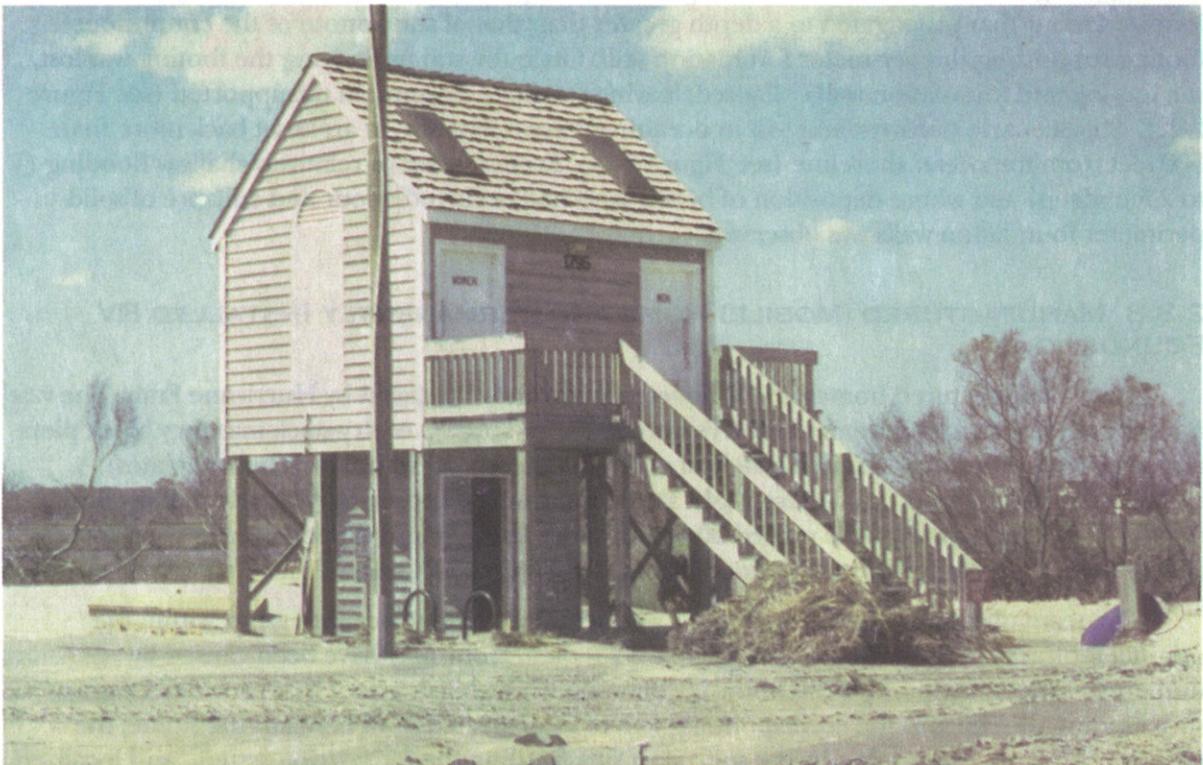
NFIP regulations require that structures in Coastal High Hazard Areas (V zones) be elevated so that the lowest horizontal structural member of the lowest floor is at or above the BFE shown on the FIRM in effect at the time of construction. In the areas visited by the BPAT, structures in V zones appeared to have been built in compliance with this requirement. For structures in A zones, the NFIP regulations require that the lowest floor be elevated to or above the BFE; no requirements are imposed for structures in B, C, and X zones. Although elevating on open foundations with lowest horizontal structural members at or above the BFE is not required outside of V zones, this practice was widely observed in A, B, C, and X zones on the barrier islands within the study area (see Figure 2-21).

*Figure 2-21 Survival of this properly elevated North Carolina State Park public rest room demonstrates the State's commitment to proper construction in coastal areas.*

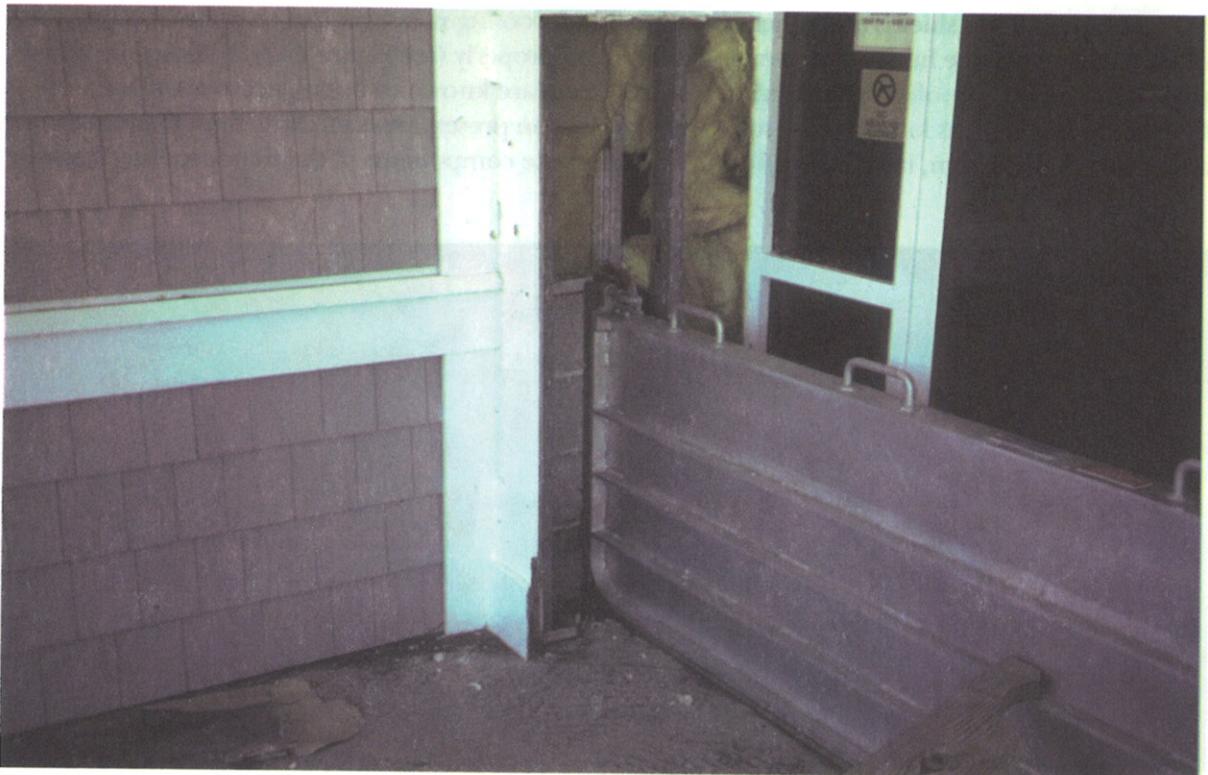
One unusual building in Wrightsville Beach is worth noting. The building is a slab-on-grade hotel that was renovated several years ago. During the renovation of the conference rooms, the owner reconstructed the exterior walls to make them watertight and installed tracks in the door openings for the placement of removable flood shields (see Figure 2-40). The flood shields were approximately 3 feet high and were manufactured by a firm that specializes in producing flood shields. Each shield was equipped with a pneumatic gasket that could be inflated to seal the gap between the track and the edge of the shield (see Figure 2-41). Construction of a solid masonry wall inside the exterior walls of the conference rooms completed the floodproofing.

The BPAT interviewed the hotel manager and engineer during the site investigation. Both were directly involved in the renovation of the hotel. Both said that the floodproofing was worth the effort but that they wished the shields had been 1 foot higher. While the shields prevented the storm surge from entering the protected area, some water splashed over the tops of the shields. The water that passed over the top flooded the conference rooms to a depth of 4 inches. It damaged the carpeting and mildewed the wall paper. However, in the remaining portions of the hotel, which were not floodproofed, the depths of flood waters reached 18 inches. In these areas, the water damaged the sheetrock and left over 2 inches of sand on the floor. Both the manager and the engineer stated that keeping sand out of the conference area was, in itself, justification for the expense of the floodproofing.

Figure 2-40 Engineered flood shield installed over opening to large dry floodproofed commercial building.

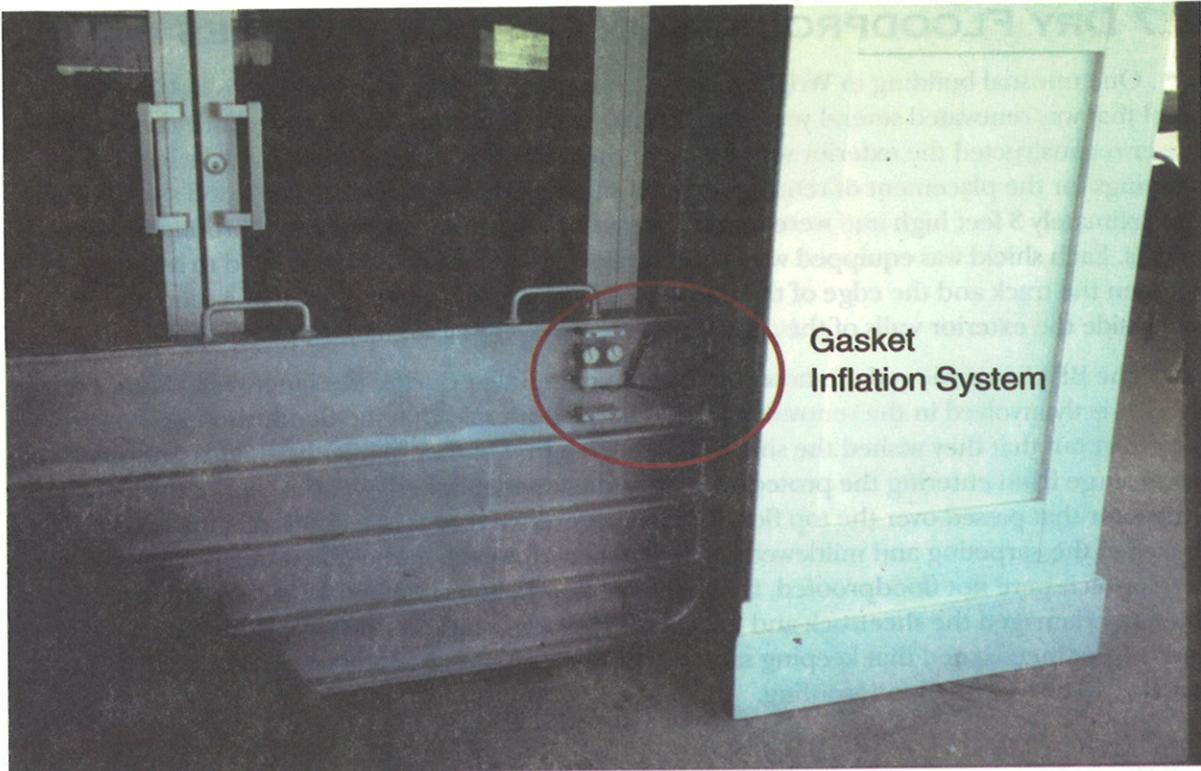
Figure 2-41 Buildings that are floodproofed require extensive engineering detailing. Note that this flood shield is sealed with a pneumatic gasket.

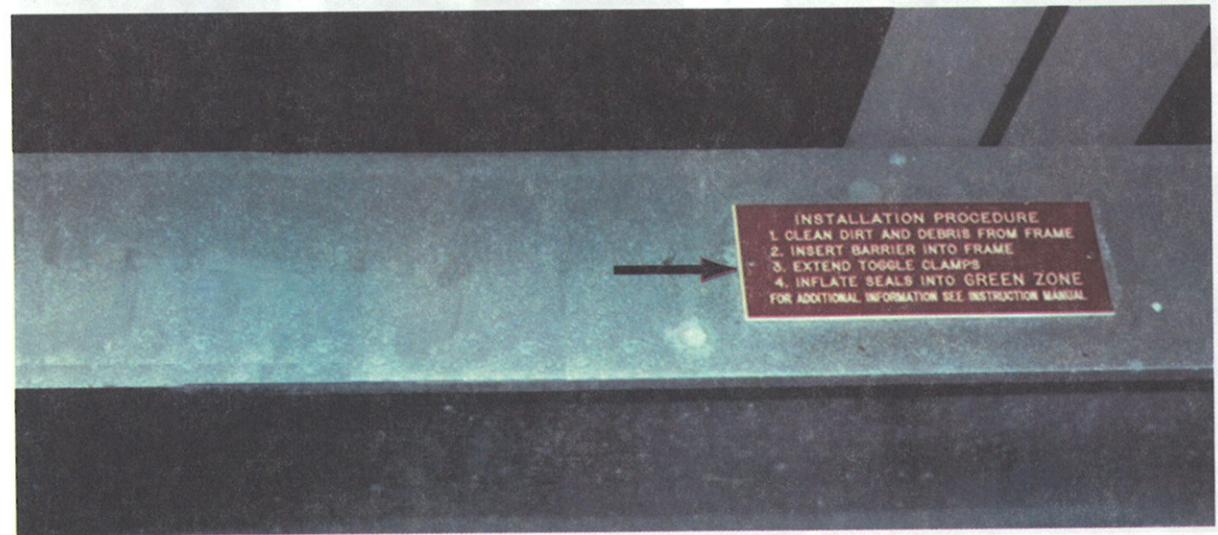
Although flood shields and other elaborate floodproofing measures can be quite effective, they often require extensive human intervention to function properly (see Figure 2-42). It should be noted that very few floodproofed buildings in coastal A zones are known to be subject to wave action. Floodproofing in areas known to be subject to wave action presents special challenges that must be addressed in the design, installation, and operation of the components of the floodproofing system.

Figure 2-42. Dry floodproofing often requires extensive human intervention. Note the detailed instructions affixed to this flood shield.

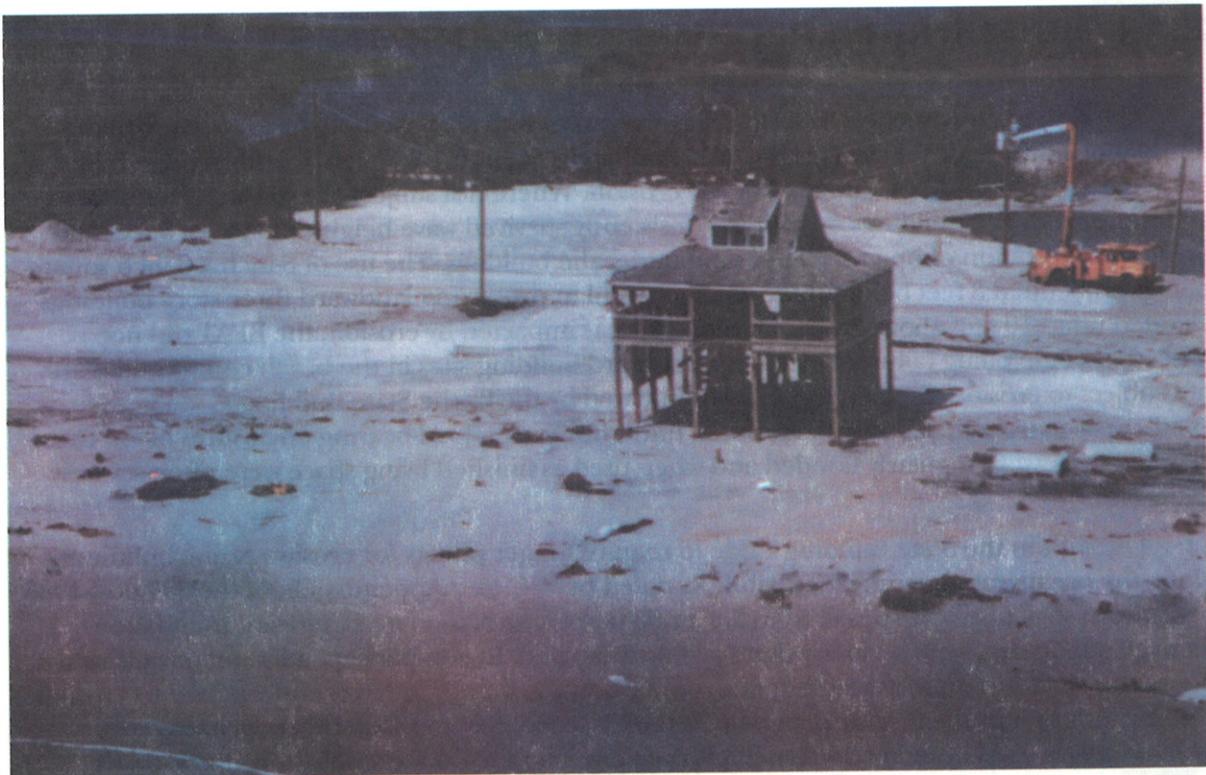
It is also important to note that the BPAT observed few situations in which the performance of breakaway walls below an elevated building may have resulted in structural damage to the building. Successful building performance during Hurricane Fran also demonstrates the value of compliance with elevation and setback requirements, the use of flood-resistant construction materials and techniques, such as in engineered concrete buildings, and compliance with other coastal design and construction requirements (see Figures 2-46, 2-47, and 2-48).

*Figure 2-46 While this house experienced 6 feet or more of vertical erosion and scour, as well as the loss of breakaway wall panels, the foundation and superstructure performed as designed.*

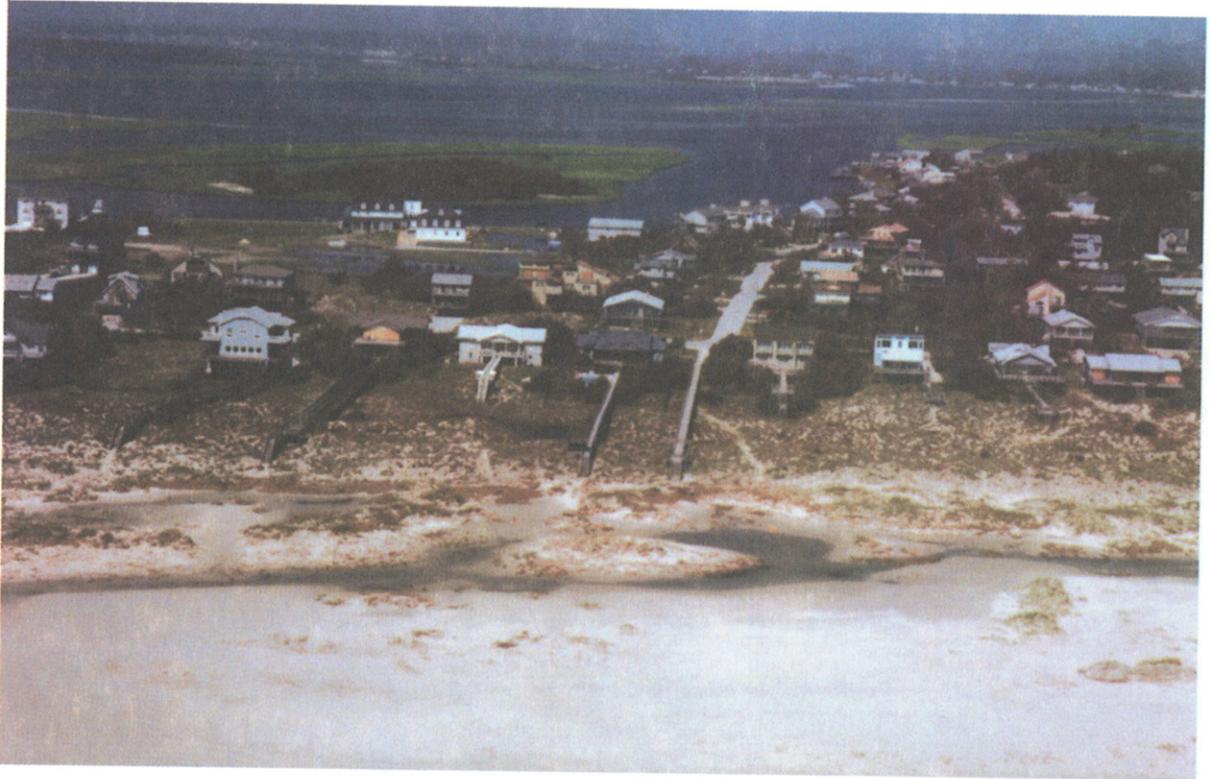
*Figure 2-47 As shown by this post-Fran photograph taken at Emerald Isle, North Carolina, proper elevation and setback from the oceanfront in conjunction with substantial protection afforded by dunes resulted in little or no flood damage to the oceanfront row of buildings.*

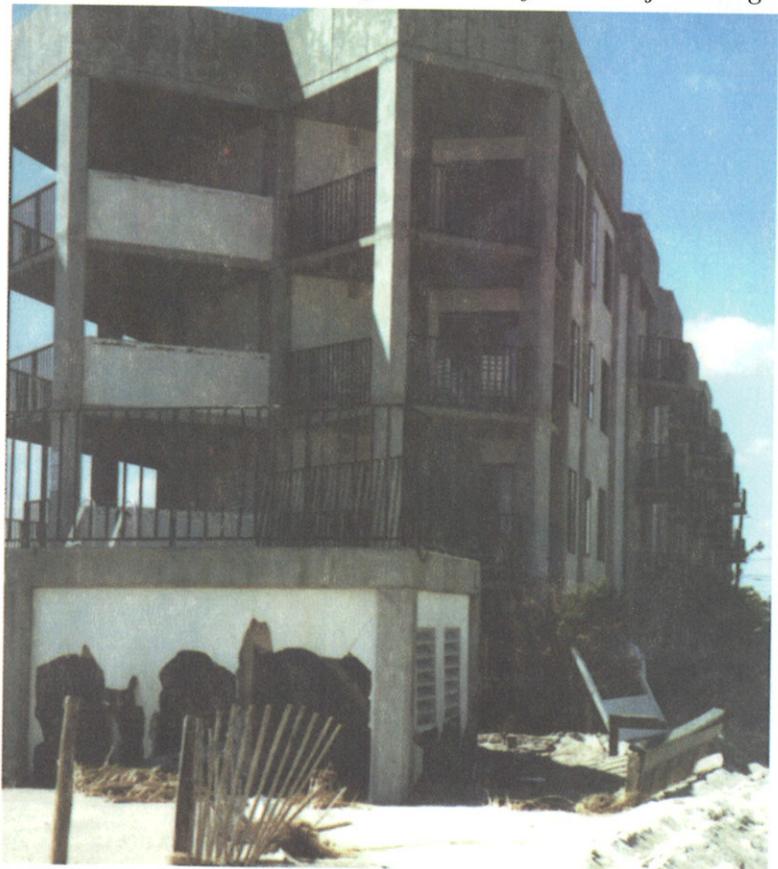
*Figure 2-48 This large, engineered oceanfront structure performed as designed.*
