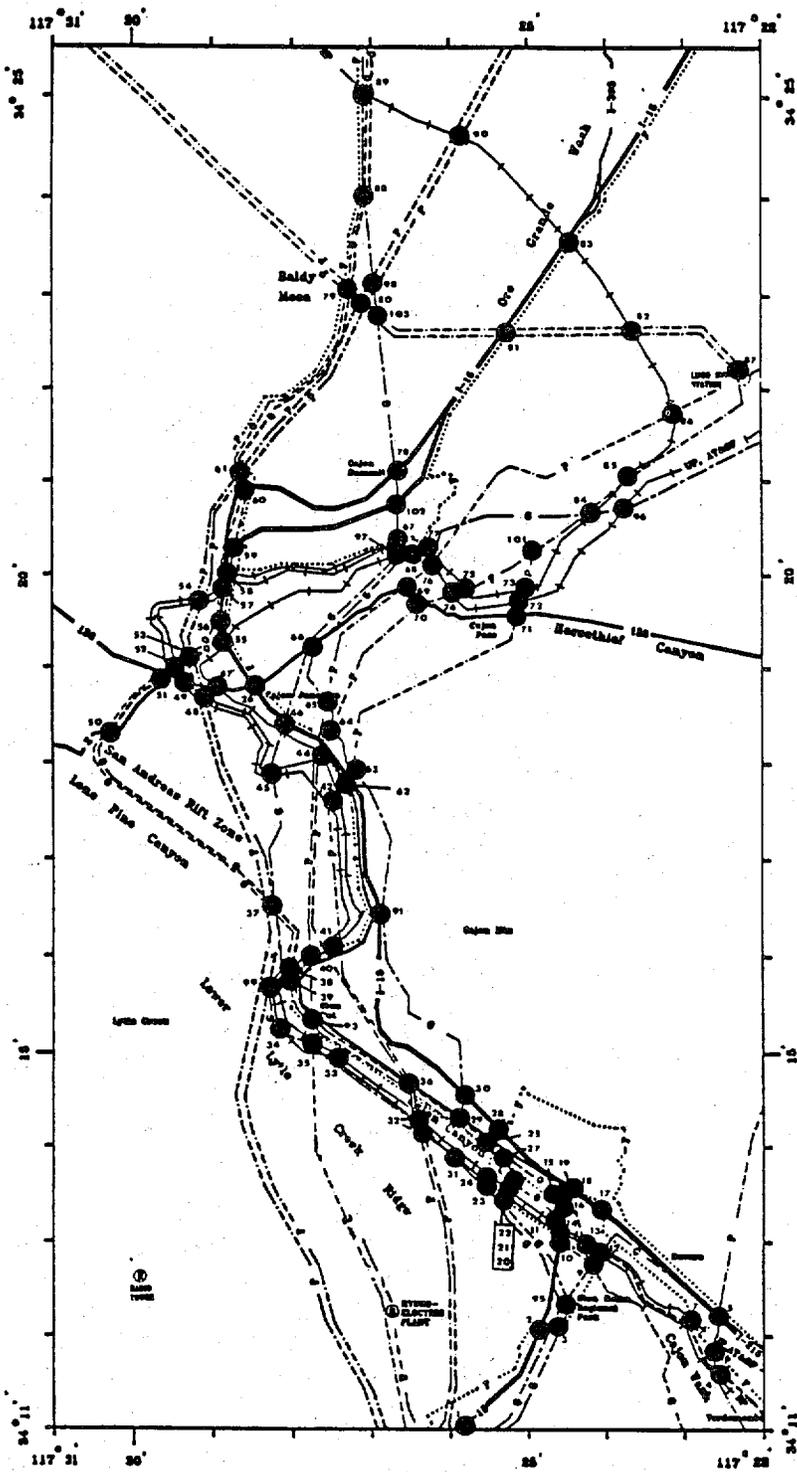
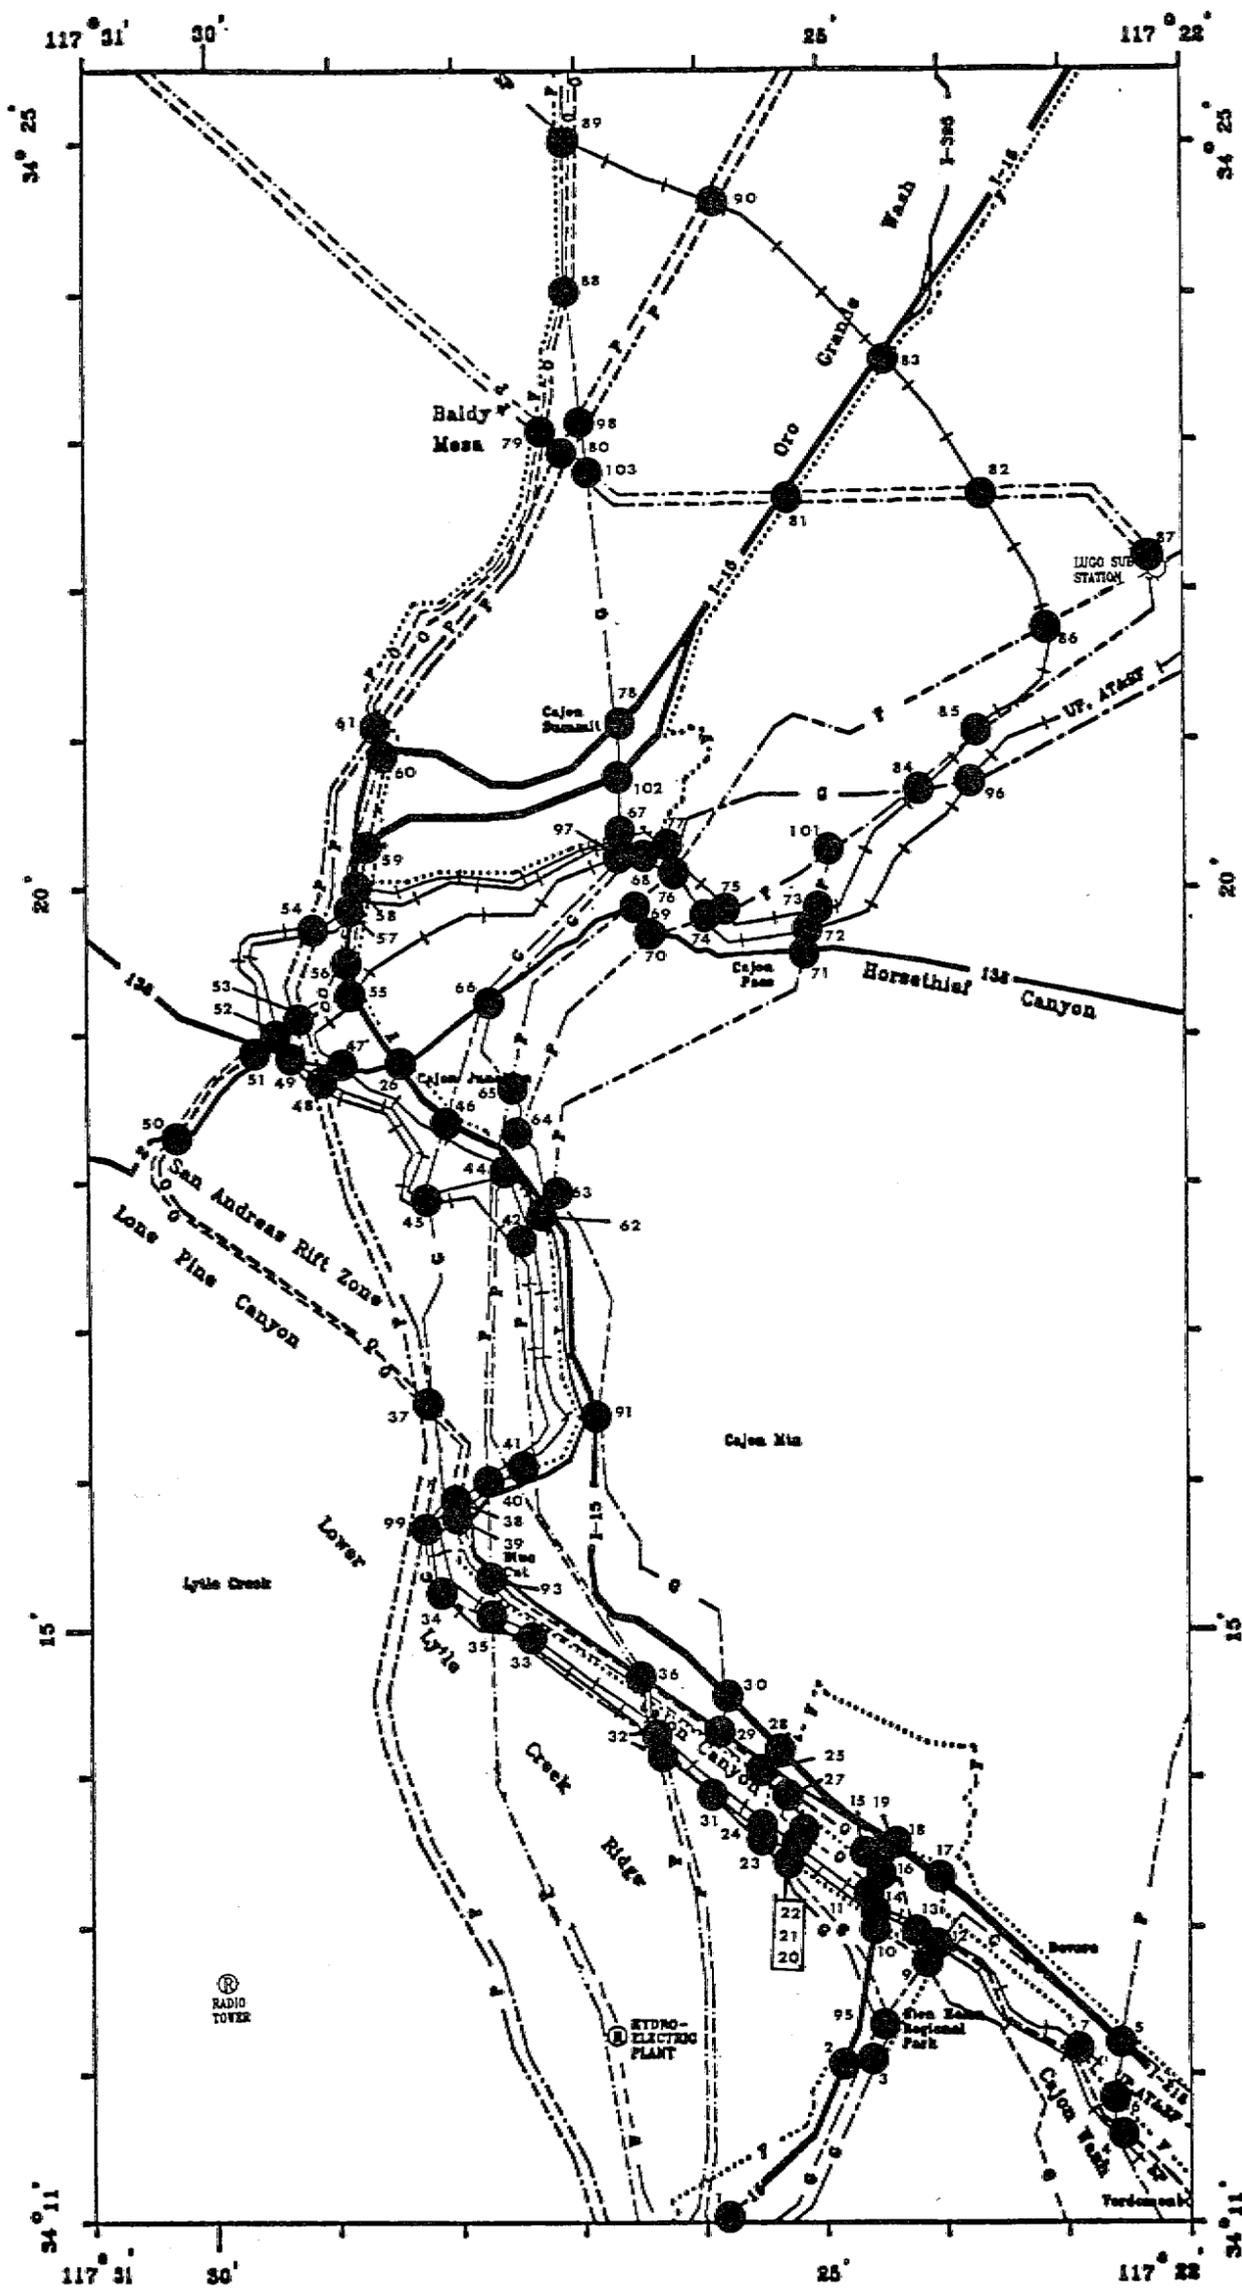
Figure 7, IDENTIFICATION OF LIFELINE COLLOCATION AT CAJON PASS

Figure 7 identifies the locations of the 101 collocations that were subsequently analyzed in this study. These collocations involved over 250 separate potential lifeline interactions. Table 15 was prepared to identify the collocation and the lifelines that were involved at that location. As the collocation evaluation was prepared, the results were tabulated against the index, thus assuring that all potential interactions were located and evaluated.

Table 15 and Figure 7 identify several critical clusters of interactions. With this in mind, a collocation damage scenario was developed for each critical cluster of interaction. Using a standard collocation damage scenario at the critical clusters helped assure the overall consistency of the interaction analyses.

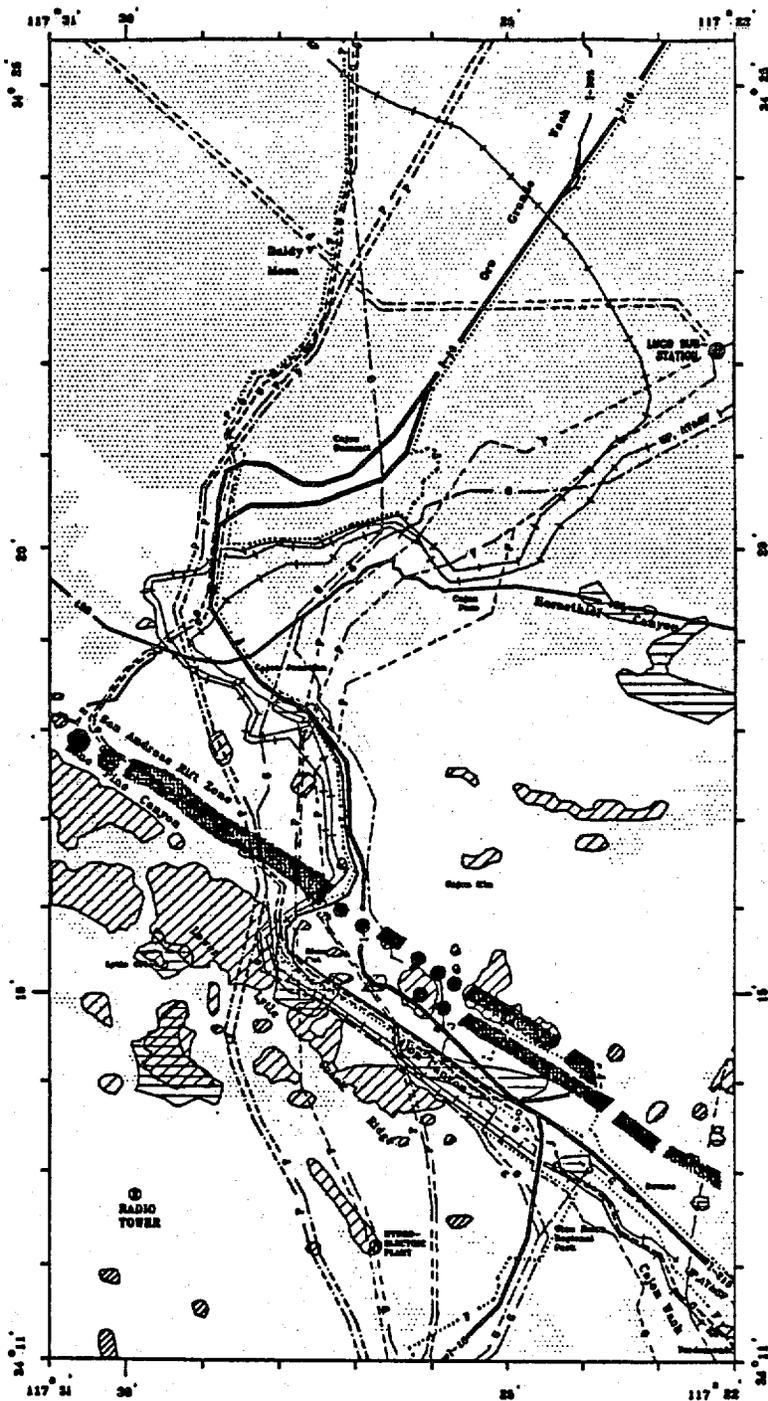
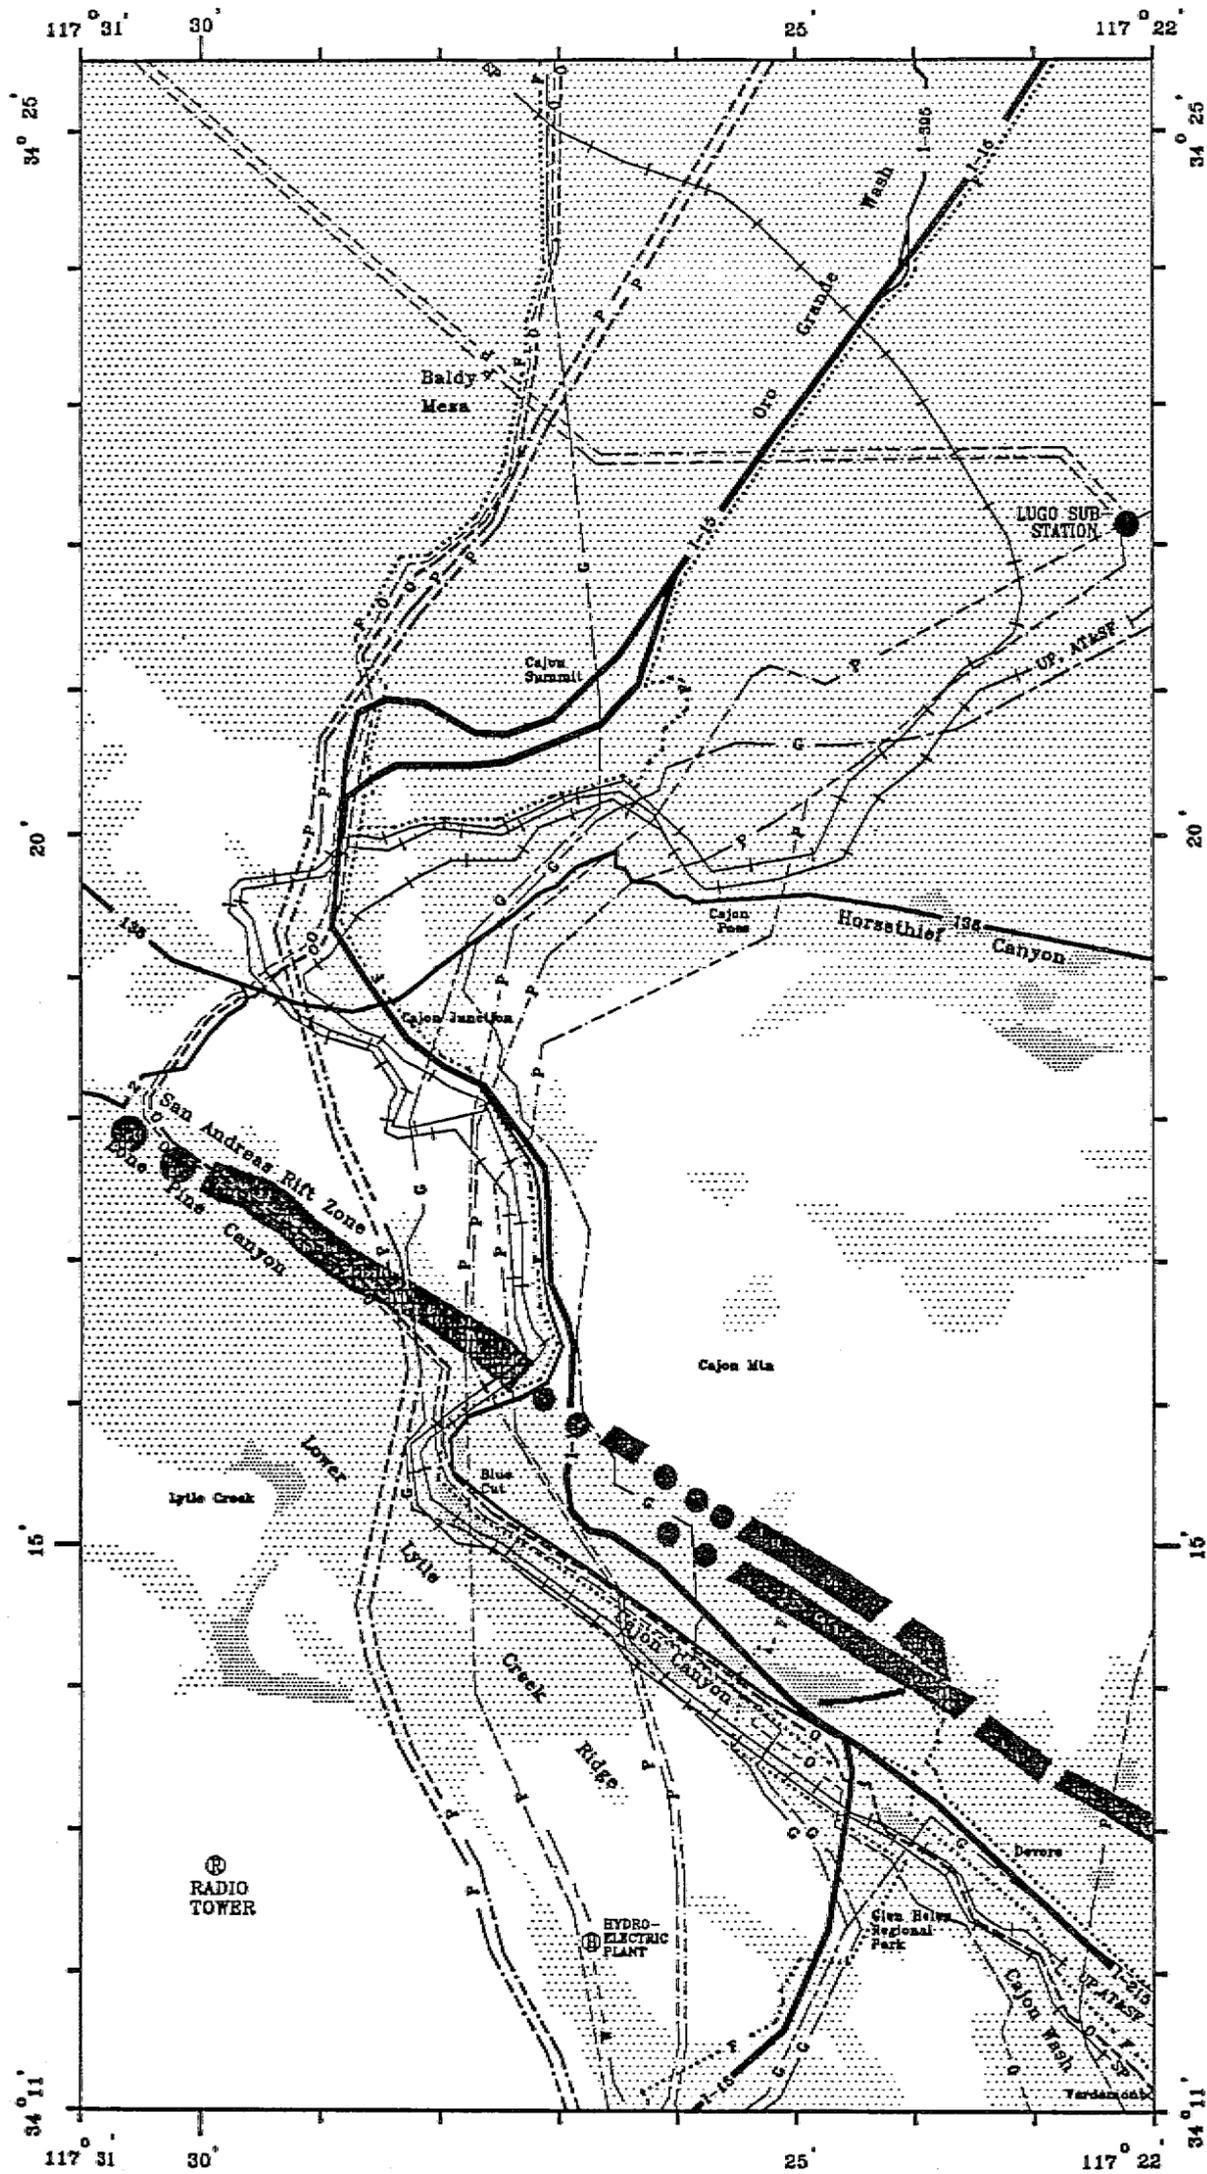
Figure 8, LIFELINE ROUTES WITH EARTHQUAKE SHAKING INTENSITY, AND POTENTIAL LANDSLIDE AND LIQUEFACTION AREAS

Figure 8 presents the summary of the calculated seismic and geologic conditions overlaid upon the lifeline routes. Although the figure is complex and filled with data, it does highlight some important information. In the figure the shaking intensities are shown with various levels of shading. The highest intensities, MMI = IX, are along the San Andreas fault rift zone. On the map they are shown as solid lines where the fault is well located, dashed where its location is estimated, and circled when it is hidden by younger rocks. The potential landslides are predominantly south of the San Andreas fault and lie in a southeast trend. There are four important regions of potential liquefaction: just south of Cajon Junction, at Blue Cut where they coincide with potential landslide regions, southeast of Blue Cut about two miles northeast of the I-15/I-215 intersection, and just south of the I-15/I-215 intersection.

Figure 8 shows that many of the conditions of high MMI value, landslide, and liquefaction overlap. This is important to note because the lifeline components in the study area (with the exception of some bridges) are not very sensitive to shaking damage. MMI values of VIII generally would only cause damage state

2 or 3 to occur (less than 5% damage expected). At those conditions, collocation induced additional damage would be slight or none at all. However, the facilities are very sensitive to ground movement and there are a number of potential landslide or lateral spread (or liquefaction) locations along the lifeline routes that coincide with MMI = VIII. North of the San Andreas fault the earthquake risk comes predominantly from shaking, but most of the peak shaking intensities are VII with a few isolated locations of VIII.

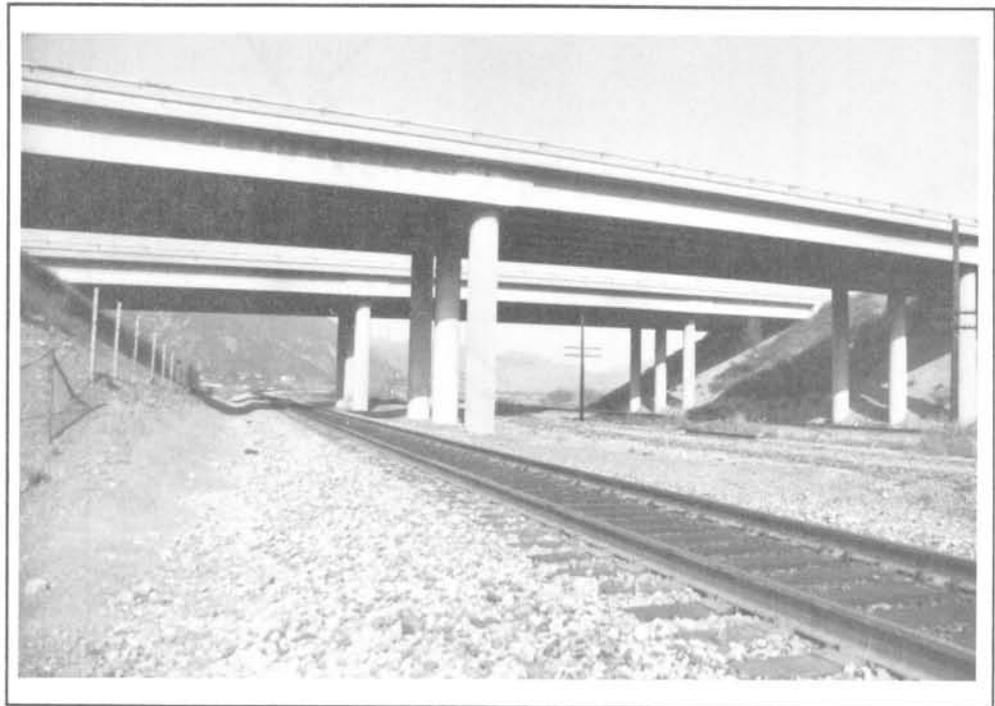
Figure 25 I-15 Bridge Over The Railroads In Cajon Wash

(1) The area near the liquefiable zone just south of the highway I-15 crossing over the railroads and the Cajon Wash, near the junction with I-215. This includes intersection points 8, 9, 10, 11, 13, 14, 15, 16, 18, and 19. A partial collapse of highway bridge No. 54-0818 over the three rail lines adds to the problems at this location. A delay time of 30 days due to this bridge problem (Figure 25) was added to the previously noted 30 day delay due to pipeline damage and hazards.

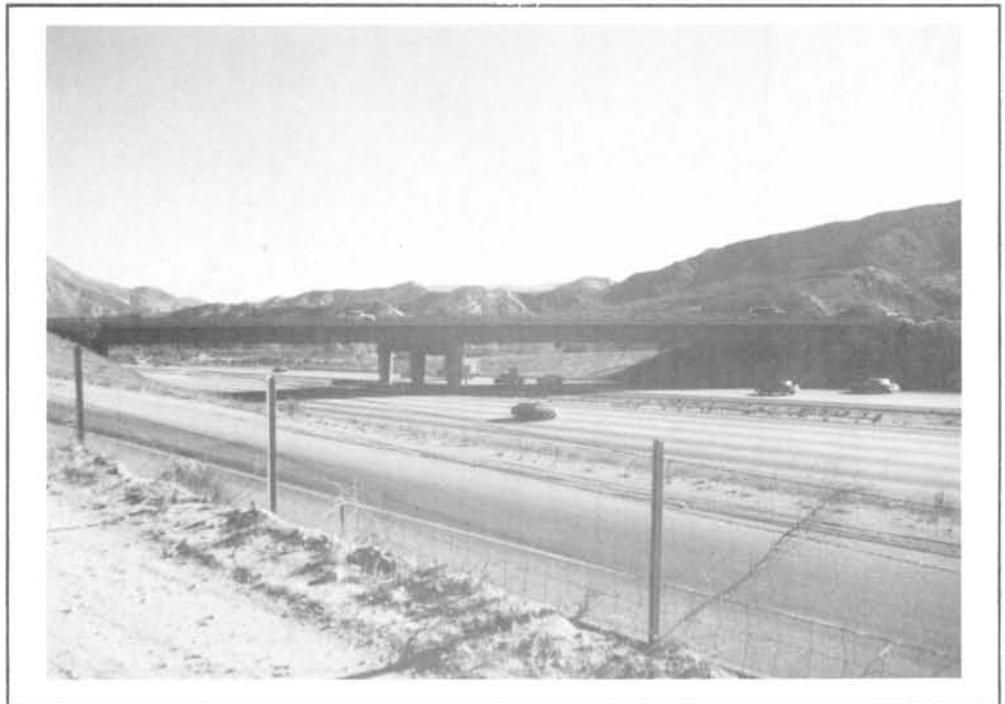
Figure 27 Highway 138 Bridge Over I-15

The highway bridges along Interstate I-15 were, for the most part, built in the late 1960's, except for the section over Lytle Creek Wash. Although they are in an area generally considered to be "California region 7", the status of retrofit is somewhat irregular. In this analysis, they are considered to be "California region 3-6" until proved to qualify for the higher degree of safety. Nevertheless, none of these bridges are expected to completely collapse, although partial collapse of several is possible. The I-15 bridge over the railway lines (Figure 25) and the high level I-15 bridge over Cajon Wash (Figure 26) are vulnerable, and there is some possibility of the partial collapse of the steel girders over I-15 at its junction with highway 138 (Figure 27).

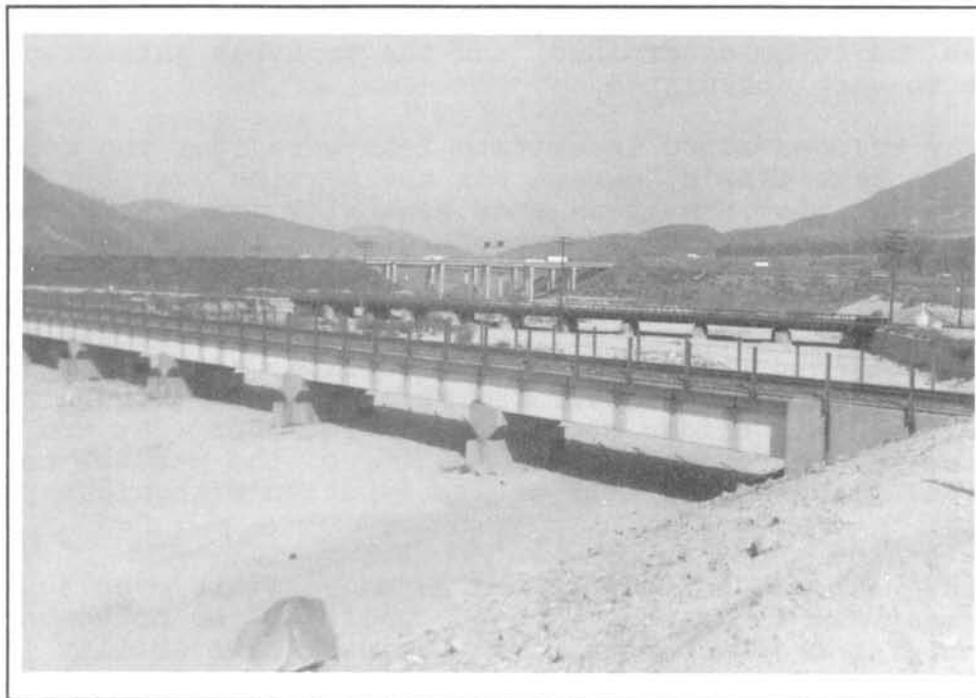
Figure 28 Railroad Bridges In Cajon Wash (I-15 Bridge
In The Background)

Many of the railroad bridges in the Cajon Pass are over 50 years old, but most are in relatively good condition. As noted in the discussion of the development of the Bridge Vulnerability Index, many of these bridges have inherent resistance to lateral loads. There are, however, several multiple simple span bridges over poor soil conditions (including possible liquefaction), such as both the Southern Pacific and Santa Fe bridges over the lower end of Cajon Wash (Figure 28). There are several more such crossings over the Cajon Creek and its branches. There is also a large two span, through

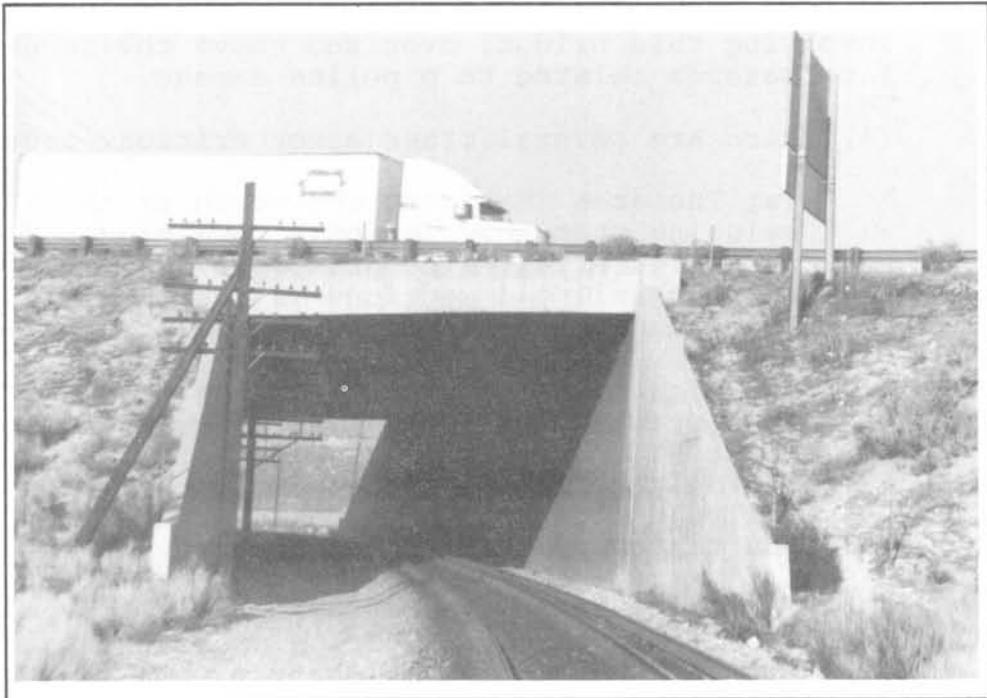
Figure 32 Typical I-15 Box Bridge Over the Railroads

(b) Highway Structures 0796, 0797 and 0827 which carry I-15 over the rail lines at Alray and Gish at intersections 55 and 57 (Figure 32). These structures may only be lightly damaged, but a 10 day delay in railroad access is assumed to permit time for inspection and temporary shoring if required.

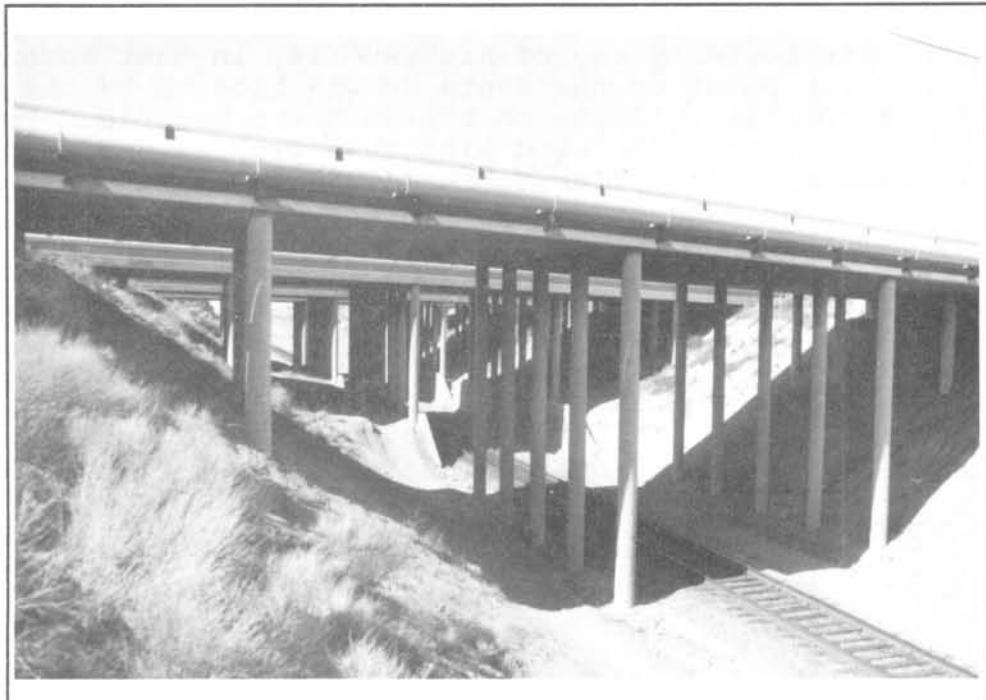
Figure 33 I-15 & Access Road Bridges Over the Southern Pacific Railroad

(c) The I-15 bridge 0664 (Figure 33) over the Southern Pacific tracks north of the pass at intersection 83 is expected to be lightly damaged, but 10 days delay is allowed for inspection (also see Figure 15 which shows details of this bridge).
