Chapter 8

ANCHORAGE OF HOME CONTENTS

8.1 GENERAL

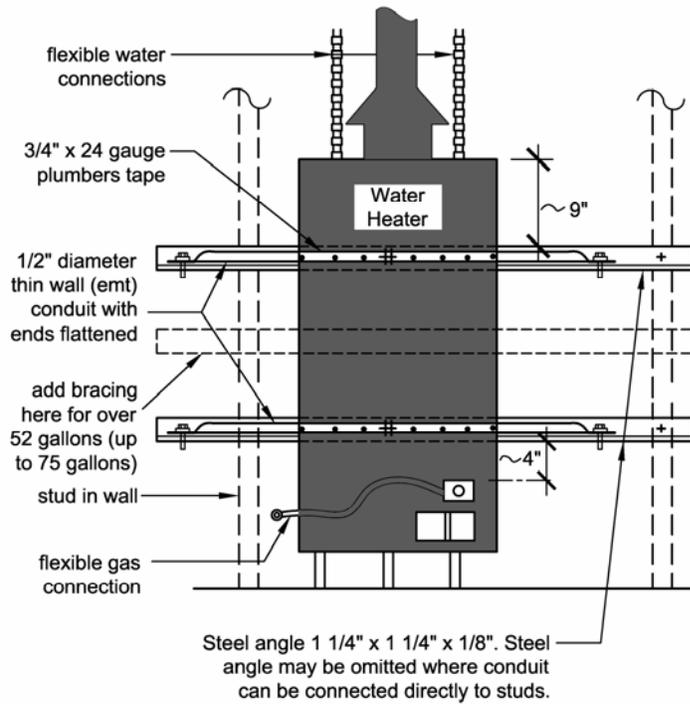
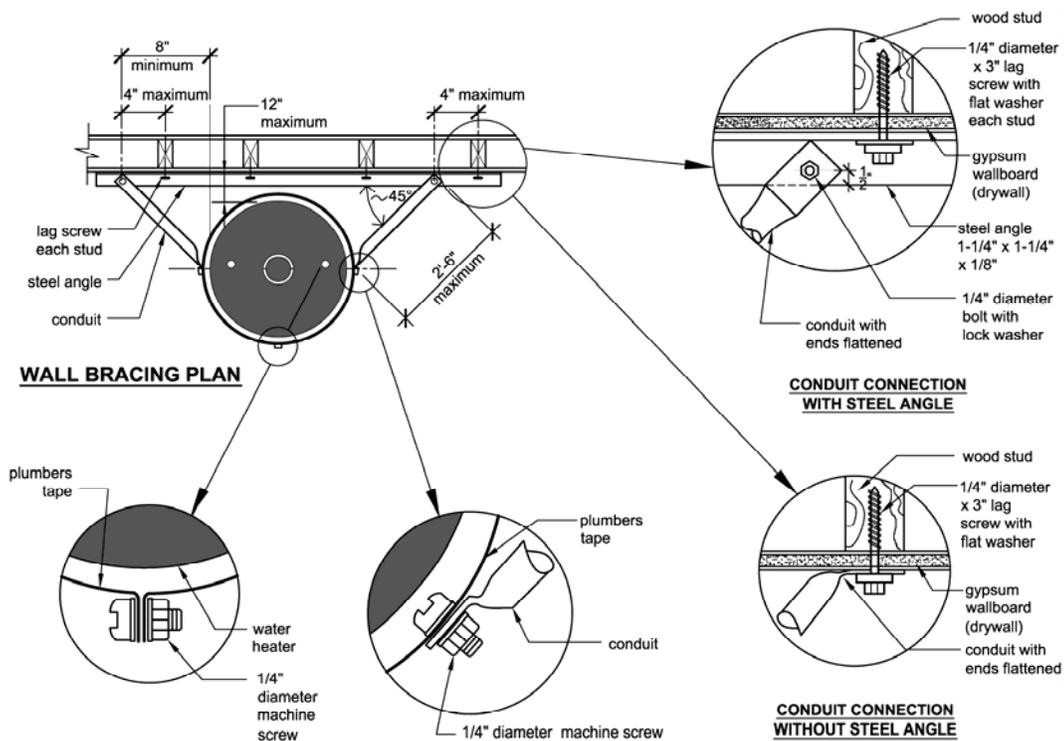
WATER HEATER WALL BRACING

This detail illustrates earthquake bracing for typical residential water heater systems (30 to 75 gallon capacity) braced to a flat wall. See wall bracing elevation at left. See second page for wall bracing plan and details.

Plumbers tape is also called galvanized steel hanger strap, and must be not thinner than 24 gauge.

WALL BRACING ELEVATION

Figure 8-1a and 8-1b Securing a water heater with wall bracing.

Note that Figures 8-1 and 8-2 are applicable only to water heaters with a maximum capacity of 52 gallons with two strap locations and with a maximum capacity of 75 gallons with three. Some jurisdictions place additional limits on water heater bracing details. Where water heaters are installed on a platform, the water heater base should be attached to the platform and the platform should be anchored to the floor. Placing water heaters in metal pans to retain any spilled water is a possible precaution in addition to bracing. The *IRC* requires that water heaters be placed in pans where loss of water would cause damage. Required clearances to walls and combustible construction need to be maintained; the water heater UL listing and local jurisdiction requirements should be verified prior to moving or installing a water heater.

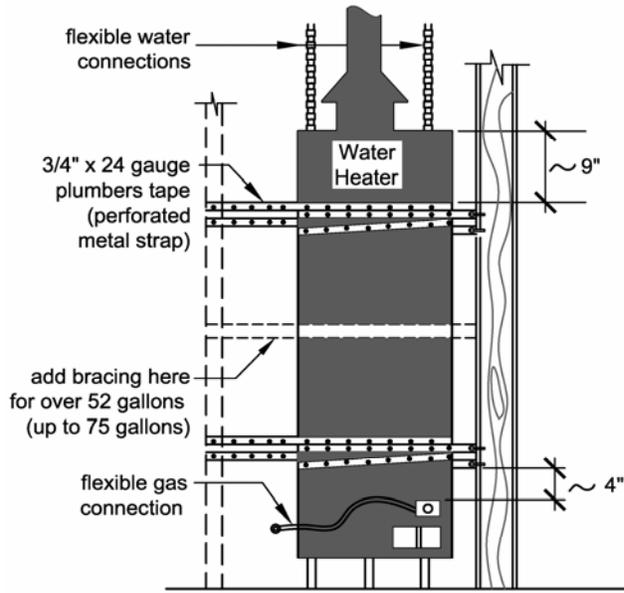
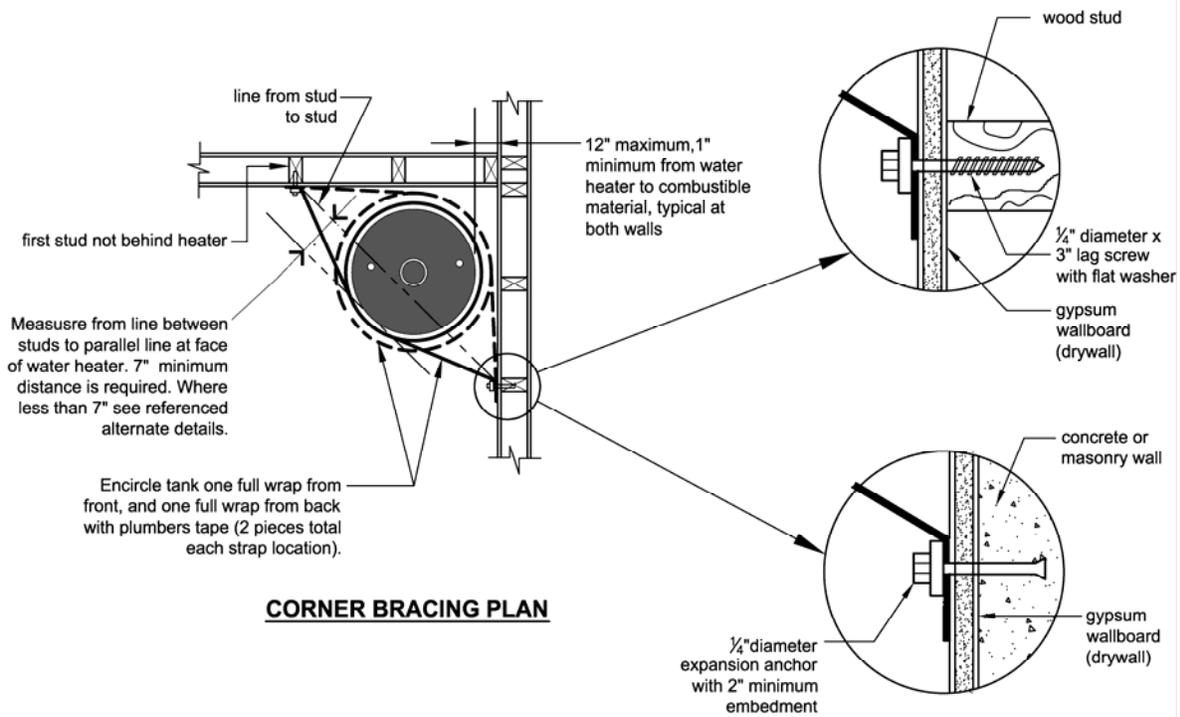
CORNER BRACING ELEVATION

WATER HEATER CORNER BRACING

This detail illustrates earthquake bracing for typical residential water heater systems (30 to 75 gallon capacity) installed at a corner. See corner bracing elevation at left. See second page for corner bracing plan and details.

Plumbers tape is also called galvanized steel hanger strap, and must be not thinner than 24 gauge.

Figure 8-2a and 8-2b Securing a water heater with corner bracing.

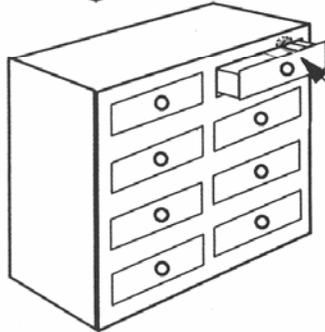
INSTALL MECHANICAL DRAWER CLOSURE (BABY-PROOF LATCHES, DRAWER LOCKS, OR OTHER SPECIALTY LATCHES)

Upgrade Detail C19

Figure 8-3a Reproduction of FEMA 74 suggestions for securing drawer and cabinet latches.

FEMA 74 provides several pages of installation notes that will be of assistance to users interested in selection and installation of fasteners appropriate to construction materials of the house (www.fema.gov/hazards/earthquakes/nehf/fema-74.shtm). Reproductions of FEMA 74 pages are shown in Figures 8-3a through 8-3f.

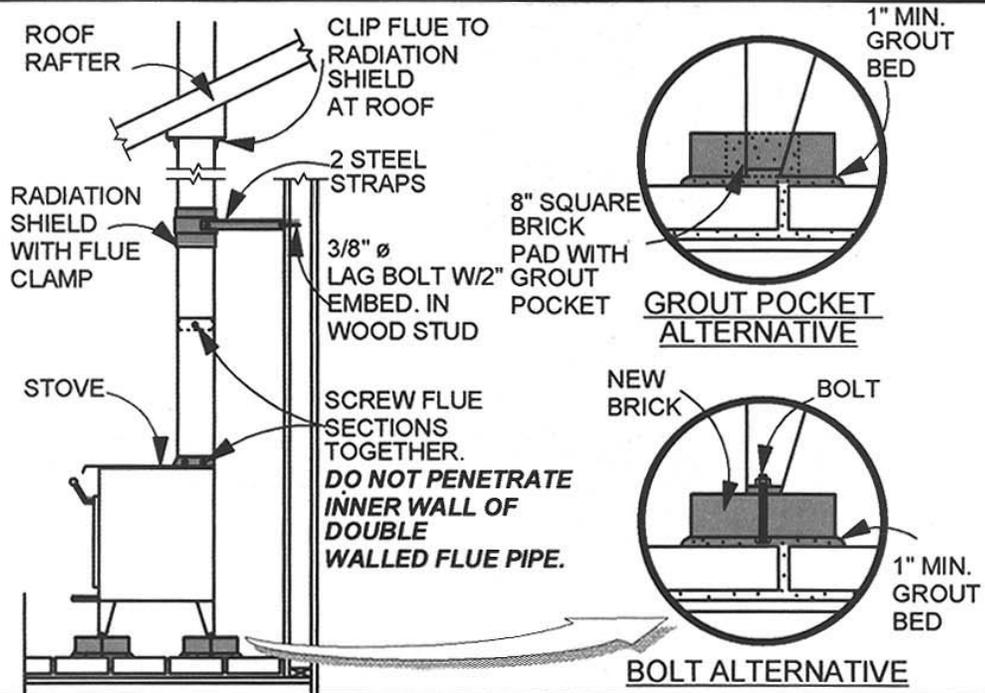
Upgrade Detail C20
 Approximate Cost: \$500

Figure 8-3b Reproduction of FEMA 74 suggestions for securing a freestanding wood stove.

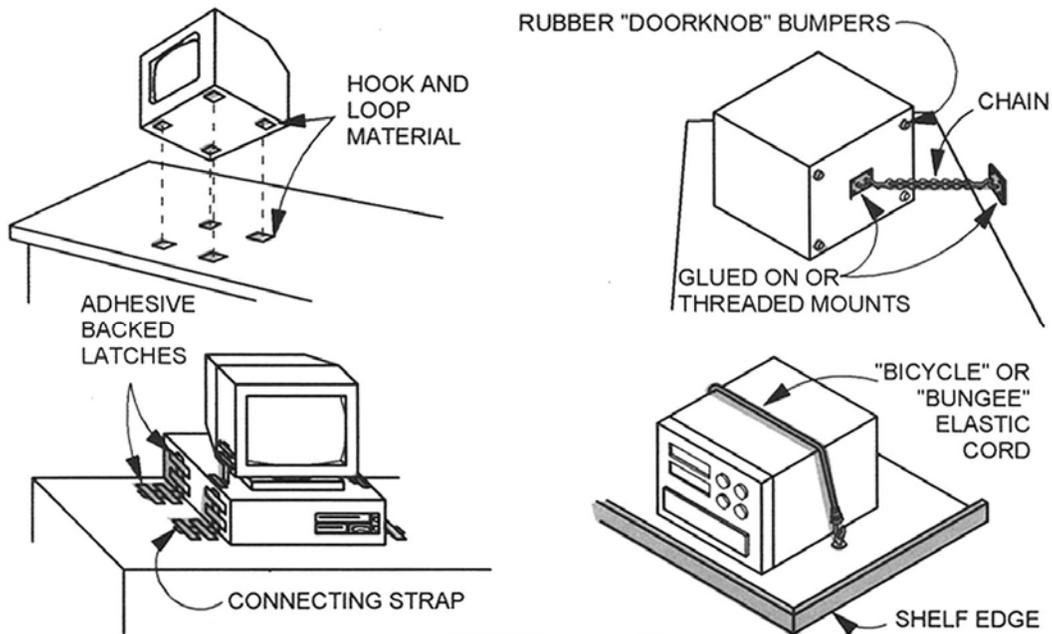
Upgrade Detail C10
Approximate Cost: \$50 per computer

Figure 8-3c Reproduction of FEMA 74 suggestions for securing desktop computers and office equipment.

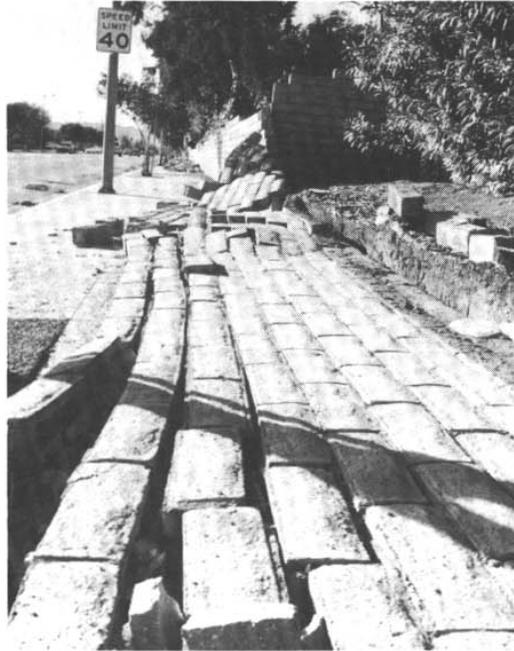
Earthquake Damage: 1994, Northridge, California
Photo Credit: Robert Reitherman

- MANY MILES OF POORLY CONSTRUCTED CONCRETE MASONRY UNIT (CMU) FENCES WERE DAMAGED DURING THE 1994 NORTHRIDGE EARTHQUAKE. COLLAPSE OF WALLS WITH INADEQUATE OR ABSENT REINFORCING AND/OR FOUNDATIONS WAS COMMON IN NORTHRIDGE AND SYLMAR. IN MANY CASES, MOST OF THE SIDEWALK WAS COVERED WITH DEBRIS, AS SHOWN ABOVE.
- FREESTANDING WALLS OR FENCES BUILT OF CMU, BRICK, OR STONE NEED TO BE ENGINEERED AND CONSTRUCTED WITH APPROPRIATE FOUNDATIONS, ADEQUATE REINFORCEMENT, AND GOOD QUALITY MORTAR.
- STANDARD DETAILS FOR LOW FENCES OR SHORT RETAINING WALLS MAY BE AVAILABLE FROM THE LOCAL BUILDING DEPARTMENT.

Figure 8-3d Reproduction of FEMA 74 suggestions for securing freestanding walls or fences.

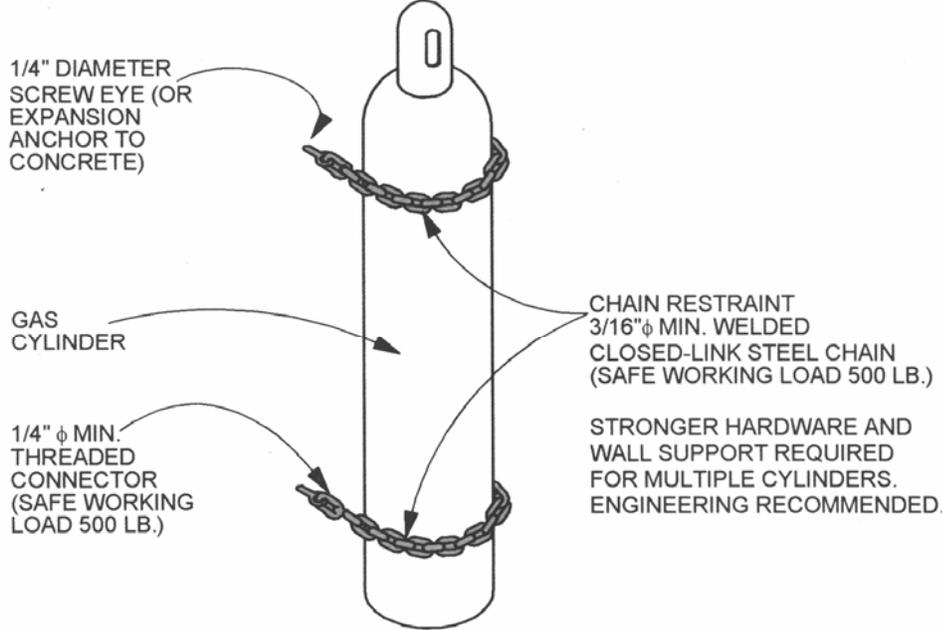
1/4" DIAMETER SCREW EYE (OR EXPANSION ANCHOR TO CONCRETE)

GAS CYLINDER

1/4" ϕ MIN. THREADED CONNECTOR (SAFE WORKING LOAD 500 LB.)

CHAIN RESTRAINT
3/16" ϕ MIN. WELDED CLOSED-LINK STEEL CHAIN (SAFE WORKING LOAD 500 LB.)

STRONGER HARDWARE AND WALL SUPPORT REQUIRED FOR MULTIPLE CYLINDERS. ENGINEERING RECOMMENDED.

Figure 8-3e Reproduction of FEMA 74 suggestions for securing compressed-gas cylinders.

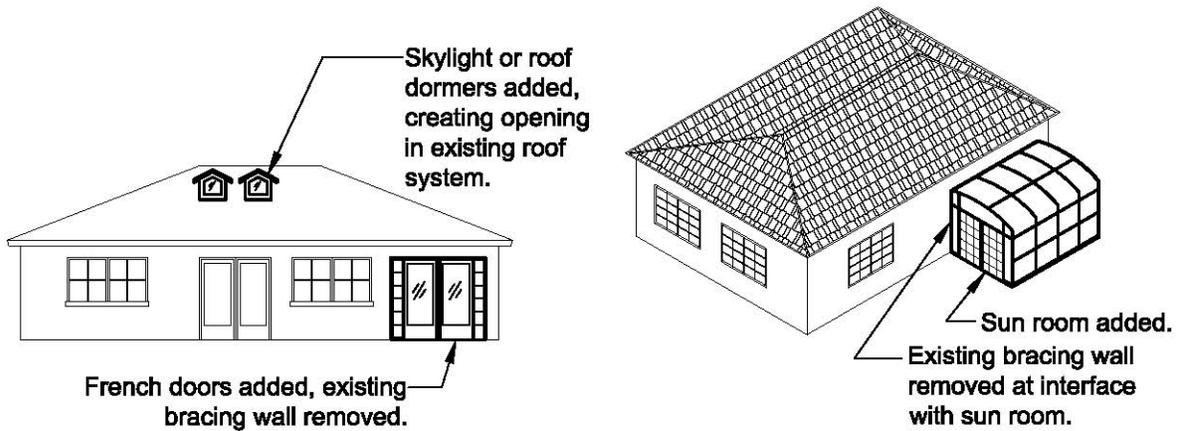
Figure 9-1 Alterations to existing house: bracing wall and roof modifications (left) and modification for the addition of sun room (right).

Alterations to existing houses often involve modification or removal of existing bracing walls and portions of floors and roofs. Figure 9-1 shows two alterations that remove exterior bracing walls from a house and disrupt the roof. Interior remodels often remove interior walls that provide bracing for earthquake and wind loads.

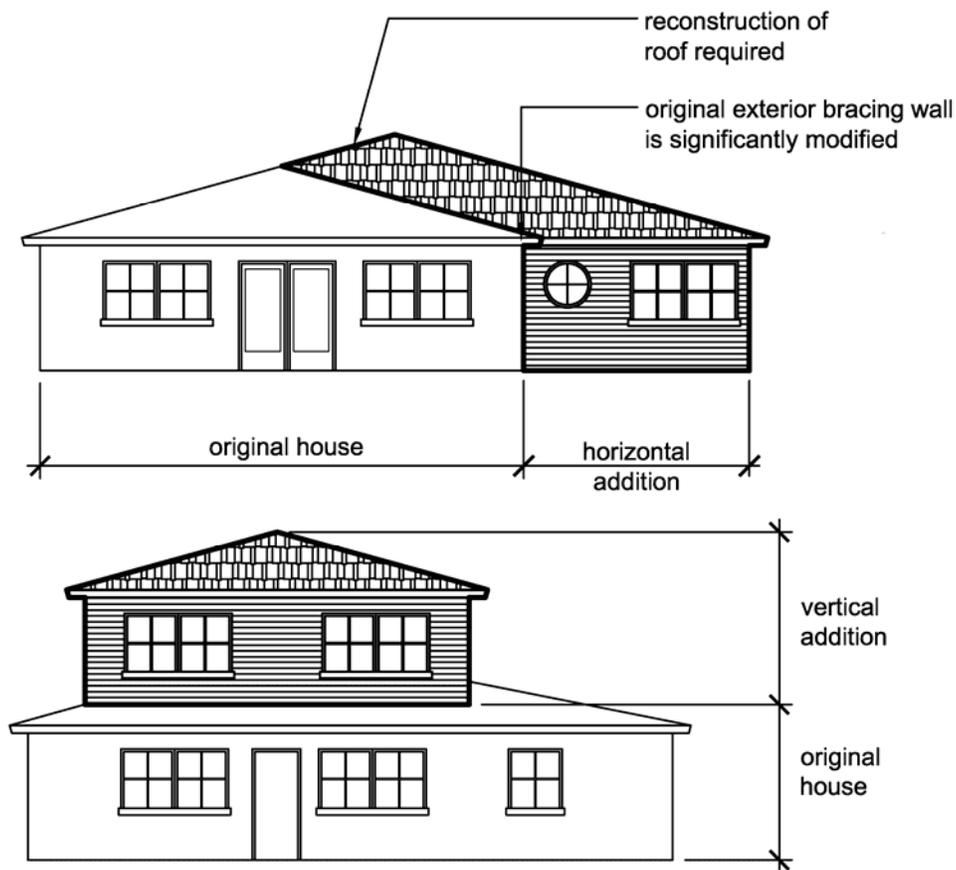
Figure 9-2 Horizontal addition (above) and vertical addition (below).

An addition to an existing house often results in both the removal of some existing bracing wall, roof, and floor areas and the addition of weight and, therefore, increased earthquake loading. Most additions can be categorized as horizontal additions, vertical additions, or a combination of the two. Horizontal additions generally are built along the side of an existing house and often require reframing of the roof. Vertical additions generally involve the addition of an upper story. Figure 9-2 illustrates horizontal and vertical additions.

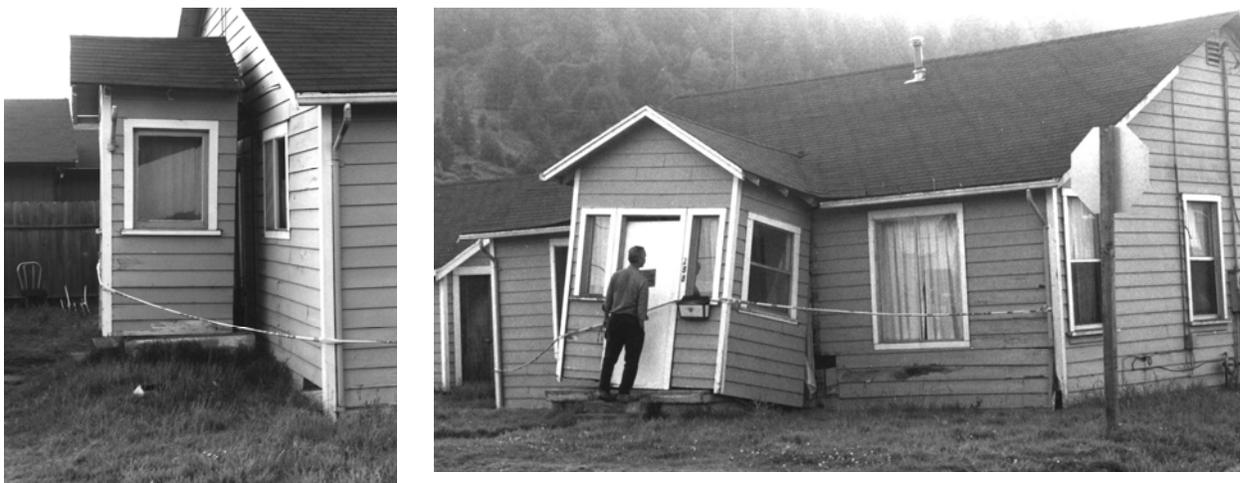
Figure 9-3 Cape Mendocino earthquake damage to cripple wall house with slab-on-grade additions.

Sheathing should be continuous and fastened to the same or interconnected framing members where possible. Where not possible, strapping of framing members should occur at a regular interval. Figure 9-3 shows the earthquake behavior of a house with failed cripple walls and adjoining (very small) slab-on-grade addition; a combination of cripple wall upgrade and strapping between the house and the addition would have greatly improved the performance of this house.

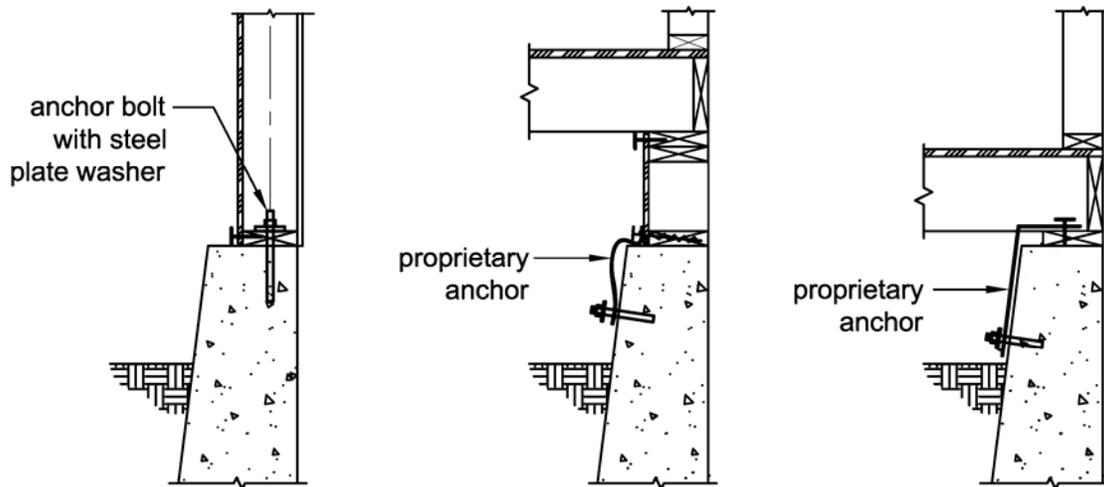
Figure 9-4 Common anchorage configurations.

Many houses constructed in California before the 1950s and even later in other parts of the United States do not have anchor bolts that attach the wall bottom plate or foundation sill plate to the concrete or masonry foundation. During an earthquake, this can allow the wood framing to slide off the foundation, causing loss of vertical support and sometimes cripple wall or partial basement story collapse. Where the headroom and foundation configuration permit, this situation can be remedied by adding new anchor bolts. Common anchorage configurations are illustrated in Figure 9-4. Expansion-type anchors can be used in strong concrete and masonry foundations. Adhesive anchors are recommended for use with unreinforced masonry or weaker concrete foundations but can be used with all foundation types. When anchor bolts are added, use of steel plate washers in accordance with the *IRC* is recommended.

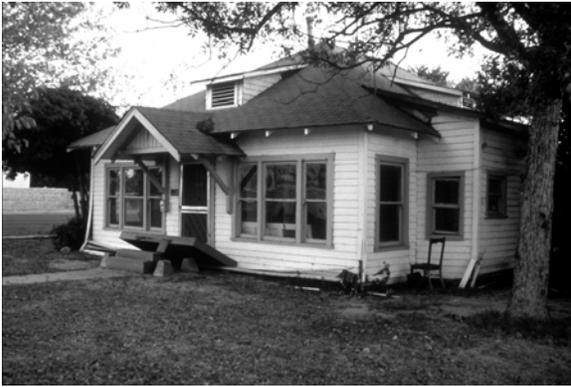
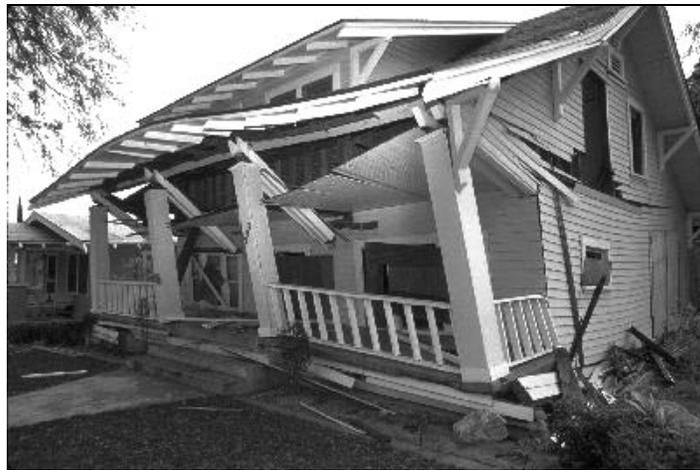
Figure 9-5a House with collapsed cripple walls. Photo Courtesy of National Information Service for Earthquake Engineering, University of California, Berkeley

Figure 9-5b A house with severe damage due to cripple wall collapse. Photo Courtesy of FEMA.

Cripple walls are partial-height wood light-frame walls that extend from the top of the foundation to the first framed floor. Cripple walls are very susceptible to damage during an earthquake but are also one of the easiest portions of a house to upgrade for improved earthquake performance. Many of the cripple walls of existing houses (especially those constructed prior to 1960) have inadequate bracing capacity due to the type of sheathing used, inadequate attachment of the sheathing, inadequate attachment of the framing to the foundation and first floor, or decay of the system. Figure 9-5a shows a house with collapsed cripple walls (note that the porch floor is still at the original house floor elevation). As a minimum, this house will have to be jacked up to be repositioned on the foundation and have utilities reconnected. The house in Figure 9-5b suffered more severe damage due to cripple wall collapse.

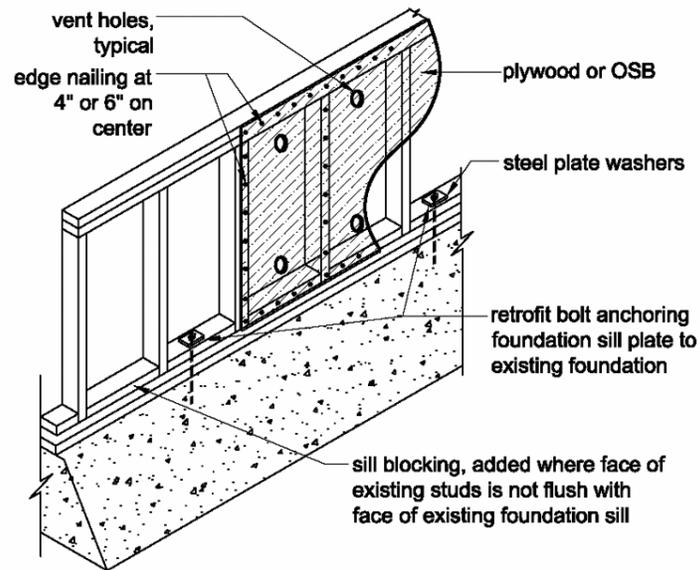
Figure 9-6 Cripple wall bracing.

Prior to an upgrade, the existing cripple wall system should be inspected and any sections of the framing that show signs of decay should be replaced. Framing materials in areas where moisture is present or in contact with the foundation should be replaced with preservative treated or decay-resistant materials. The upgrade should include anchorage of the foundation sill plate to the foundation, framing anchorage to the first-floor framing, and sheathing of the cripple walls with wood structural panel sheathing applied to either the exterior or interior face of the crawl space walls. Sheathing and connections may be installed to meet the requirements of the *IRC* or in accordance with other provisions developed specifically for upgrades. The basic elements of cripple wall bracing are illustrated in Figure 9-6.

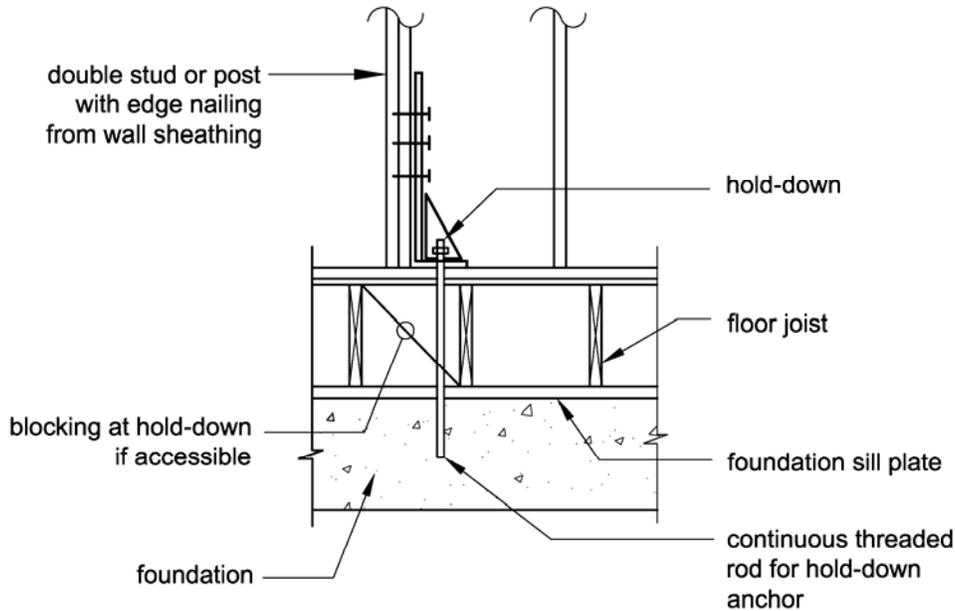
Figure 9-7 Weak- and soft-story bracing.

Earthquake damage often is concentrated in the first story of multistory houses because the first story experiences higher loads while usually having the least amount of bracing. To reduce this damage, the first-story walls can be upgraded to increase their strength and stiffness. One method of accomplishing this is to remove the interior finish material (usually gypsum wall board or interior plaster) at the bottom of the wall in the corners of the house and to add hold-down anchors for overturning resistance. The anchors should be attached to the end studs (or other studs that have sheathing edge nailing) and the vertical rod or bolt should be attached to the foundation below (see Figure 9-7). This upgrade does not require that the entire interior finish be removed but only a section in each corner that is one stud spacing in width and several feet in height. This is an effective upgrade measure where continuous reinforced foundations exist.

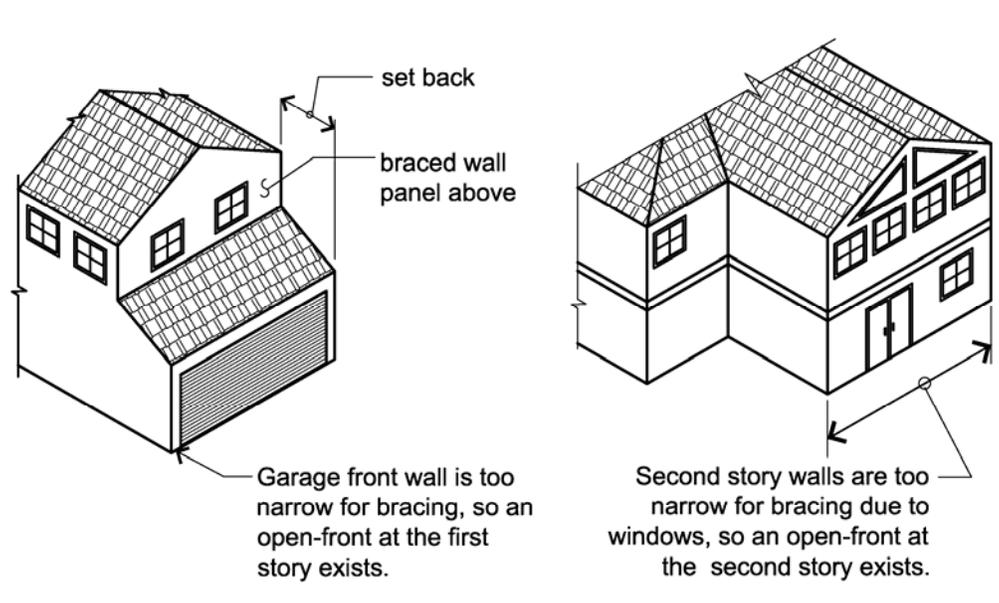
Figure 9-8 Common open-front occurrences in one- and two-family detached houses.

front configurations in one- and two-family houses are the fronts of attached garages with inadequate bracing length and window walls with no bracing. These conditions are illustrated in Figure 9-8.

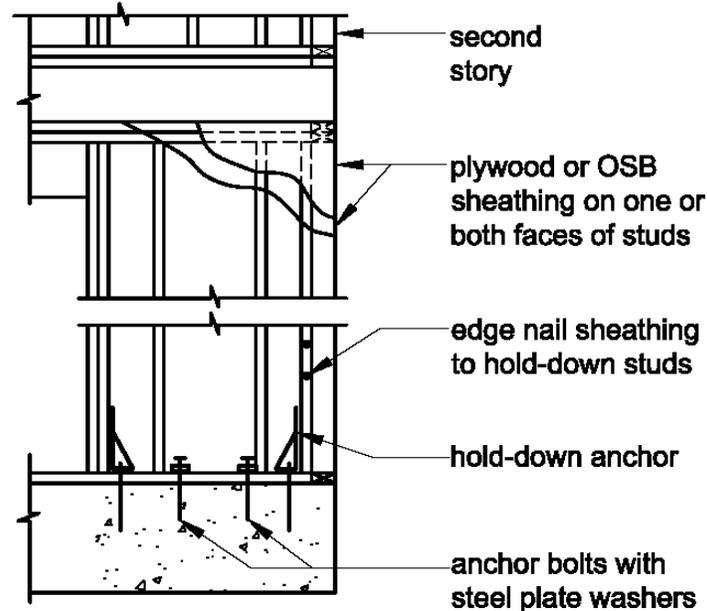
Figure 9-9 Detailing of narrow bracing wall piers at open fronts.

The open-front garage condition is of most concern when there is living space over the garage. In newer houses, narrow wall segments at the side of garage door openings may contain pre-fabricated bracing wall systems or engineered bracing walls that can be identified by the use of steel hold-down connectors or straps. Where there is no indication of such bracing systems, the installation of bracing is recommended. In detached one- and two-family houses, wood structural panel sheathing and anchorage connectors can be added in accordance with *IRC* provisions using adhesive anchors to existing foundations (Figure 9-9). The performance of narrow bracing walls with hold-down devices relies on the continuity of the existing foundation. If the existing foundation is not continuous, shows signs of damage or is constructed of unreinforced masonry or post-tensioned concrete, an engineering evaluation should be undertaken. Steel moment frames or collectors transferring loads to other portions of the house are alternative upgrade measures where use of bracing walls is not possible.

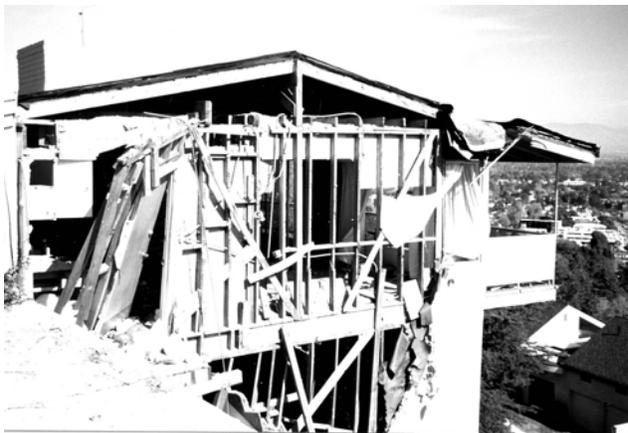
Figure 9-10 House located on a hillside site damaged during the Northridge, California, earthquake.

A number of houses on steep hillsides collapsed or were severely damaged in the Northridge earthquake. Where damage occurred, the lot sloped downward from the street level, and the main floor of the house was located at or near street level with either a stilt system or tall wood light-frame walls between the house and grade. Many of the failures began with floor framing pulling away from the uphill foundation or foundation wall. Typical damage to these types of houses is shown in Figure 9-10. As a result of Northridge earthquake damage, the City of Los Angeles has developed provisions for anchoring such houses to their uphill foundations to reduce the risk of failure.

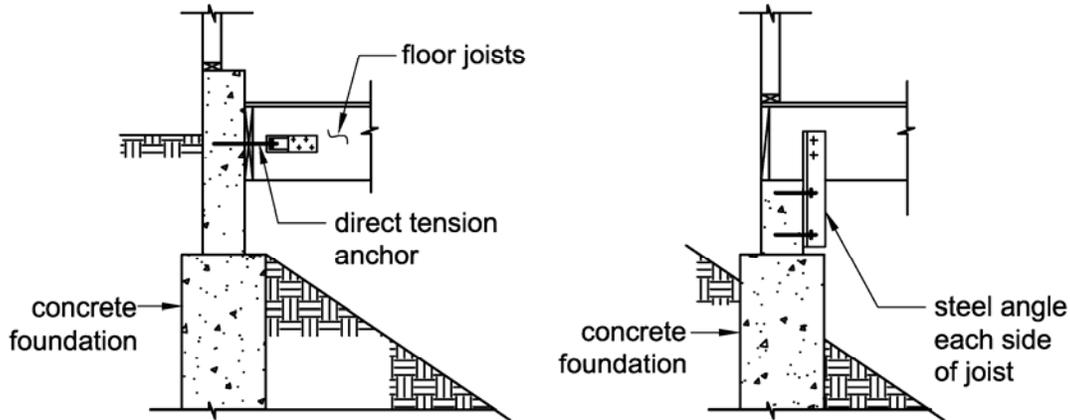
Figure 9-11 Anchorage of floor framing to the uphill foundation.

- Securely anchoring the floor framing to the uphill foundation. This will require that anchors (i.e., hold-down connectors) be used to attach the floor joists to the foundation

using adhesive anchors (see Figure 9-11). This detail should be repeated at each framed floor level that attaches directly to an uphill foundation.

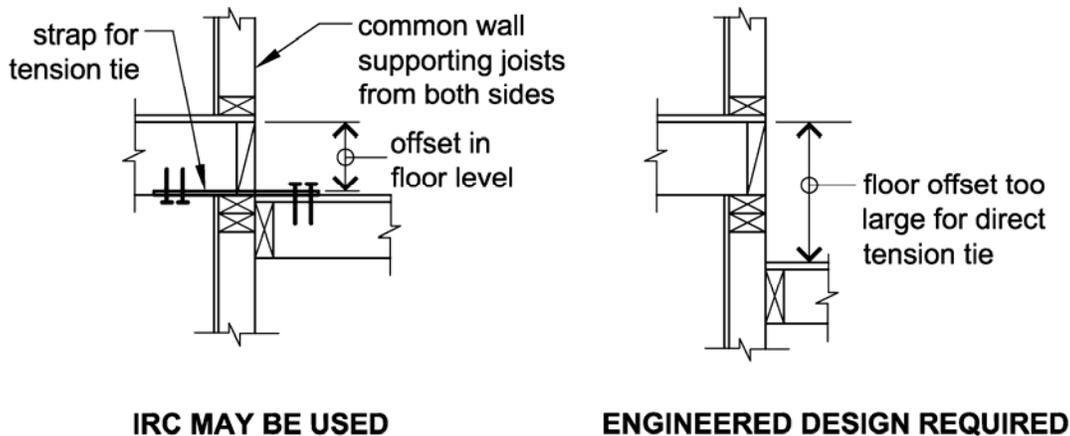
Figure 9-12 Split-level ties for floor framing.

Split-level houses experienced partial collapse and significant damage in the 1971 San Fernando earthquake. These houses had vertical offsets in the floor framing elevation on either side of a common wall or other support as shown in Figure 9-12. Earthquake damage occurred when sections of floor and roof framing pulled away from the common wall. (See Section 2.3 of this guide for additional discussion of irregularities.) The behavior of split-level configurations can be improved by adequately anchoring floor framing on either side to the common wall. Where offset floors are close enough in elevation that a direct tension tie can be provided between levels, an upgrade can be accomplished with installation of steel straps; a strap spacing of not more than 8 feet on center is recommended (Figure 9-12). Where direct tension ties are not practical, ATC (1976) provides a variety of details for anchorage of framing to the supporting wall. Finish removal will often be required in order to install connections, making this upgrade most practical when remodel work is occurring. It is difficult to establish a priority for this upgrade because significant damage was observed only in the San Fernando earthquake and photos suggest that the houses damaged had little or no positive connection provided between offset floor levels. An applicable reference is *A Methodology for Seismic Design and Construction of Single-Family Dwellings* (ATC, 1976).

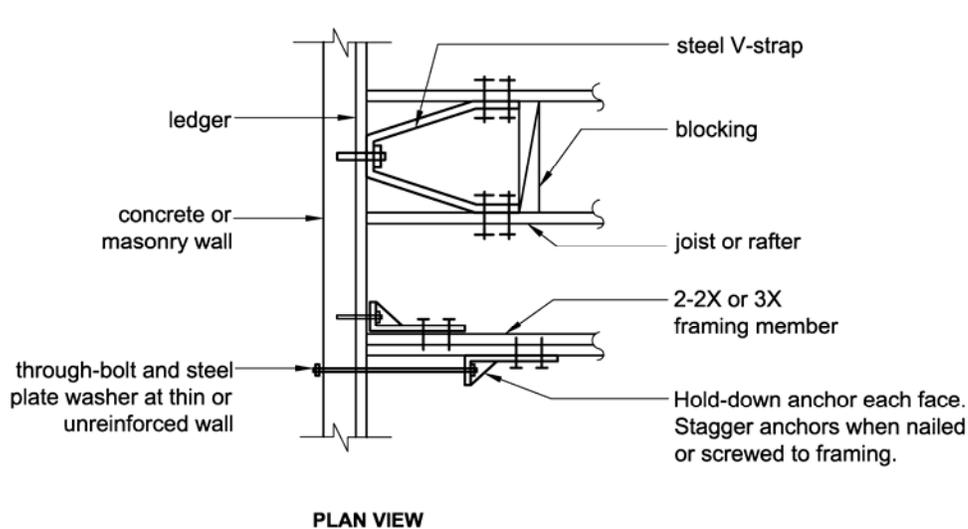
Figure 9-13 Anchorage of concrete or masonry walls to floor, roof, or ceiling framing.

Under earthquake loading, concrete and masonry walls can pull away from roof and floor framing. This is primarily a concern where bolted ledgers support framing and no direct anchorage of the wall to the framing exists. This condition can be effectively upgraded by providing a tension connection between the wall and the floor and roof framing as shown in Figure 9-13. The connection should be made to the joists when the joists run perpendicular to the wall and should be made to blocking and extend at least 4 or 5 feet into the interior of the floor system when the joists run perpendicular. An engineering evaluation of the existing condition and engineered design of upgrade measures are recommended.
