Stream Bank Repair Measure Protects Sewer Line

Full Mitigation Best Practice Story

Broome County, New York

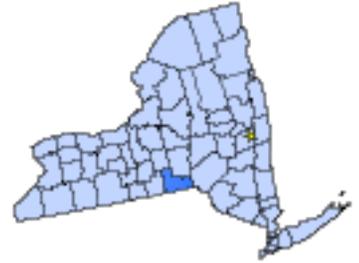
Albany, NY – Repairs of a section of a stream bank in the Town of Vestal, damaged by Tropical Depression Ivan last fall, included special measures that have proven to be successful in protecting an adjacent sewer line.

Together with restoring the stream bank to its pre-disaster condition, the Choconut Creek project also involved installation of filter fabric and large stone rip rap to protect the sewer line from erosion. The special mitigation work amounted to about \$3,400 of the total \$42,000 project cost, with the federal share at about \$32,000.
