Built to Protect Against Floods, Windstorms, and Earthquakes

Full Mitigation Best Practice Story

Columbia County, Oregon

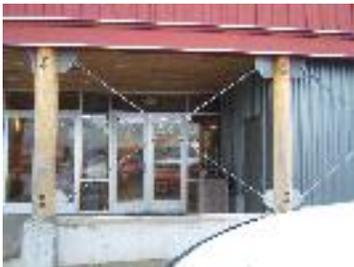
Exterior load-bearing construction

Now, the building is anchored on pilings set 60 feet into the bedrock. The all-steel exterior is reinforced from the roof down to the floor and then secured to the pilings, and the roof sections were machined together so that there are no seams to catch the wind.

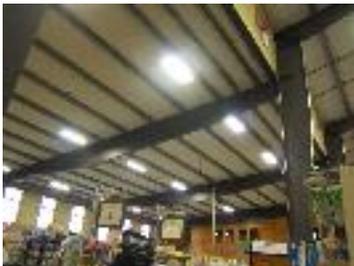
Interior load-bearing construction

Stemper hired engineers to design a building that would protect his investment from damages and his employees from injuries resulting from floods, windstorms, and earthquakes. The storm drainage system was re-engineered, and the entire structure incorporates the best features of continuous load-bearing construction.
