## Multiple Mitigation Measures Save Home From Wildfire

### Full Mitigation Best Practice Story

#### *San Diego County, California*

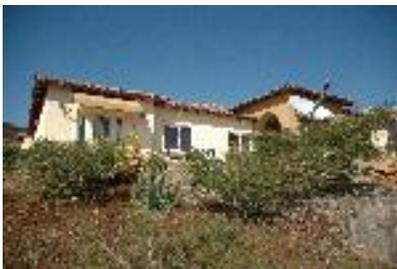
The Bullocks home – untouched by the Harris Fire - October 2007

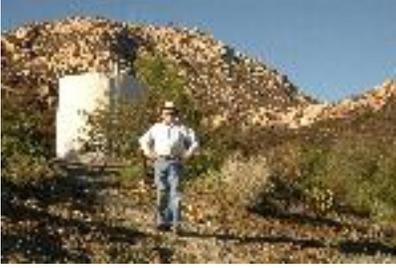
10,000-gallon water tank

The next thing the Bullocks will do to enhance protection of their property is remove a pine tree that was growing next to the water tank behind and upslope from their house.

That decision was made when the Bullocks found out that vegetation by a water tank could ignite, destroying the water tank, as had happened on other properties in other fire areas.

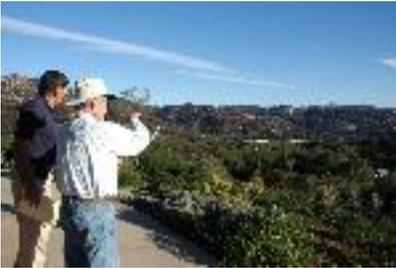
Defensible space on Bullocks property

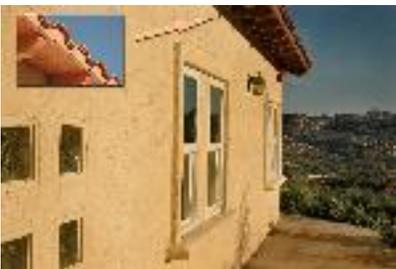
Boxed-in eaves, stucco exterior, double-pane windows, fire alarm and hardscape

A wide swath of defensible space planted with fire-resistant vegetation that is watered regularly with a special irrigation system helped save their home. So did its construction – a tile roof with boxed-in air vents that repel flying embers, stucco walls, concrete aprons around three sides of the structure, and the asphalt driveway at the back of the house. The Bullocks also have a fire hydrant (required by the county as a condition of the building permit) fed by water from a 10,000-gallon water tank.
