## High Marks for Accuracy: Tracking Flood Levels in Lewis County

### Full Mitigation Best Practice Story

#### *Lewis County, Washington*

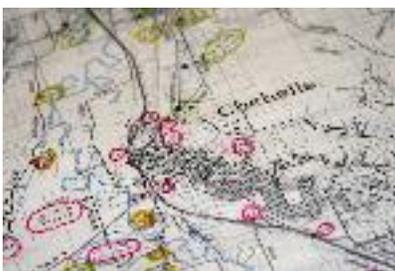
Map displaying high water marks

“We’re teaming up with the Cities, the State’s Department of Ecology, and the Federal Emergency Management Agency (FEMA) to complete the collection of elevations,” said Matt Hyatt, Lewis County’s Geographic Information System (GIS) Manager. “Our GIS Division is acting as the central location for collecting and distributing the maps and information that will aid in the planning effort. Once all the elevations have been surveyed by the different agencies, we’ll compile them into a single map, which will demonstrate the extent and depth of the inundation area, and assist analysis by the flood engineers and specialists to better understand the exact nature of this event.”

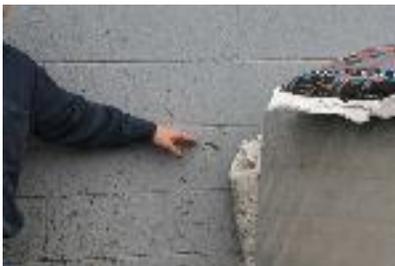
Martin Roy indicates one of the high water marks made on a building

The procedure to capture water elevation data is initially simple. A series of points are marked throughout an impacted community. These can take the form of marks made on walls, nails driven into telephone poles, and other similar methods of indicating how high the water actually reached. At each point, a Global Positioning Satellite (GPS) reading is taken and a description of the area and marking is noted.
