South Padre Island: Living with Mother Nature's Wrath

Full Mitigation Best Practice Story

Cameron County, Texas

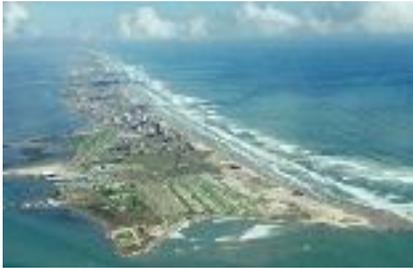
City Hall, South Padre Island

A case in point is City Hall, completed just before Hurricane Dolly. It fared very well with just minor water damage from rain that came through and under a door.

City Hall is a shiny new building, colorful and very pleasant, with generous impact-resistant windows that fill the rooms with sun and light. But on closer inspection, it is also a vault. It has a concrete, monolithic-pour roof deck, and its floors and ceilings are poured concrete with concrete blocks filled between the massive columns.

“This building is equipped with an on-site generator and was built to weather a moderate storm, the kind we just had with Dolly,” Mitchim said. “The entire two-story City Hall is built 10 feet above sea level. That's two feet higher than the code requirement. Why? To build in an extra measure of safety for this critical public building near the sea.”
