## *Katrina's Challenge: A Small Elevated House*

**Pascagoula, MS** – Laura Watson’s house on Pine Street in Pascagoula, Mississippi, has suffered damage over the years from repetitive flooding caused by heavy rains and hurricanes. Concerned that she would have to leave the home and community she loves, Ms. Watson decided it was necessary to take steps to mitigate her home against storm damage after Hurricanes Elena (1985) and Georges (1998).

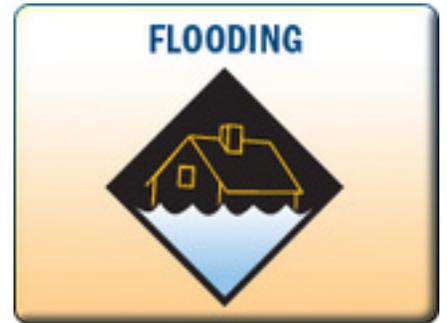
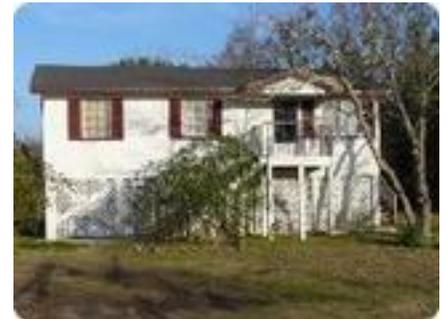
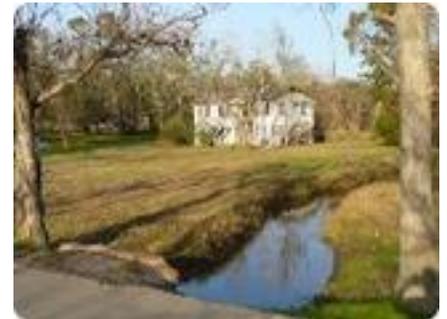
The house was elevated to 14.1 feet above mean sea level on eighteen 10-inch by 10-inch timber pilings embedded six feet into the ground. The pilings are located on the front, center, and back of the house for support. White lattice, which is designed to break away, conceals a storage space beneath the home. Corner bracings were added for further support, and galvanized hurricane straps were also installed.

Ms. Watson surveyed her house for damages, and was amazed to find that practically everything was intact. There was one broken window on the back of the house and scattered debris in the yard from surrounding properties. Upon further inspection, she discovered that although the house was elevated, five feet of water had entered the living area. However, Laura noted, “if my house had not been elevated it would have been completely under water.
